NEW ZEALAND ARCHAEOLOGICAL ASSOCIATION NEWSLETTER

DAMAGE TO MAORI ROCK CARVING
IN NORTH OTAGO

N.F. Turner

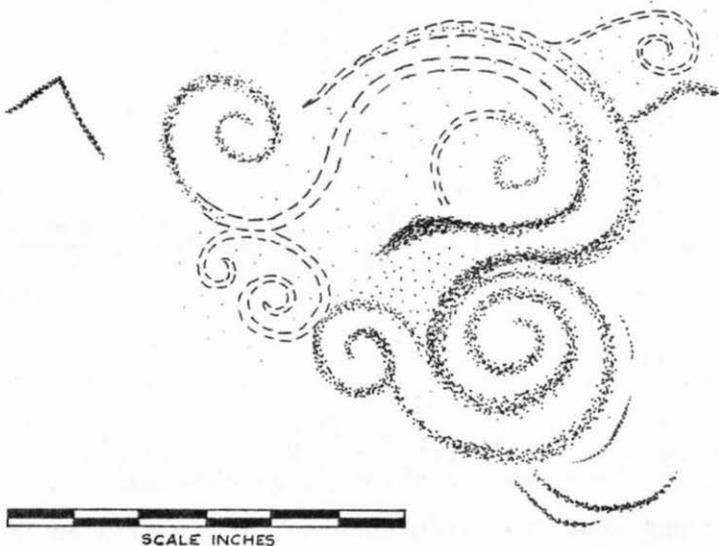
The shelter containing the carving is a low, shallow, south-facing overhang, large enough to accommodate two or three people lying down, and the spiral design was probably carved from this position as it is close to the floor (though this has doubtless built up in recent years). The damage was caused in a well intentioned attempt to make a cast of it by placing a wet plaster of paris mixture against the rock and removing it when dry.

This has resulted in large flakes of the soft friable limestone being broken off as the plaster was removed, completely destroying some of the spirals and damaging others to the extent that the lines can only just be traced (photographs of the design before and after damage are held at the Canterbury Museum). Quite apart from this not being a suitable way to make a cast (it is not possible to get an accurate positive from it), the rough handling is deplorable, and clearly demonstrates the necessity of preventing untrained personnel attempting to investigate pre-historic sites without supervision.

In the illustration herewith (based on a recent Canterbury Museum photograph and an earlier charcoal sketch by the writer) the dashes indicate parts of the carving destroyed while the stippling shows how it now appears.
