# RECORDING THE HUTTON STREET CEMETERY, OTAHUHU

ARDEN CRUICKSHANK AND MATTHEW  
CAMPBELL  
CFG HERITAGE

In 2012 unconsented fills were dumped in the Roman Catholic cemetery at Hutton Street, Otahuhu, in the gully that ran through the cemetery, and several graves bordering the gully were damaged. The Catholic Diocese of Auckland agreed to remediate the damage by removing contaminated fill, landscaping the balance and repairing damaged graves. CFG Heritage were commissioned to record the damage to graves and their repair, as well as monitor fill removal and contouring (Judge and Mallows 2012; Campbell 2013; Cruickshank 2014).

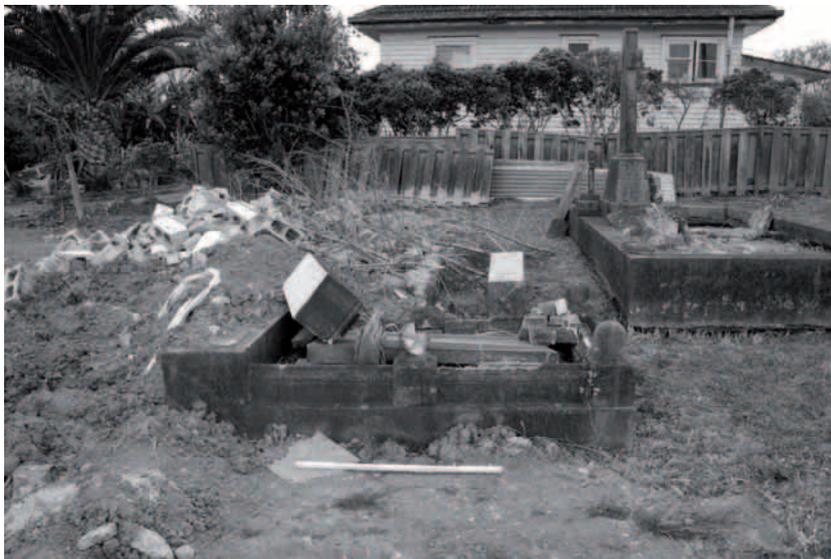
This grave plot was severely damaged as a result of the earthworks. Either the deposition of fill or the use of machinery in the area has led to the headstone toppling over, resulting in damage to the headstone and kerbing. Fill had been deposited around the western, northern and southern edges of the grave. It was not possible to record the headstone in any detail during initial assessment as it had fallen face down and many of the motifs had been broken off. The monument and grave surrounds were repaired by Stone Conservation Ltd, which involved cleaning, resetting the headstone and repairing it, resetting the concrete kerbing and rebuilding surface damage with

*Figure 3. Grave 1, the Molloy and Little grave, before remediation.*

It was difficult to tell what condition the grave plot was in before it was impacted by the fill dumping. The damage to the central orb posts appeared to be old, as the iron reinforcing bars were heavily corroded and the patina of the damage was not as light in colour as the fresh damage associated with the toppling of the headstone.

The unconsented fill dumping caused serious structural damage, not only to the headstone but the north eastern corner had been shunted out of alignment. There was a portion of the northern edge kerbing that was missing, but it did not appear to be recent damage.

The fill that was packed around the western and northern edges of the grave plot was a mixed clay fill, which contained less of the large chunks of concrete that were present in the fill in the immediate vicinity. This gave the impression that it was intentionally placed around the grave in an attempt to prevent damage to it.

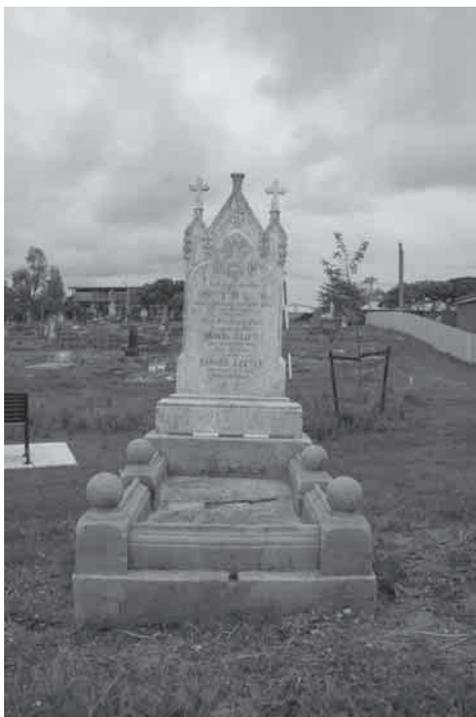
*Figure 4. Grave 1, the Molloy and Little grave, after remediation.*

either lime-based mortar or marble dust mixed with an epoxy. Once this was done it was recorded in detail.

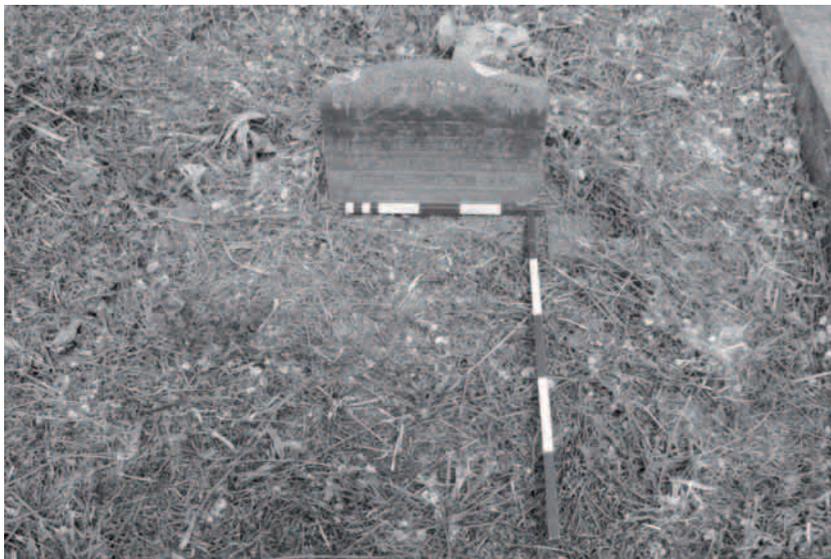
This plot was initially feared to have been badly affected by flooding that occurred once the gully had been filled. The high water mark is visible on the headstone as a dark line above the word 'PATRICIA' in Figures 5 and 6. All that was visible of the grave was a partially obscured headstone and what was assumed to be a segment of kerbing on the northern edge of the headstone. The soil obscuring the grave plot was finer than the fill material and it was thought to be connected to the flooding and general sediment flow down the hill.

*Figure 5. Grave 8, Patricia McFarlane, before remediation.*

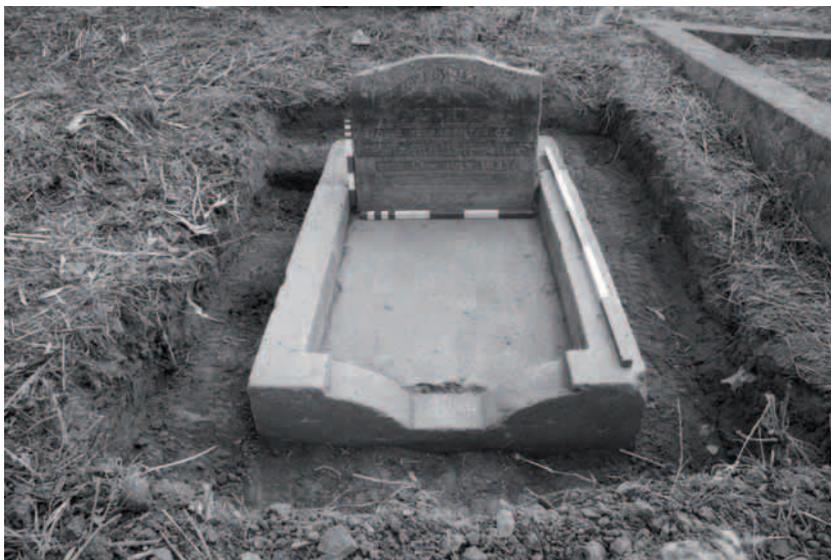
*Figure 6. Grave 8, Patricia McFarlane, after remediation.*

Once the sediment was removed two small areas of damage in the top corners of the headstone became visible, which appear as if it had had two small decorative items pinned into it. These were not recovered in the fill surrounding the grave and may have been stolen by vandals.

The headstone is not in situ, but has been placed back neatly on the bodystone. This is not thought to have happened during the filling event, as the damage to the portion of the kerbing where the headstone originally sat has a weathered patina.

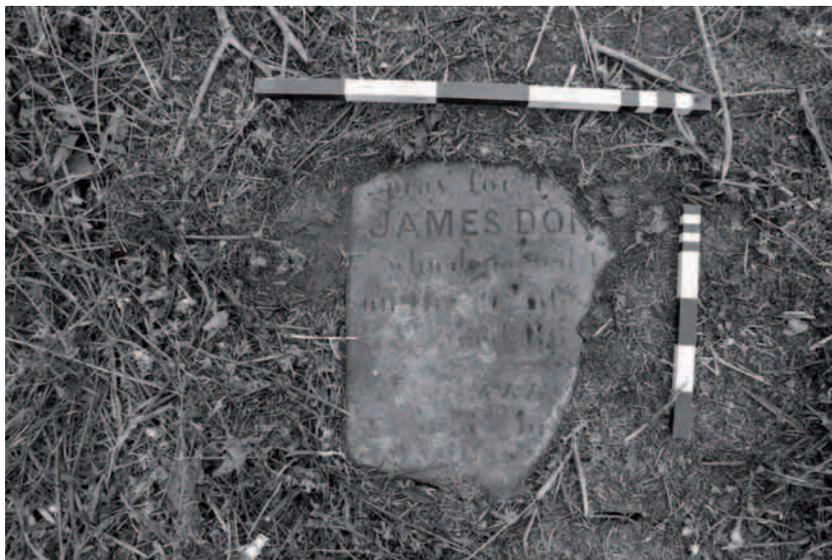
A fragment of headstone was initially uncovered in the grass to the south of the last visible grave along the east side of the cemetery. On clearing the grass around it, a further four fragments of the same headstone were recovered. Judging by the distribution of the fragments, it is likely that it fell and broke and has remained in situ. The headstone appears to be a limestone flat-topped marker with a central semi-circle element. The damage to this grave was not associated with dumping of fills. The text has been incised into it and reads:

*Figure 7. Grave 15, fragment of James Donnelly's headstone.*

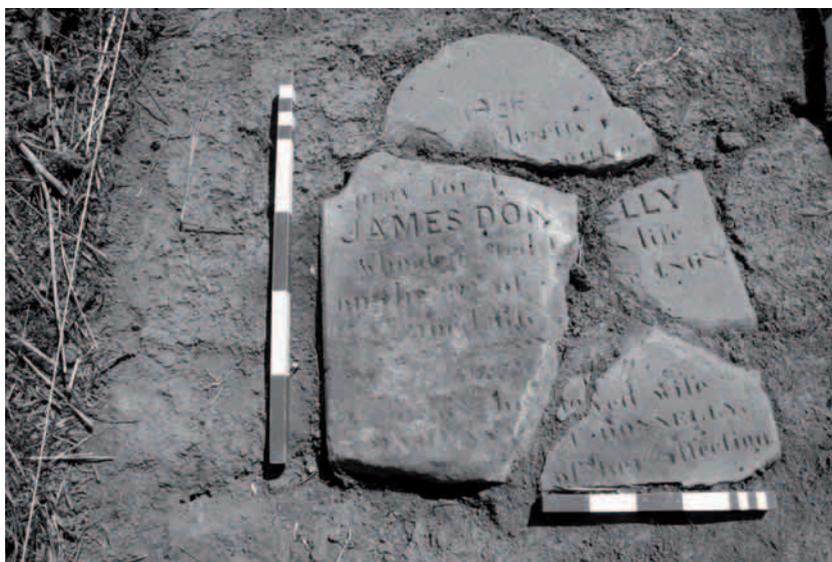
*Figure 8. Grave 15, four fragments of James Donnelly's headstone after excavation.*
