Recycling & Working Class Architectural Respectability

The Buildings Archaeology of 38 Richmond Street, Dunedin

**Peter Petchey
Southern Archaeology Ltd.**

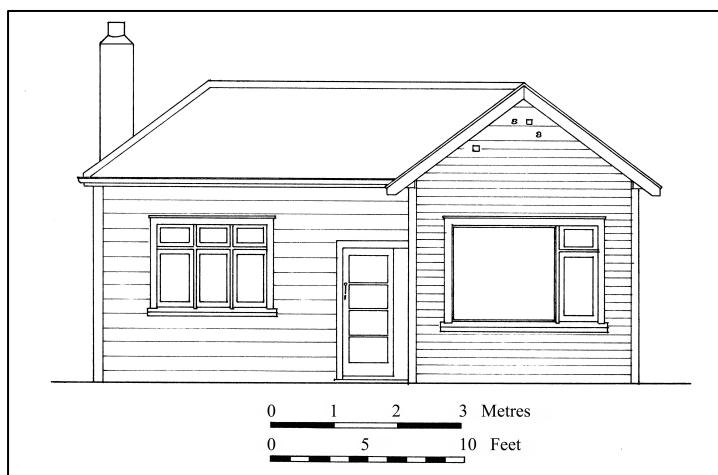
The house stood with its front square to the street, as was the universal practice at the time of its construction. The façade consisted of a single bay on the south side with a large plate glass window with side casement, a four-panel glazed front door, and a three-casement window on the north side (Figure 3). The overall proportions of the house gave away its late nineteenth century origins, but the late Victorian detailing that it would once have possessed had been removed.

Figure 3. The front of 38 Richmond Street in 2016. The basic form was of a small bay cottage, but all of the windows had been changed to update its appearance during the twentieth century.

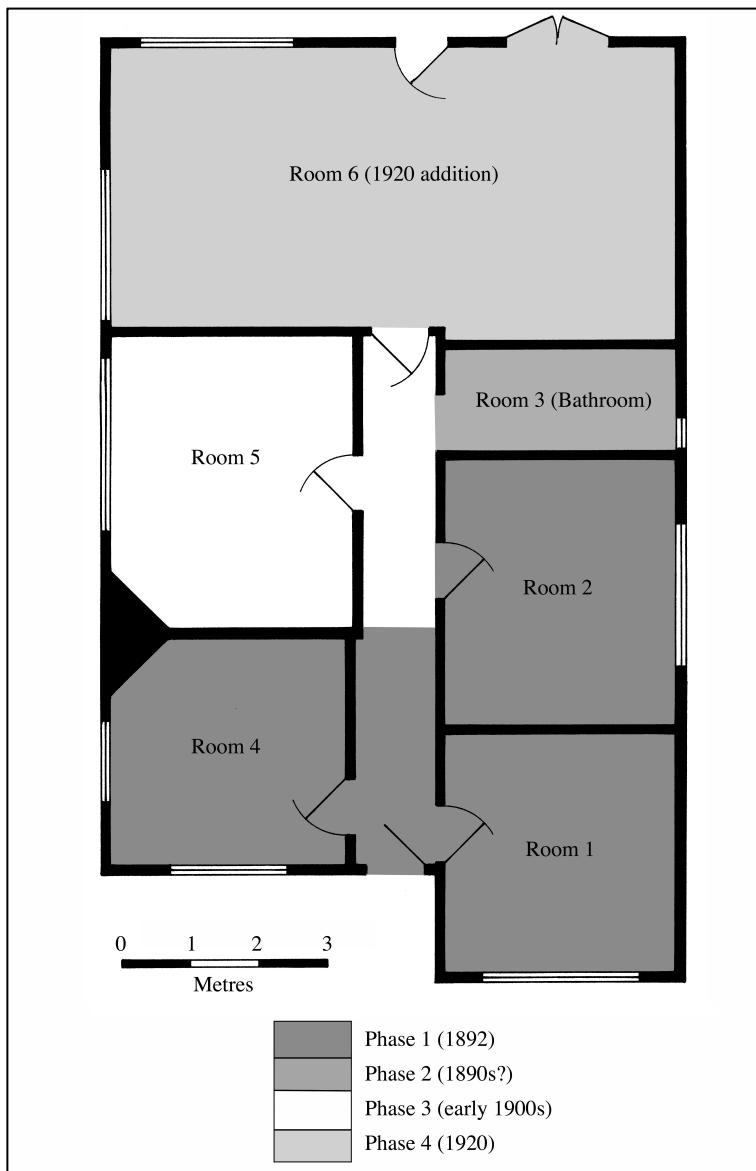
Figure 4. Floor plan of 38 Richmond Street in 2016 showing building phases based on examination of the house structure and room number used in the house description.

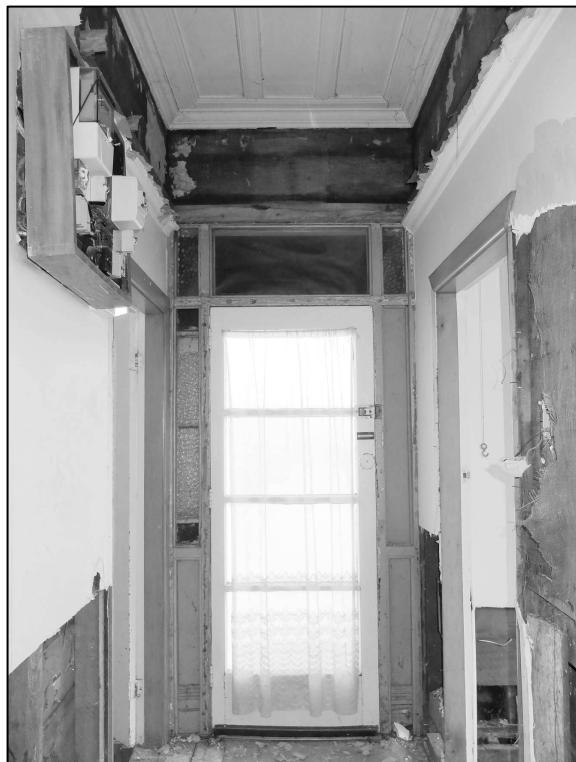
Figure 5. The hallway, showing the original hall ceiling that had been hidden by a later dropped ceiling, and the old door frame with sidelights and fanlights.

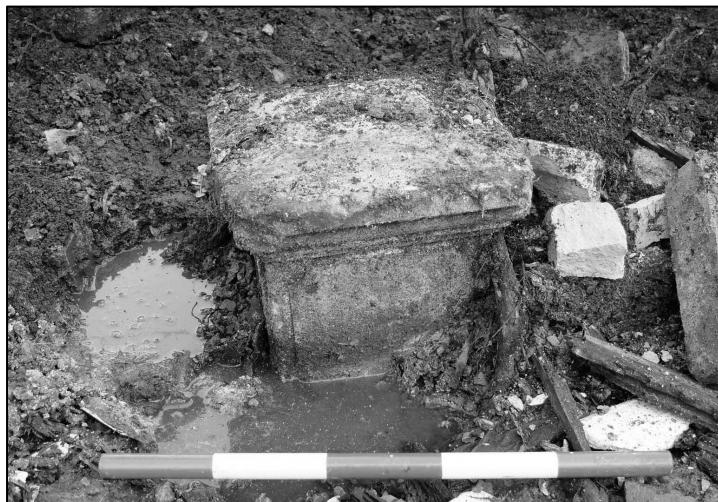
The foundations were mainly timber piles, many of which were rotten, and there were numerous repairs in concrete and timber along the front wall, including a carved limestone post (Figure 6) that had been used as a support. This was clearly recycled from elsewhere, although it was not possible to determine whether it was incorporated during the 1892 house build or during a later repair. The piles of the rear 1920 extension (Room 6) were concrete, and some were formed simply by using a bucket as a mould, and one galvanised steel bucket was even left in place on the pile it had created (Figure 7). These piles simply sat on the surface and were not dug into the ground.

Figure 6. The carved limestone post that had been incorporated into the front wall foundations.

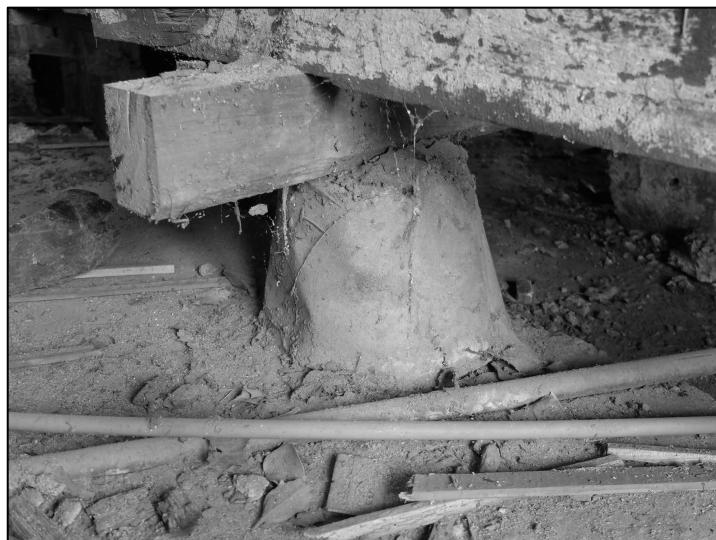
Figure 7. Bucket shaped concrete pile with the bucket left in place in the 1920 section of the house. These 'bucket' piles were not set into the ground, but just rested on an earlier asphalt surface.

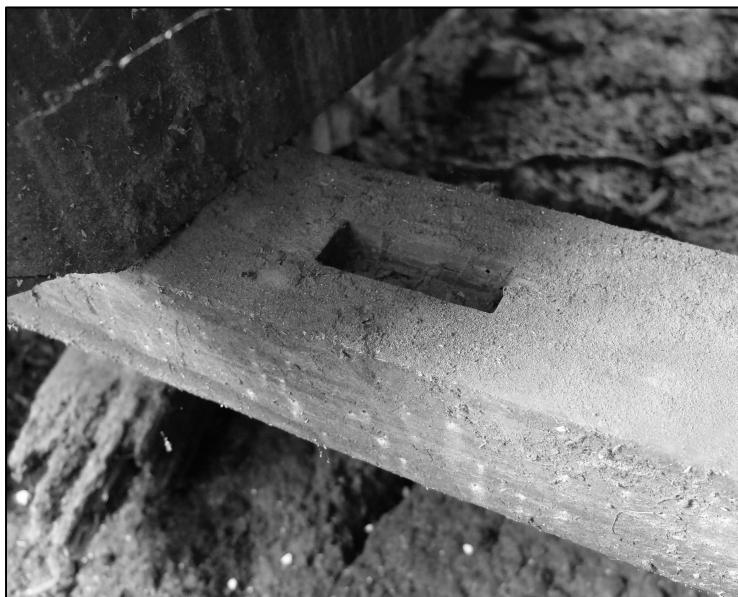
The floor framing in the front 1892 section of the house included bearers recycled from elsewhere, with redundant mortises (Figure 8). The wall framing in the same area (Rooms 1, 2, 4) was conventionally constructed from 2 inch by 3 inch (50mm by 75mm) studs set at nominal 22 inch (560mm) centres. The studs were butted and nailed into the plates, without the mortise and tenon joints that are often seen on slightly older houses. In Room 5 the external wall framing was conventional, using 2 inch by 4 inch (50mm by 100mm) studs at centres that varied between 16 inches and 17 $\frac{1}{2}$ inches (400mm to 450mm). The framing timbers and the sarking in this room appeared to be newly milled and of a more consistent appearance than the timbers in the other parts of the house, suggesting that unlike the original 1892 cottage and 1920 extension, new timbers were used when this extension was made. In the 1920 extension (Room 6) the wall framing was built from a variety of second hand timbers including 2 inch by 3 inch (50mm by 75mm) lengths laid flat. The sarking was a mixture of second hand timbers.

Figure 8. A floor bearer in the front section of the house with a redundant mortise, evidence of its earlier use, probably as a top or bottom plate of a timber framed wall.

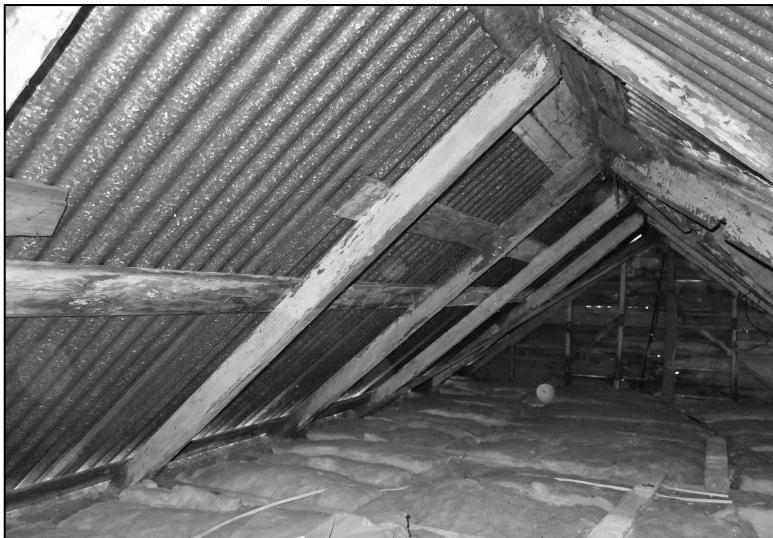
The roof framing was lightweight and roughly built. The rafters were all recycled timbers of varying sizes (Table 1), and were widely and variably spaced, from 39 inches (1m) to 49 inches (1.24m) (centre to centre) apart. There was minimal use of purlins: in some places only a board at the top and bottom of the roof plane and one in the middle (Figure 9), and these boards were simply reused 1 inch (25mm) thick planks. Once again, timbers with redundant mortises were used in the roof structure.

Figure 9. The very lightweight and sparse framing of the roof at 38 Richmond Street, possible only because corrugated iron was used as the roof cladding.
