ARCHAEOLOGY IN NEW ZEALAND

Stabilising an Ordinary Stone House Ruin

Jill Hamel

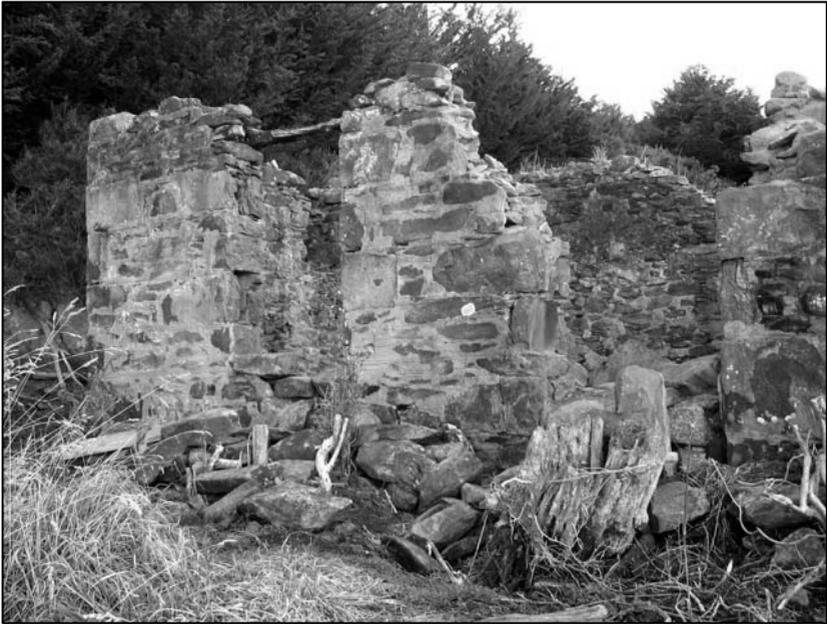
lintels had been wooden with all but one burnt out, and no sign of stone arches. There was one small fireplace remaining, with a metal bar as lintel and the chimney flue within the wall, i.e. there were no chimney stacks in need of stabilising. Everything that was *not* built of stone - the roof, floors and window frames - had been 'salvaged' by nearby crib owners. Two 5 m sections of wall retained their gables. Most of the other walls still stood 2.6 m high and 450 mm thick (Figure 2). The rock was mostly naturally split Dunedin basalt from nearby paddocks, except for large, shallow, fully trimmed blocks (500 x400 across and 120 mm deep) for windows, doors and corners.

Figure 2. McKessar's house ruin before stabilisation work was undertaken.

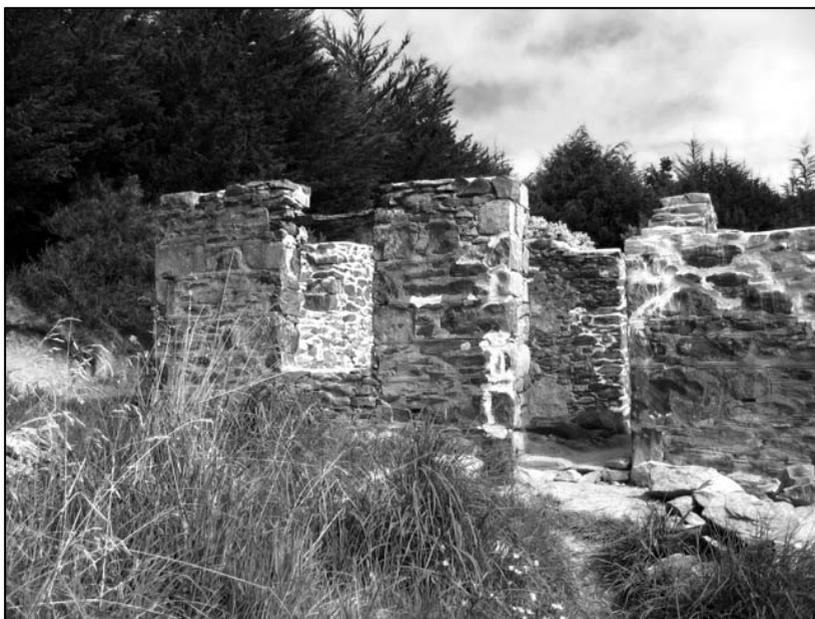
Figure 3. McKessar's house ruin after stabilisation work had been completed.

Virtually no trimming of stone by chisel was needed – it was a matter of slapping on the clay mortar and picking the right rock off the pile of fallen material. We capped the tops of the walls with small flat rocks set with cement, that could be easily removed (Figure 3). The clay for the mortar was taken from the bank that had been cut at the back of the house, where it could be easily dropped into a wheelbarrow. We used 18 bags (20 kg each) of quick lime made up into lime putty which had to cure for 6-10 weeks before use, but for later work on an adjacent building (Hamel n.d.), we used freshly baked hydrated lime which heated much more slowly (though vigorously), and which could be used within days of mixing.

Dunedin loessic clay made up most of the volume of mortar – 12 shovelfuls to 2 of lime putty and very little water – to make a malleable mortar. Pointing was done with a mix of white sea sand and lime putty - 3 shovels of sea sand to 1 of lime putty and a third of a shovel of clay for colour. Capping was done with 4-5 of sharp sand to 1 of cement. (Dunedin sharp sand is relatively yellow from the yellow quartz grains in it).
