ARCHAEOLOGY IN NEW ZEALAND

A Bridge Too Far? - The Burke St Wharf Project That Bankrupted The Thames Borough

David Wilton

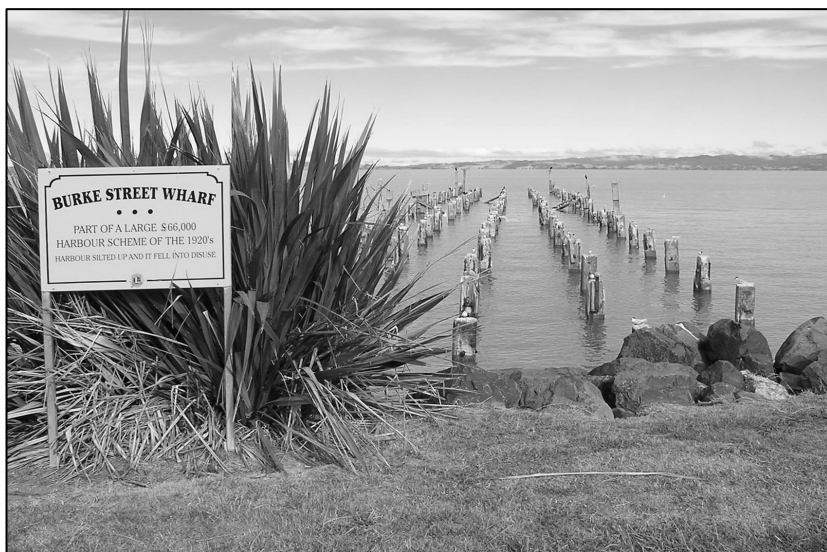
Figure 1. Burke St wharf as it is today. Apart from Shortland wharf, which is still intact and in use, this is the only visible wharf structure remaining in Thames or Taranaki.

At first glance, the archaeology of the wharf appears to be confined to the array of ferro-concrete piles, shown in Figure 1. Some of these have timber baulks bolted to them, and date from the 1920s harbour project. However, closer examination, at very low water, reveals an almost parallel structure of stubs of timber piles amongst the ferro-concrete, plus a few large timber piles tucked in close to the sea wall (partly concealed by flax bushes). The timber piles are likely to date from the original Goods Wharf of the 1870s, but have not been further investigated (e.g. dendrochronological dating may be helpful).

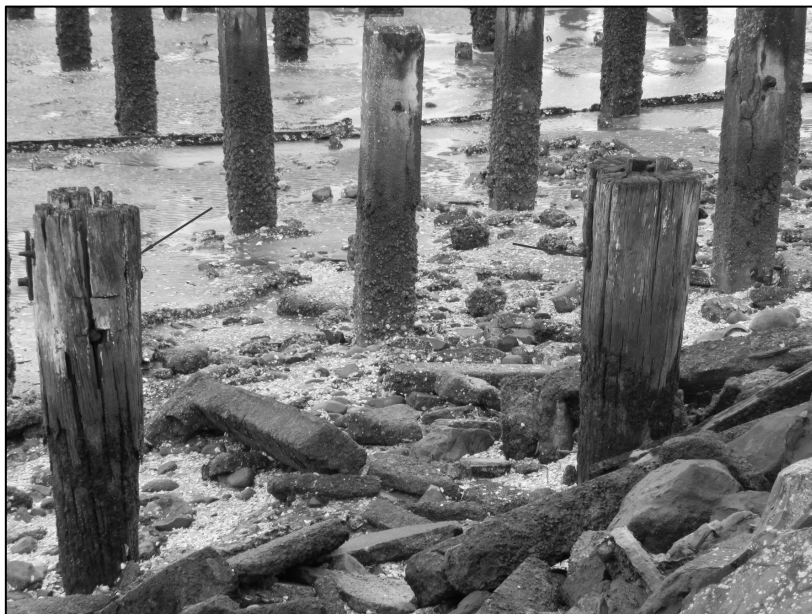
Figure 4. Large timber piles at landward end of the wharf structure; these were probably part of the original 1870s construction.

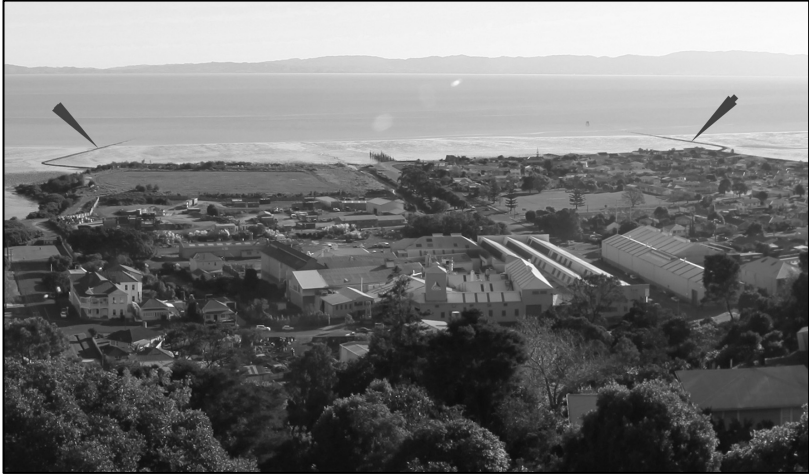
Figure 5. Burke St harbour - lateral breakwater walls indicated (Eric Gosse photo, taken from top of WW1 monument, Waiotahi Valley).

However, there is archaeological evidence that at least part of the enclosure structure was built. According to local surveyor Morrie Dunwoodie (Pers comm, July 2016) who was involved with the Moanataiari reclamation and subdivision in the 1970s, the landward (eastern) wing of the harbour enclosure was used as the base of the western sea wall for the subdivision. The northern and southern wings of the harbour enclosure (i.e. ‘laterals’) are still in situ (Figure 5), and can be negotiated on foot, almost to the outer ends, at low tides.

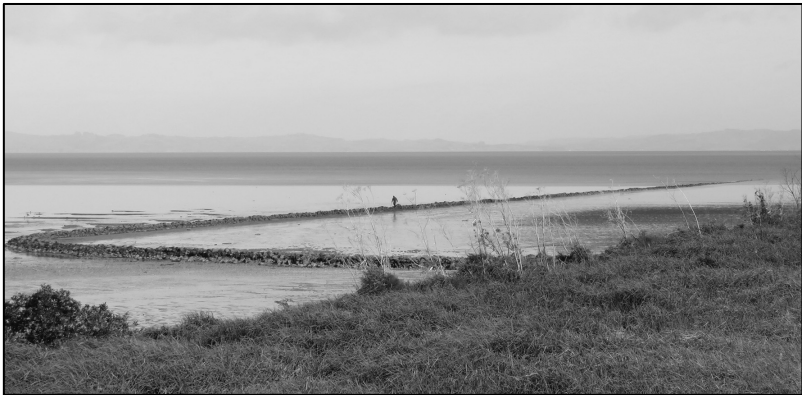
Figure 6. Southern lateral wall, taken at low tide.

Walking out to the end of the southern lateral wall didn't produce any definitive results, as the end of the wall was below low-water mark and one could only get to within about 20m of the (estimated) end. It was possible, however, to observe the northern lateral wall and that the wall appeared to end at the beacon.

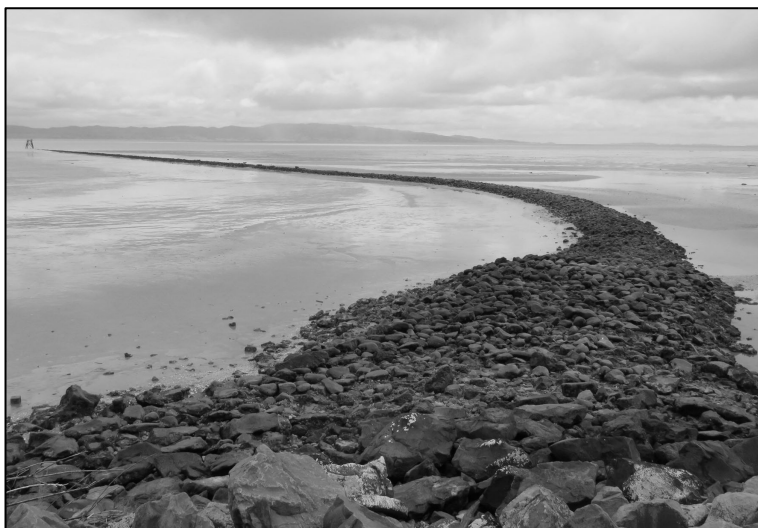
Figure 7. Northern lateral wall, leading to beacon (taken at low tide).

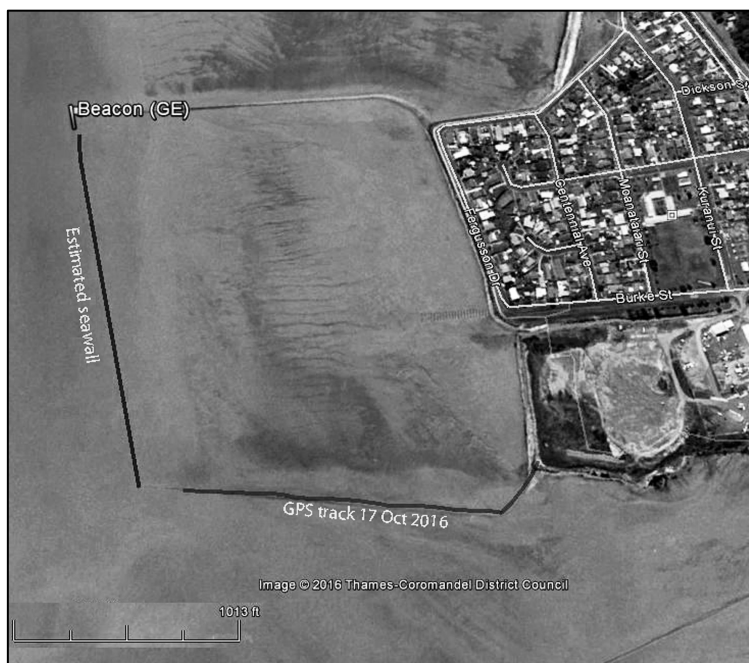
Figure 8. Google Earth view of Burke St wharf area - 2001 aerial photo taken at or near low tide. Shows lateral walls, the beacon at the western end of the north lateral, estimated location of seaward wall (if built) and GPS track from the 17th October attempt to walk out to the end of the southern lateral wall.

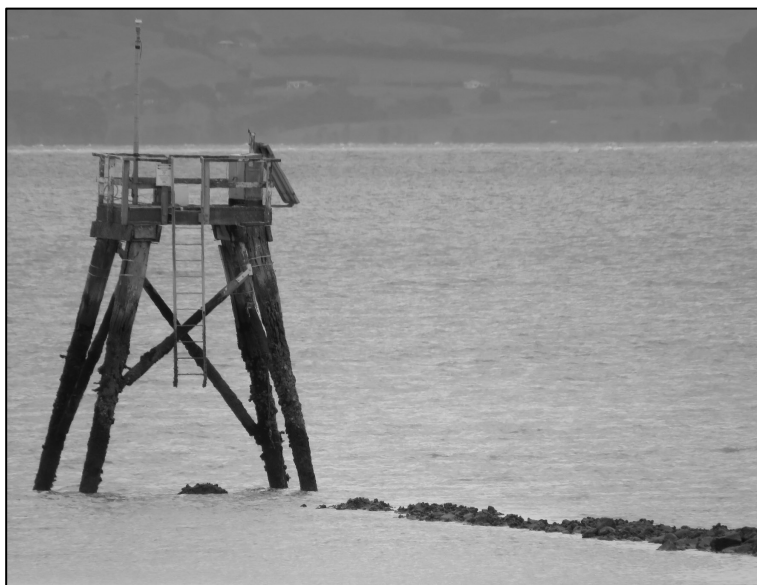
Figure 9. Beacon at seaward end of north lateral wall (taken at spring low tide, 'super moon' period).
