ARCHAEOLOGY IN NEW ZEALAND

A SURVEY OF HISTORIC COALMINING FEATURES ON THE HUNTLY COALFIELD

Neville A. Ritchie
Regional Archaeologist
Department of Conservation
Hamilton

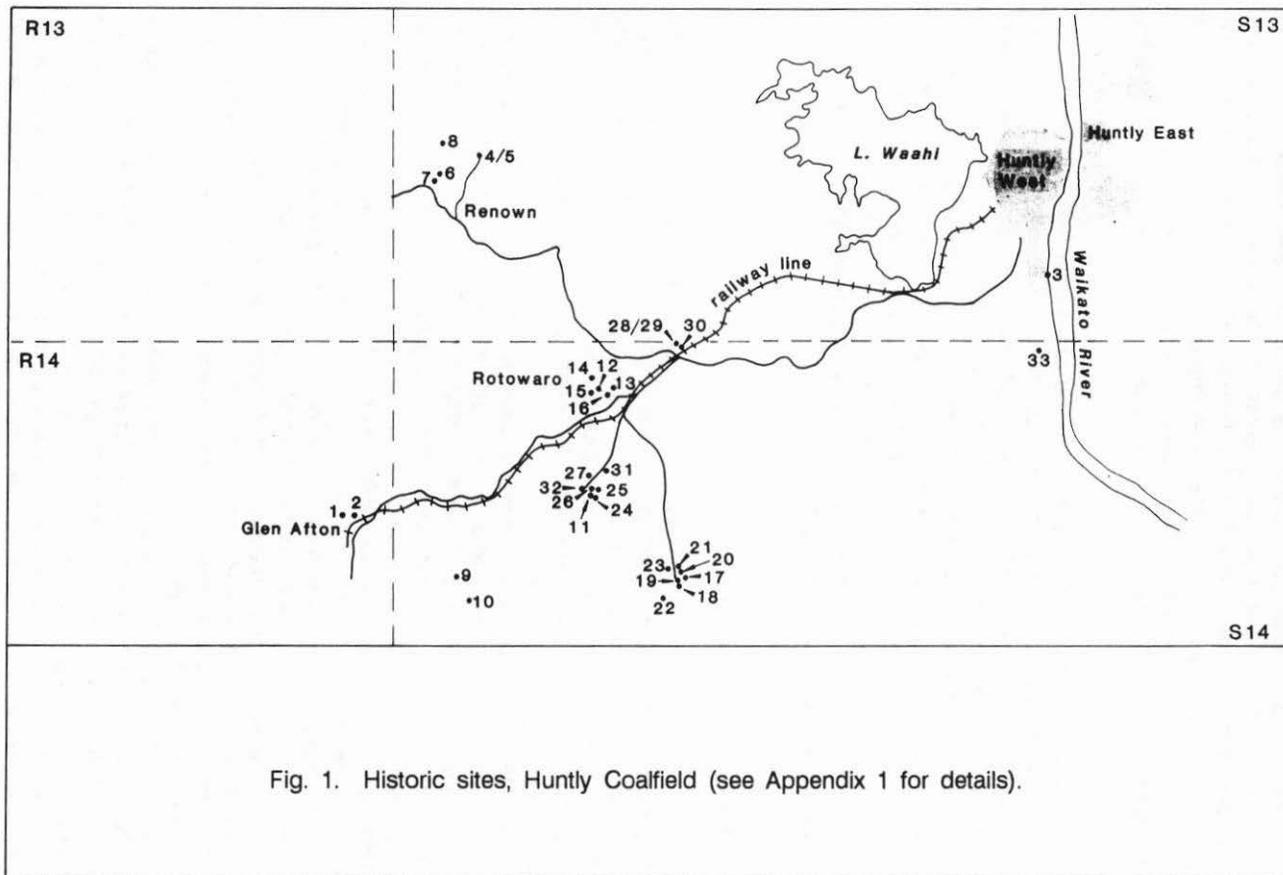
Fig. 1. Historic sites, Huntly Coalfield (see Appendix 1 for details).

This paper concerns the Huntly coalfield survey, during which Warren Gumbley and the author recorded 33 historic mining sites and their associated structural remains (Ritchie in prep.) (Fig. 1). The survey was limited to surface features. Dwellings were excluded.

On the Huntly coalfield, good examples of most of the types of structures and equipment associated with underground coalmining can now be found only around Rotowaro, and most postdate 1930 (Fig. 1). Virtually all traces of the equipment and structures associated with the first 50 years of mining on the coalfield, i.e. in the days when mining was centred under and immediately around Huntly township, have been removed or obliterated. These include the traditional pitheads (poppetheads/headframes) which were a feature of the early mining at Huntly, along with pit ponies (used in some of the mines), and coal wharfs along the Waikato River (the main archaeological evidence of pit ponies is the presence of stables near the pitheads).

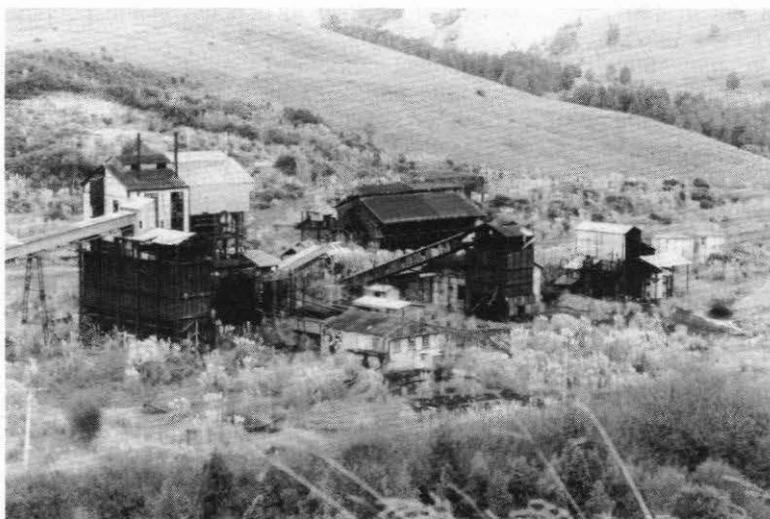
Plate 1. The Waikato Carbonisation Works site (S14/156) at Rotowaro.

A case in point revolves around the retention of the former Carbonisation Works and briquetting plant at Rotowaro. This major industrial facility ceased production and was abandoned in 1985. Recently the NZHPT declared the site a historic conservation area (Plate 1), much to the bewilderment of some local people who would prefer to see the plant demolished and the site restored to a more natural state (McKenzie, Simmons and O'Keeffe 1991). While their feelings are understandable (some had to contend with fumes from the plant), there is little appreciation of the historic role of the facility or its technology. Prior to the advent of automatic fuel-injected boilers there was no market for slack coal. When the establishment of a combined briquetting and carbonisation plant was first mooted in 1930 there was no opposition. On the contrary, it was widely considered that it would give a tremendous boost to the local industry because it would enable the utilisation of the vast tonnages of slack coal which still had to be brought to the surface even though there was no market for it. The plant was purchased in 1931 after a worldwide investigation into slack coal usage and with a view to finding a technological solution to the problem of the growing coal dumps around the Huntly coalfield. Despite the pollution problems (which weren't recognised as such in the 1930s) the Carbo Works achieved its purpose for many years. Thousands of tonnes of dumped slack coal were mined and converted into marketable briquettes (2 tons of coal produced 1 ton of briquettes), and other marketable byproducts. The slack coal mined subsequently was also utilised. During World War Two the plant was considered a strategic asset (the operators were exempted from overseas

The NZHPT's action is to stall for time. There is little possibility in the immediate future that the site can be interpreted and opened to the public (it is in a designated 'construction area'), but the Trust's initiative should ensure that it is not needlessly destroyed without due consideration of its historical and technological values. One of the difficulties with the site is that it is not ruinous enough. It has not had time to be reduced to a few key elements which people can more readily relate to and which would also make the ruins so much easier to maintain and interpret.

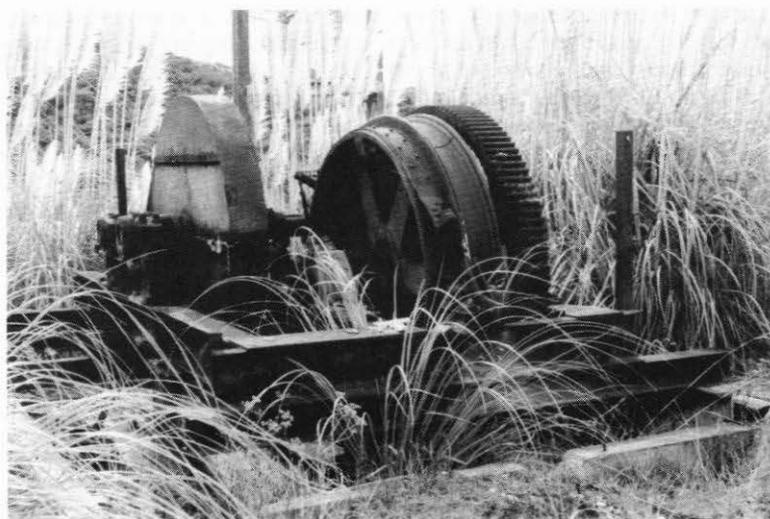
Plate 2. Winding gear and motor, Rotowaro No. 1 mine (S14/149).

Prior to the advent of opencast mining (which became economically feasible with the advent of modern earthmoving machinery) the only way to access an underground coal seam or other mineral deposits was by means of shafts or tunnels driven from the surface. Once an access has been created, it is necessary to establish a means of conveying the coal from the seams to the surface. Machinery associated with this work (Plate 2) includes headframes

for raising and lowering cages in shafts, and endless ropes (rope-roads) for hauling skips in and out of mines via inclined haulages. Belt conveyors have replaced rope-roads in newer mines. Archaeological evidence of surface haulages includes return wheel carriages, creeper loops (usually sited at the end of rope-road haulages, creepers are endless chains with hooks which catch onto the axles of skips and pull them along to a point where they can be clipped on to a main haulage again), and back balances (heavy counterweights to maintain tension on the ropeway - see Ritchie and Hooker in prep. for detailed explanations of mining terms). Cableways are often used to convey coal from mines, but were not used extensively at Huntly (the twin cableway which conveys coal from the Kopuku mine (North Waikato) to the Meremere power station is a good extant example). The only cableway located during the survey was used to convey limestone to the Pukemiro colliery railhead. Some coalfields, probably the most notable being that at Denniston on the West Coast, transported coal from the mines to loading facilities via substantial self-acting inclines (there were no similar self-acting inclines on the Huntly field).

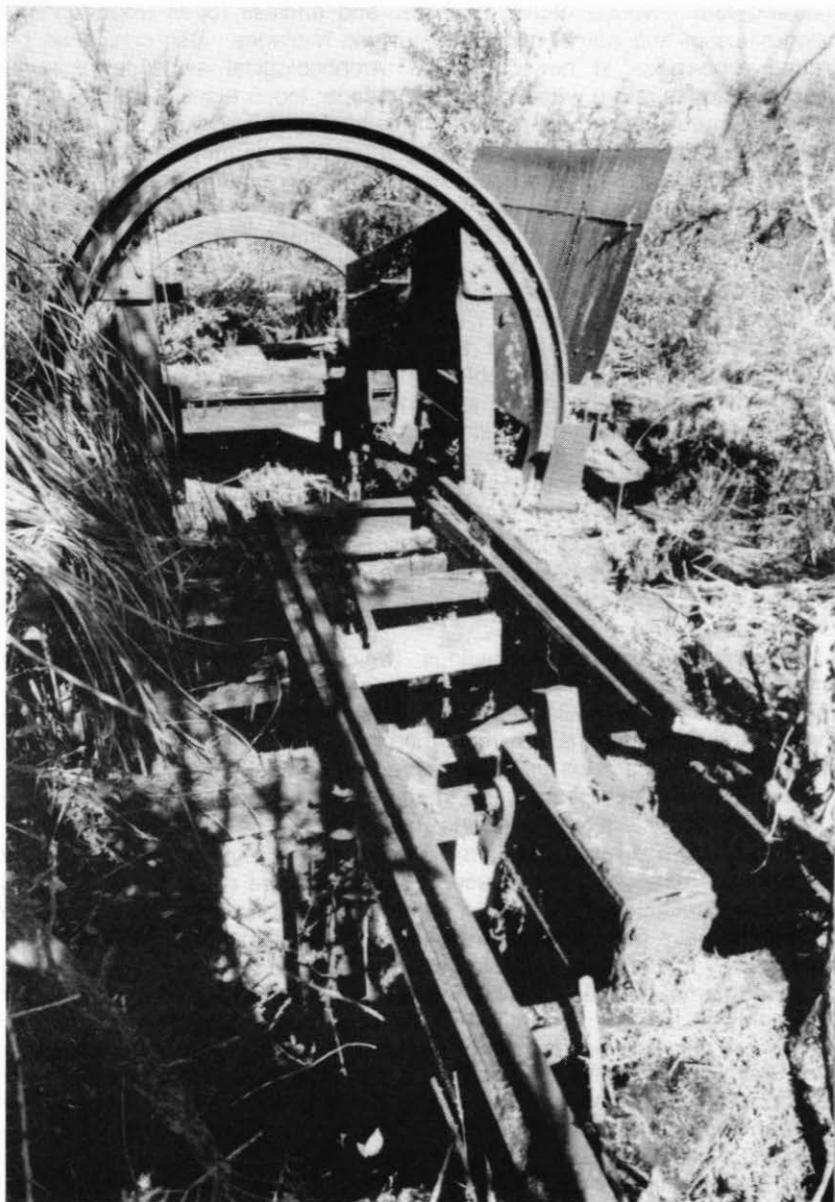
Plate 3. Renown mine rope-road tippler, Rotowaro (S14/152).

Auxiliary surface structures associated with haulage include clipping sheds (where skips are attached to the endless ropes); weigh bridges, and tippers. The latter are machines for inverting skips and tipping their contents into bunkers from which the coal is loaded (usually via a conveyor) into road or rail transport (Plate 3). Other surface coal-handling facilities include screens and bins for grading and storing coal. The latter are usually the most imposing mine-head structures.
