ARCHAEOLOGY IN NEW ZEALAND

The Archaeology of a Kitchen and Servants' Quarters in Maori Hill, Dunedin.

Jeremy Moyle

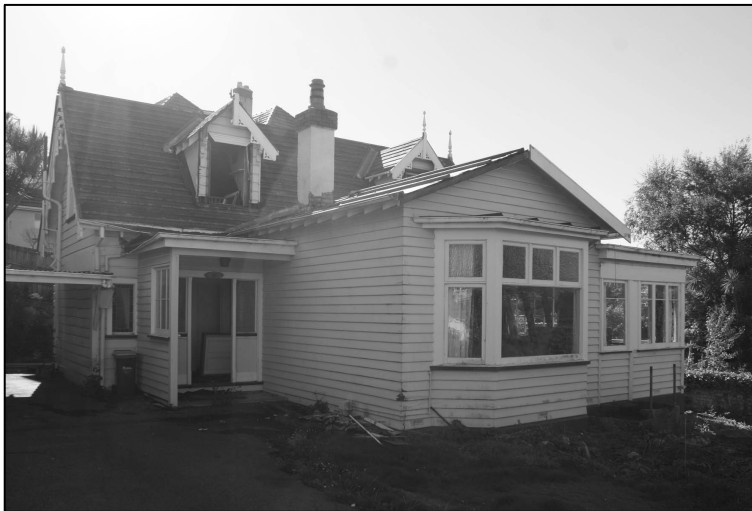
Figure 2. The house at 26 Drivers Road, looking north (J. Moyle).

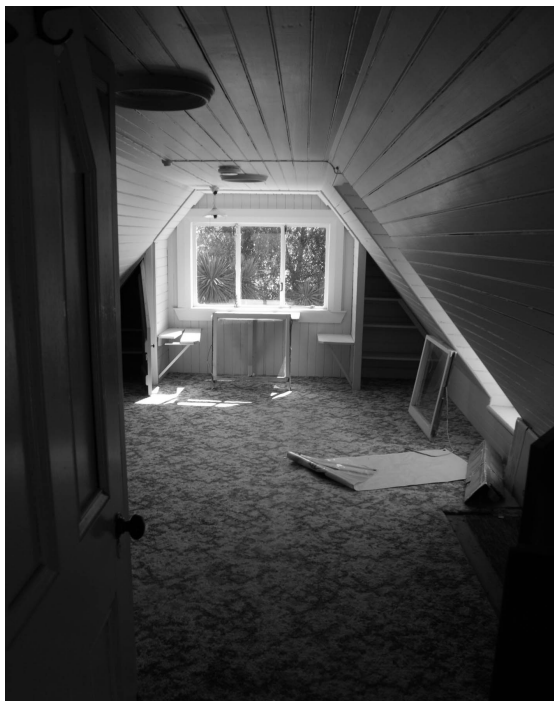
Figure 8 (left). Servants' bedroom, looking north-east. The window at the end is a 20th century addition; the gable space formally held the chimney for the kitchen range below.

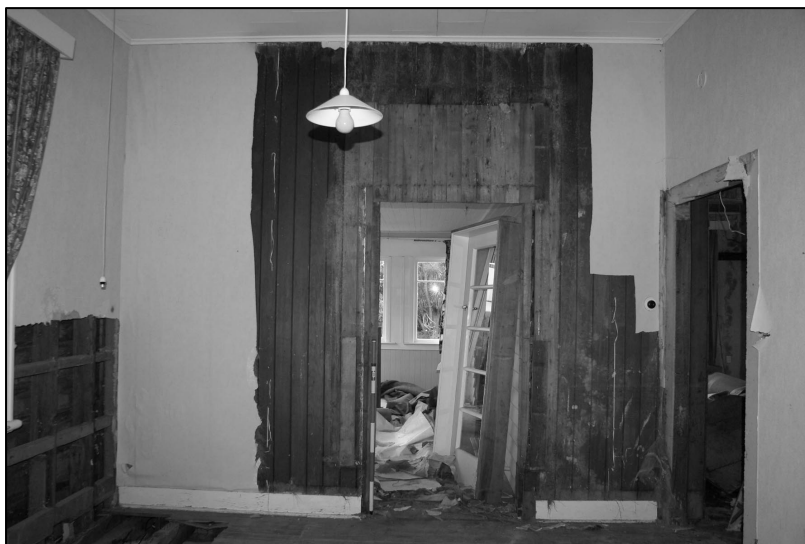
Figure 9 (below). Varnished match lining in what was originally the kitchen. The outline of a former south-east window removed in the 1927 alterations is also visible.

Match lining was used for the interior walls and ceilings throughout the entire original structure (Figure 9). The original treatment of this lining varied between rooms. 'Work' areas like the hallway and the kitchen had varnished timber. In other rooms it was painted: yellow-cream in the scullery, green in Room B, dark green in the staircase and Room I, and grey in the upstairs servants' bedroom. Marks on the walls of the scullery and kitchen indicated former shelving.

Light was provided around the building by a variety of different window types. Two very large 5 x 8 ft (1524 x 2438mm) sash windows were originally present on the south-east elevation. The remnant marks of which were most visible in the former kitchen space (Figure 9). On the north-west elevation there were smaller 6½ x 3¼ ft (198 x 991 mm) windows. While only three windows were evident on this side, it is possible there was a fourth that was destroyed by the 1970s addition. Above, the two attic rooms were each lit by single small sash windows set in south-east facing dormers (Figure 2).

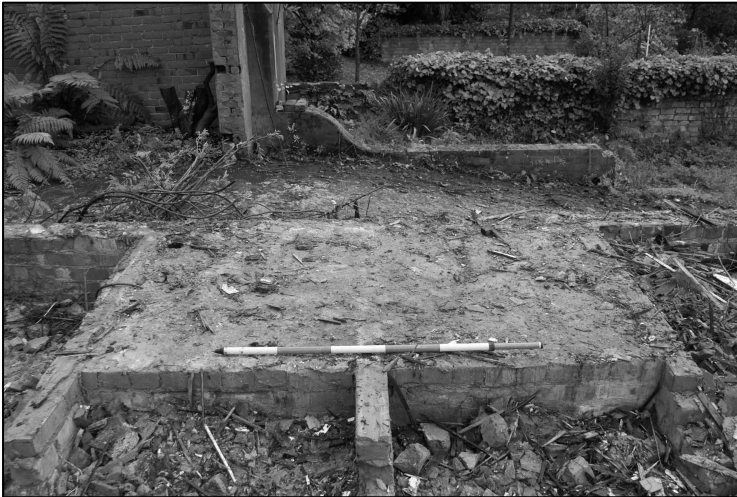
Figure 10. Original kitchen range foundation visible after the building demolition.

A particularly notable feature encountered during investigations was the kitchen range foundation discovered beneath later flooring at the north-east end of the building. This was a substantial $7\frac{1}{2} \times 4\frac{3}{4}$ ft (2286 x 1295 mm) concrete pad (Figure 10). This size suggests that the range was itself a massive item like the Shacklock No. 5, a 6 ft (1829 mm) wide, twin-oven, 760kg cast-iron behemoth (Angus 1973). A range like this would have

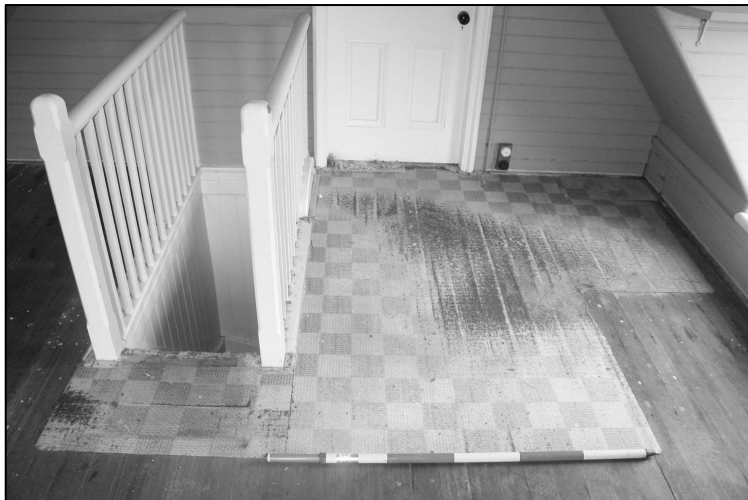
The building's small staircase stood in contrast to the large range. Measuring just 2 ft (610 mm) in width, this staircase provided a narrow passage up from the hallway to the attic rooms (Figure 11). Cuts for hinges in the frame at the base of the stairs showed that it was originally closed off by a door.

Figure 11. The top of the narrow Staircase in Room I relative to the door to Room H. The age of the linoleum floor remnants is unclear.

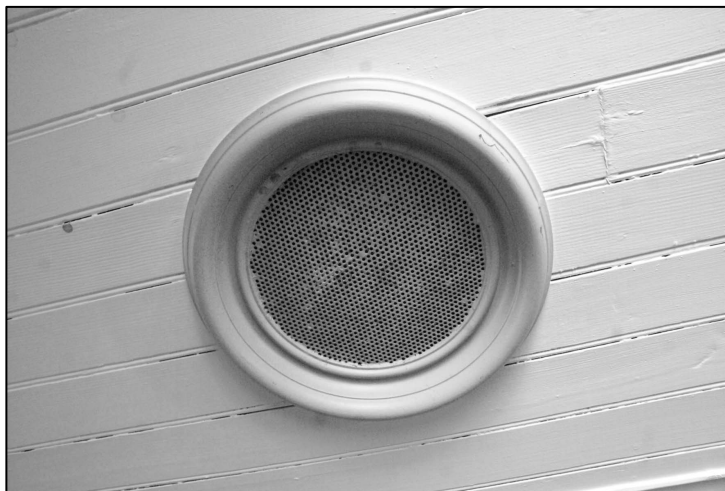
to the main house were discovered in the floor space of Room I, while plain ventilators were present in the ceilings of both attic rooms (Figure 12). A brass twist doorbell was located in the exterior door adjoining the scullery.

Figure 12. Plain ceiling ventilators in the attic Rooms I and H.

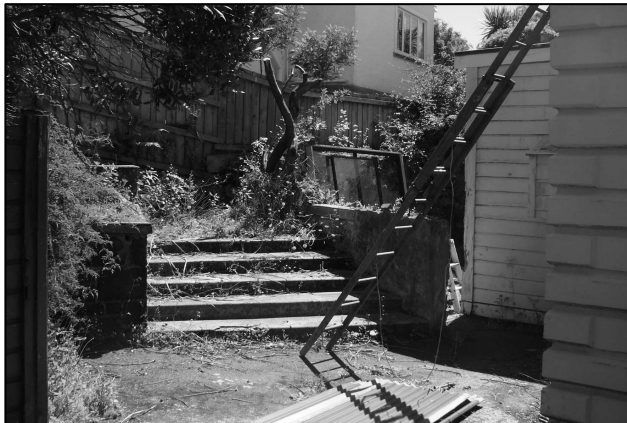
Figure 14. The stone stairway to the rear of the estate, looking north. The west corner of the original kitchen and servants' quarters structure is visible in the foreground at the right of the image.
