ARCHAEOLOGICAL INVESTIGATIONS AT SCOTT HOUSE (R11/2358): INTERIM REPORT

**BEATRICE HUDSON
CFG HERITAGE LTD**

A standing historic house at Mangere, Auckland, was investigated in late 2007. The curtilage, defined by modern fences, was investigated in October, and after house demolition, the area under the house was excavated for artefacts and for features. The work, carried out by CFG Heritage, was commissioned by Auckland Airport Limited in advance of earthworks associated with construction of the northern runway. Archaeological investigations were required as a condition of authority 2007/323, issued by the Historic Places Trust under section 14 of the Historic Places Act 1993, and included buildings archaeology, excavation of features around the house and excavation of the underfloor area to recover artefacts.

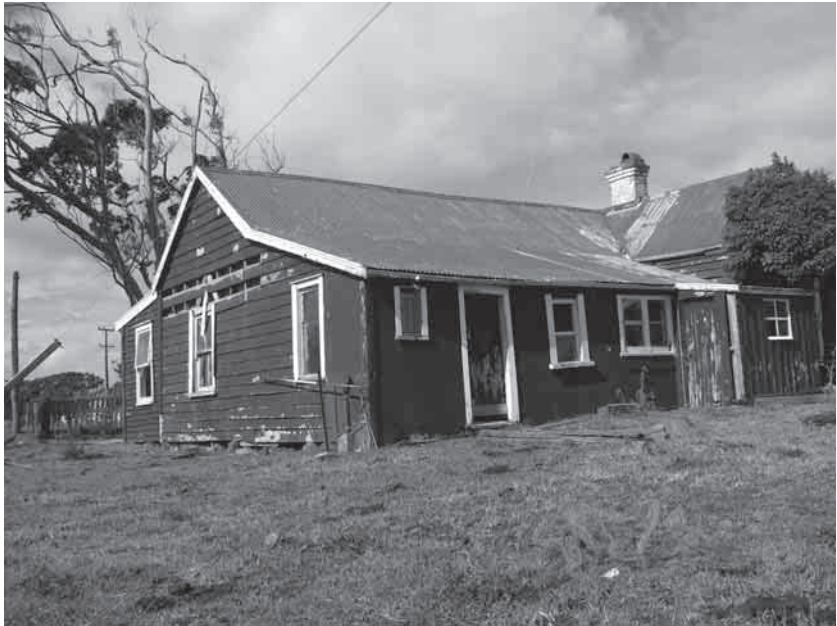
Figure 1. Scott House showing the north and west side prior to excavations starting. The main roofline in the centre is that of the original Phase I cottage and the room added on the north in Phase II. The lean-to is also Phase II. Wooden shingles were present under the roofing iron on these parts of the house. On the right, with the brick chimney, is the Phase III addition to the house.

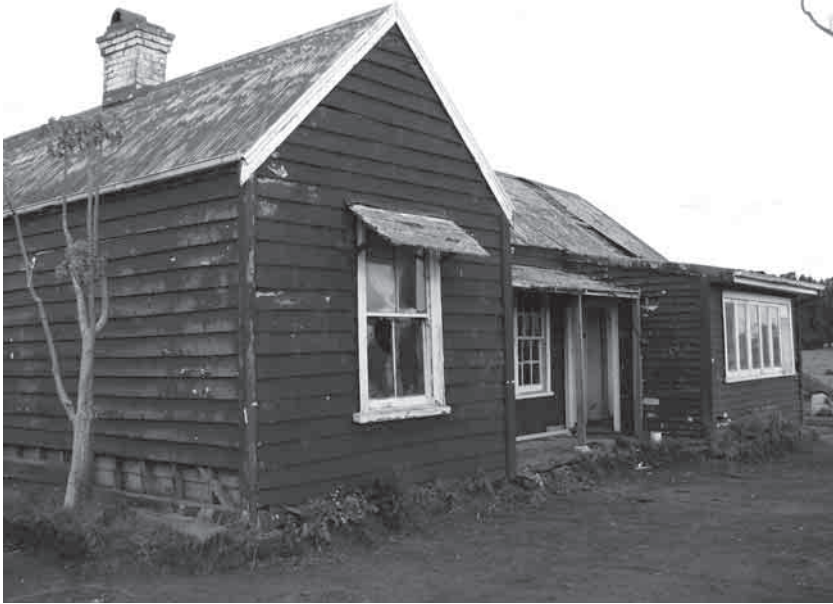
Figure 2. The front of the house from the southeast corner. The Phase III addition is in the foreground. The verandah may be a later addition to the original cottage.

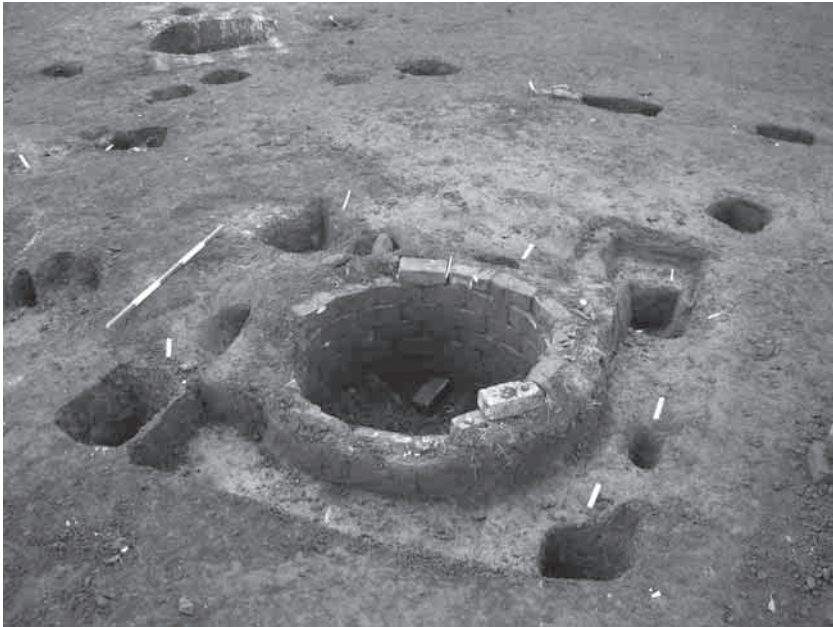
Figure 4. The earlier of the wells showing postholes of the above ground structure. The later well is visible in the upper left of the photo.

the digging of the second well. The later well had a fill of mixed rubbish including bottles, shoes, timber and miscellaneous material dating to the middle of the 20th century and is most likely from the clean-out or demolition of a farm shed. Four large postholes were located around each well, indicating that structures had stood over the wells, probably for a roof and windlass (Figure 4).
