ARCHAEOLOGY OF WOODVILLE, AUCKLAND: 3D MODELLING OF BUILT HERITAGE

SIMON H. BICKLER¹
THOMAS MACDIARMID
BARRY BAQUIE¹

¹CLOUGH & ASSOCIATES LTD.

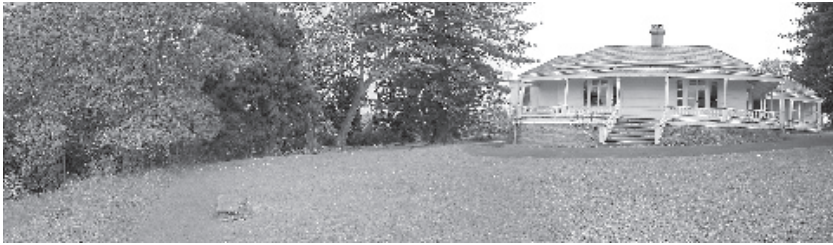
Figure 1. View of House and garden looking south east (courtesy Hamish Macdonald).

A property in Remuera, Auckland has been re-developed and a historic house (Figure 1), previously known as Woodville, moved off-site and a small cottage demolished. The results of the archaeological recording and investigations at Woodville complemented earlier work done by Pearson (2005), Foster (2005), the landscape studies by Adam (2005, 2006) and the photographic recording of the house by Hamish Macdonald. The archaeological report (Bickler et al. 2010) focused on four additional elements:

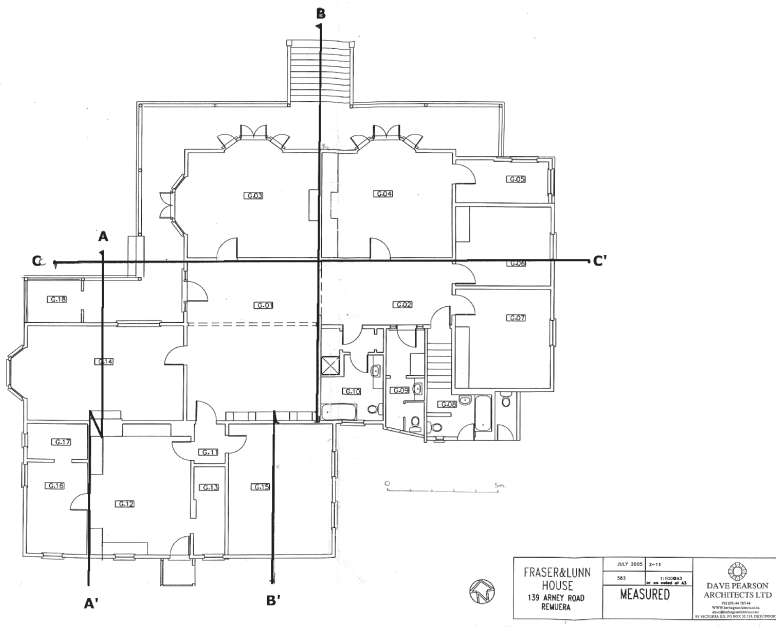
Figure 2. Floor plan of house (Pearson 2005: 18) showing the profiles drawn in detail for the current study.

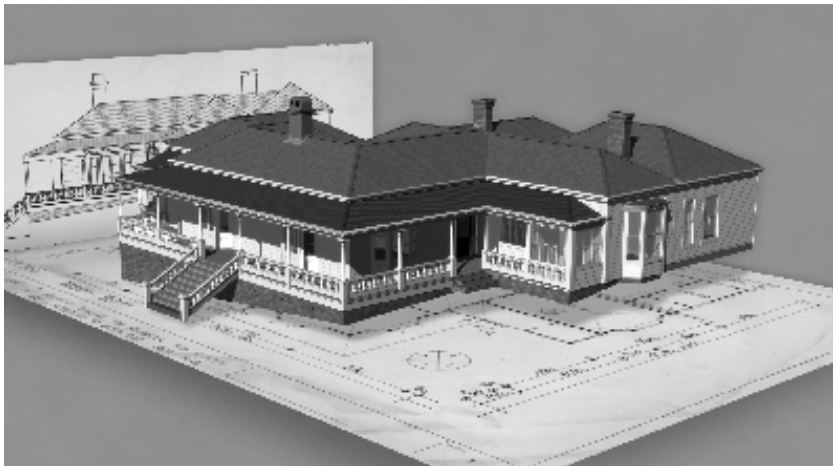
Figure 4. 3D Model of the house with Pearson's (2005) plans.

The rendered 3D model produced of the house is shown in Figure 4. Missing from the model are exterior elements such as drainage which was relatively modern on the Woodville property and of not such particular interest but could be added in at a later time.

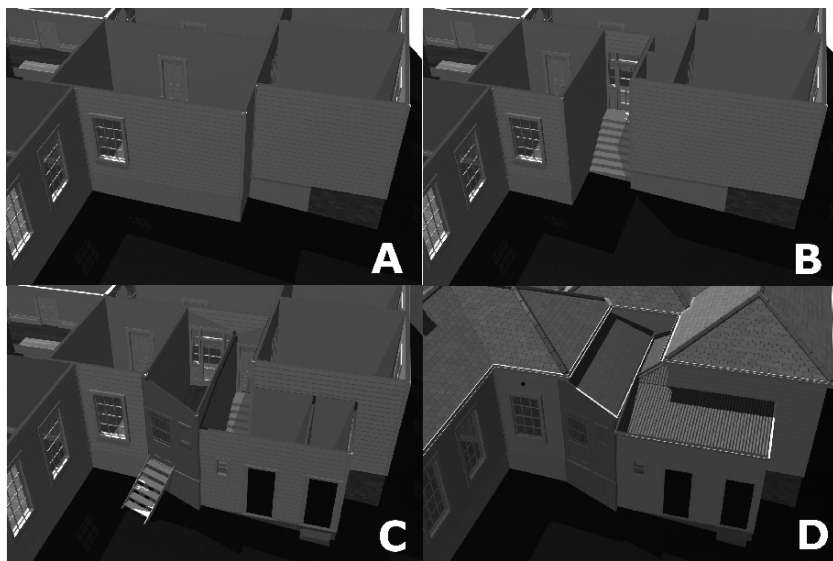
Figure 6. Reconstruction sequence for the south-east corner of the house.

explore different reconstructions to assist to determining the one we felt most likely. Our favoured reconstruction is shown in Figure 6. As suggested in Figure 5, the original villa probably had a rectangular room (G9 and G10) extending to the east to meet the area of the eastern rooms (Figure 6A). This was halved at some point and a new major entrance constructed in the eastern half providing direct access to the back of the original hallway (Figure 6B). Whether this replaced the front entrance to the house at this time is not known, but this is a possibility with access via Woodville Road near the stables.

Other changes to this area were made in Phase 3. The plans for the Wright's renovations in the 1950s (Pearson 2005) show the entrance (G09) being enclosed and turned into a cloakroom (Figure 6C) and sometime soon after the outhouse, which had been serving as a bathroom for servants living in the cottage (see Pearson 2005), was incorporated into the main house (Figure 6D). This reconstruction gained some support from the presence of the later wood on concrete piles used below G15.

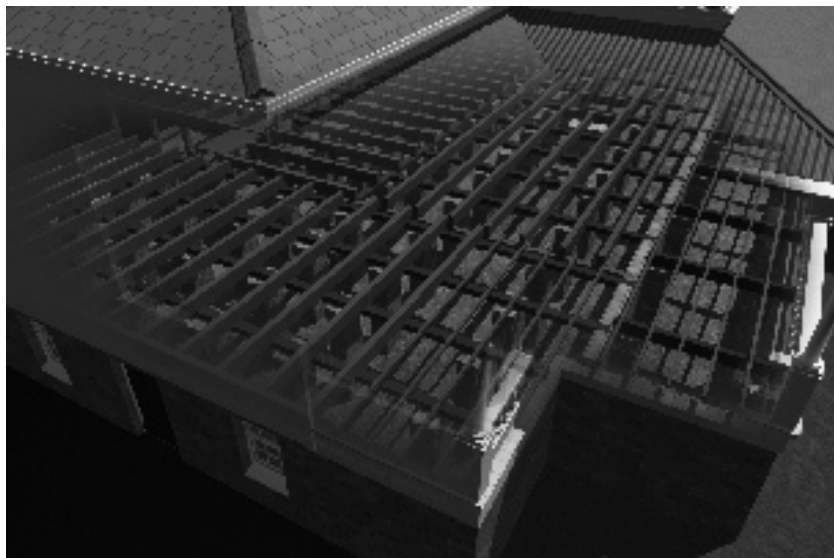
Figure 7. View from NE corner of the house showing floor joists and beams.

Some additional views of the basement were created (Figures 7 and 8). This served as the primary record for the piling as this was not transferred with the house when it was removed. Reconstructions of the roof space could also have been done but as these were preserved in the house, they were not considered a priority, although the information to do this was available in the architectural recording (Bickler *et al.* 2010).

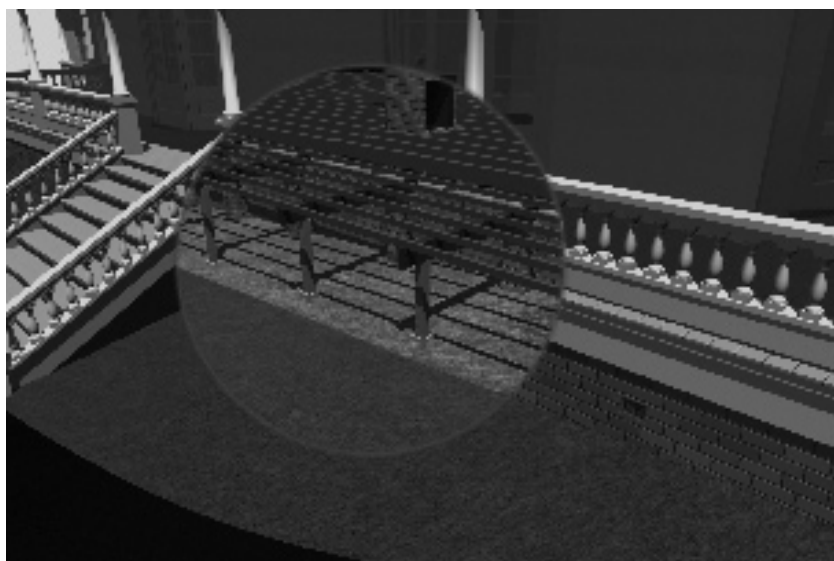
Figure 8. Close-up of the underfloor of the northern verandah.

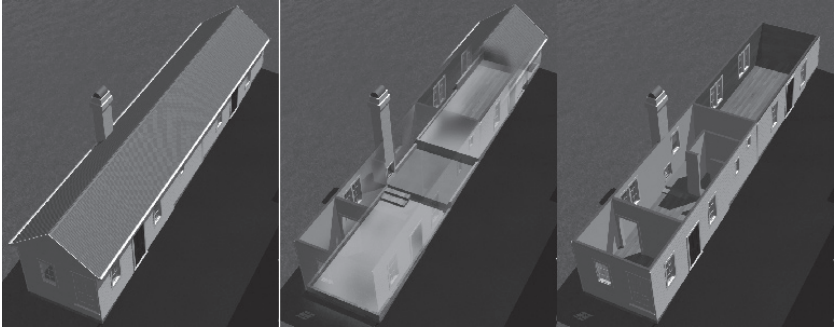
Figure 9. 3D model of the cottage – with roof, flooring only and modern partitions

The demolition of the cottage and its subsequent excavation was added to the drawn up profile to create a 3D model of the wooden cottage (Figure 9). The use of kauri throughout most of the original part of the cottage is not particularly surprising, and illustrates the early preference for this material for building purposes. Other key elements noted in the construction were the mortise and tenon joints between the wall studs and the bottom plate. The walls were covered by a thin kauri sarking, over which gib had been added at some point. Covering that was the later wood framed at the base with kauri.

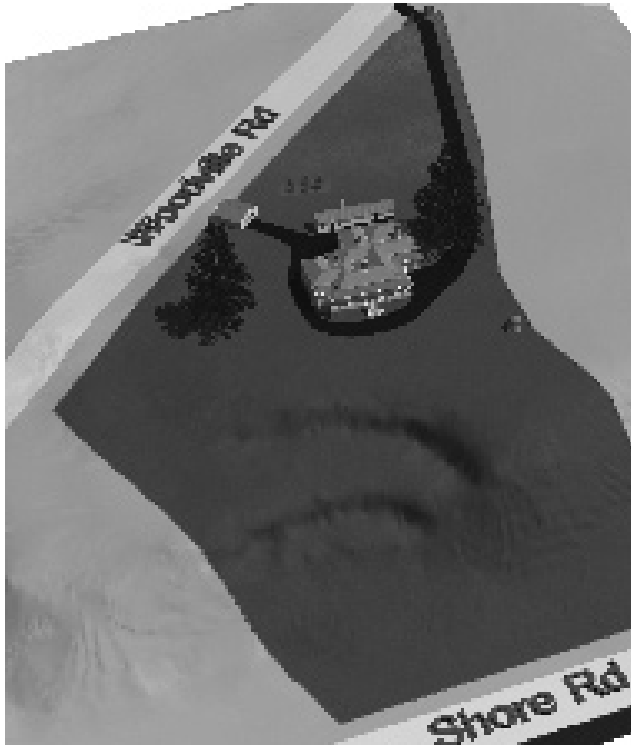
Figure 10. 3D Computer based model using LIDAR data showing reconstructed terraces.

The various models of the structures created were placed with in the context of the property (Figure 10). LiDAR data was used to create the contour and then some digital enhancement of the front garden terraces was carried out. Further reconstruction could have been done to smooth out the terracing and re-create the original topography. The key focus though was to bring the main 3D models of the structures, including the house, cottage, gazebo, front gate and stables together as a record which could be viewed from any angle.
