EARTHWORKS RESTORATION USING INSTANT TURF BASED ON EXPERIENCE AT THE ALEXANDRA REDOUBT, A FORMER ARMED CONSTABULARY FORTIFICATION AT PIRONGIA

Neville A Ritchie
Regional Archaeologist
Department of Conservation, Hamilton

ABSTRACT

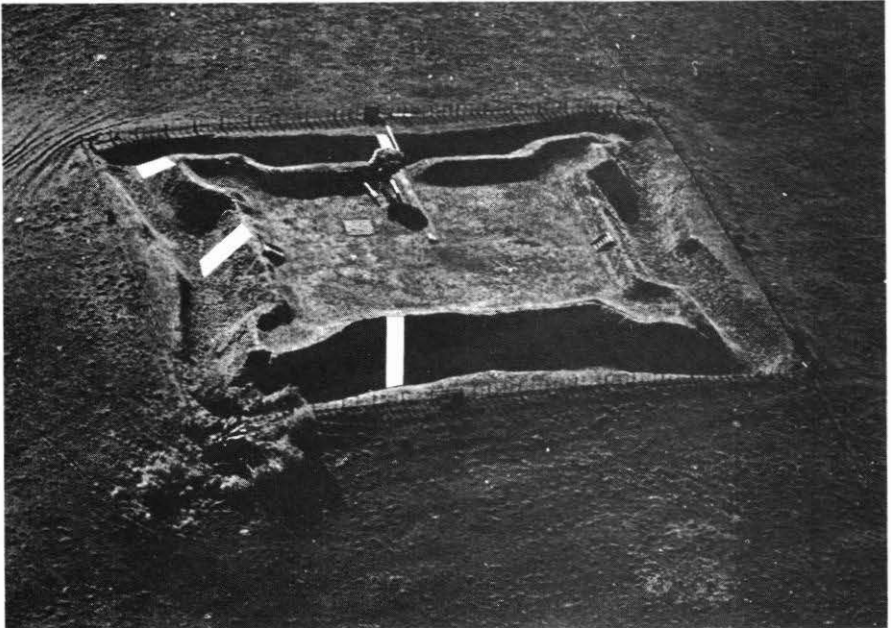
Figure 1. An aerial view of the Alexandra redoubt, Pirongia taken in 1980 (Photo: Waikato Museum). The three white oblongs show the location of the main repair work outlined in the text.

From the outset of the Pirongia job, it was appreciated that the displaced material at the bottom of the three main ruts (marked on Fig.1) did not appear to contain enough deposit to backfill them. In other words, some fill would have to be brought from another location. With this in mind the following strategy was devised (depicted in Figs. 2-5):

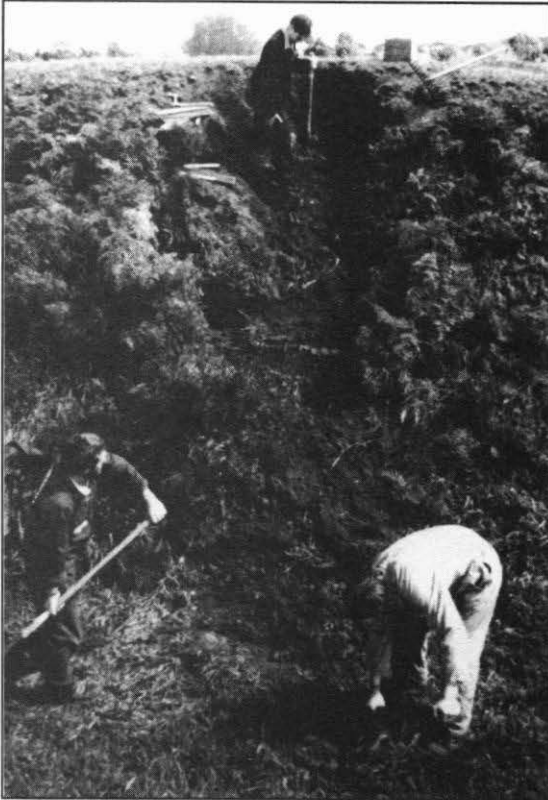
Figure 2. View showing initial backfilling of the rut on the west wall of the Alexandra redoubt using displaced material. All the ruts were created by children sliding down the slopes.

1. Place short pieces of untreated planks across the two deep ruts and hold these in position with untreated wooden pegs (so that the timberwork will rot away reasonably rapidly).
2. Backfill each rut by shovelling the eroded material above the retaining planks and compacting it.
3. Top the ruts up with "rotten turf" and compact and smooth it, ready for overlaying rolls of instant turf.
4. Lay, cut and fit rolls of instant turf over the infilled ruts and secure the instant turf using popsicle sticks (which rapidly rot away).
5. Erect temporary fences around the repaired areas to enable the grass to get well established.

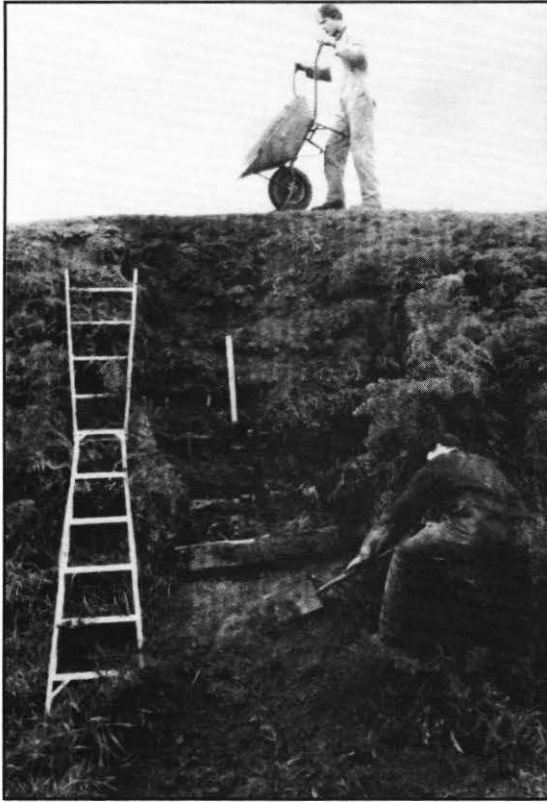
Figure 3. View showing the retaining boards in position and backfilling well underway using rotten turf (west side)

place with the back of a spade. The rotten turf compacted by at least one third of its volume when tamped into place. It proved easiest to handle and had the maximum adhesion when it was damp (i.e. when it was placed after or during rain showers). The untreated short-term retaining boards effectively held the fill on the steep slope but from hindsight longer pegs (up to 1m long) and wider boards would have sped up the process and generally made it easier. The untreated pegs and retaining planks were made from demolished pallets. Our experience would suggest it is probably easier to cut pieces of wood to the exact length required at the work site if possible.

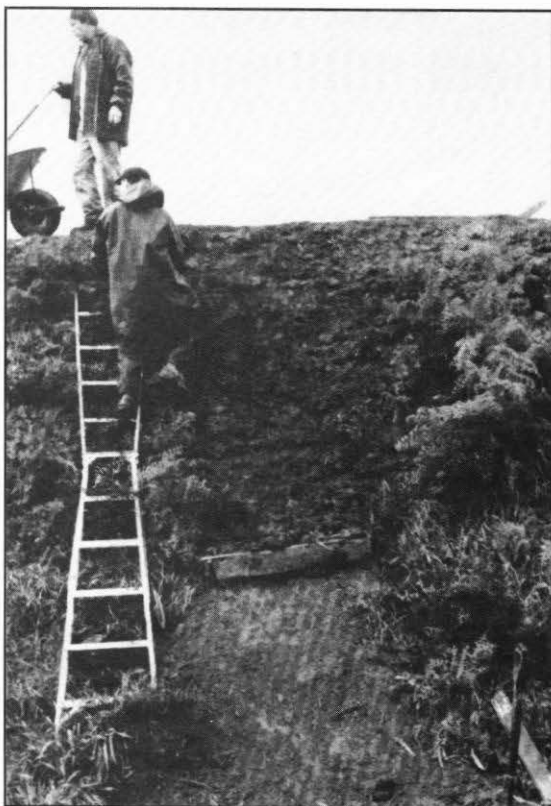
Figure 4. The upper part of the same rut after the rotten turf has been hand-tamped and a smooth surface created for overlying the instant turf.

The three main ruts were backfilled with a combination of the original fill and the rotten turf, both products being hand kneaded, tramped, or tamped into

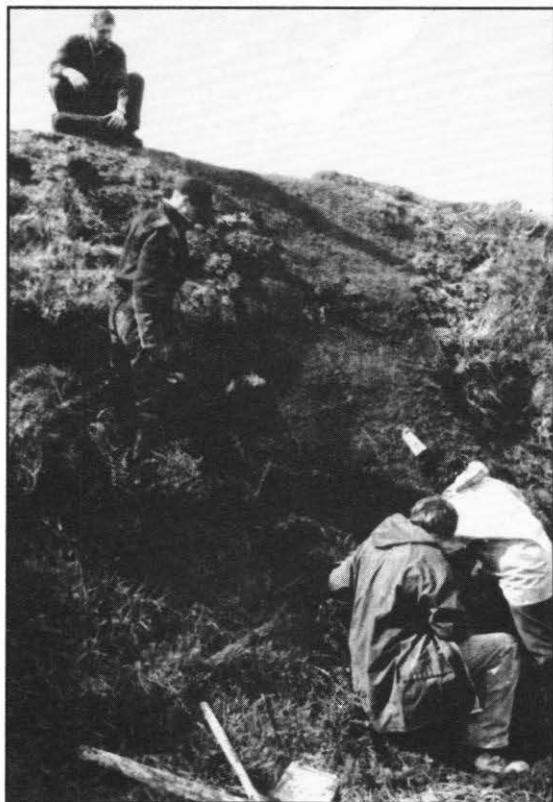
Figure 5. Rolls of instant turf being laid and cut to fit and secured in place using popsicle sticks (south side rut).

laid and cut to fit if necessary. Although instant turf rolls like a carpet and tends to follow the contours it is critically important to avoid gaps between the bottom of the turf and the underlying ground surface if a good grass strike (without dead patches) is to be achieved. This is because grass roots tend to die back if exposed to air. The other major concern was the possibility that sections of instant turf might slip down the steep sides of the redoubt following their initial placement. This potential problem is resolved by a simple trick of the trade- viz. popsicle sticks which are poked (about 6-12 per roll of turf) through the grass and into the underlying surface. The popsicle sticks hold the turf in place on the steep slope until the roots are well established, and rapidly rot away thereafter. They also present no impediment to mowing.
