### **NEW ZEALAND ARCHAEOLOGICAL ASSOCIATION NEWSLETTER**

# EXCAVATION OF A NINETEENTH CENTURY KAURI BUSHMEN'S HUT SITE, WAITAKERE RANGES, WEST AUCKLAND

Bruce Havward and N.Z. Geological Survey Glen Eden Lower Hutt

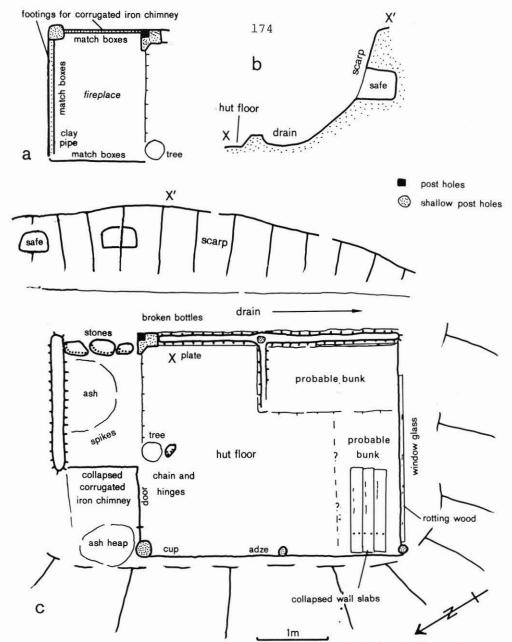
FIGURE 2. a. Plan of excavated lower level (1870s) of fireplace.
b. Section showing relationship between hut floor, east
wall baulk, drain and terrace scarp. c. Plan of excavated hut site and upper level (post 1900?) of fireplace.

Surface features. Prior to our clearing and excavating, the site was readily identifiable as an 8 x 4 m man-made terrace on the sloping crest of a small spur. The terrace was backed by a near-vertical scarp, up to 1.8 m high (Fig. 2b,c). Several tracks radiated out from the north end of the terrace; one led off down the spur in the direction of the dam; a second, somewhat incised, track led up the spur and was possibly used by packhorses to bring in supplies; and a third led along the contours in an upstream direction.

The site of the hut itself was identifiable by scattered debris on the surface and a low, straight ridge (3.7 m long, 0.2 m high, 0.4 m wide) marking the eastern wall. A line of three stream-rounded stones and a 2 m long, low ridge at right angles to these, clearly identified the fireplace at the north end (Fig. 2c). The extent of the hut to the west and south was not determinable apart from the limits imposed by the size of the terrace.

Also visible was a hole (0.5 m high, 0.55 m wide, 0.6 m deep) cut into the scarp at the back of the terrace adjacent to the north-east corner of the hut (Figs. 2b,c). This was undoubtedly an underground safe used to keep food cool. A square piece of birdwire netting found nearby appeared to fit across the opening to the safe.

Subsurface features. Excavations showed the hut to have been  $3.7 \times 3.2 \text{ m}$  in plan with a 1.9 x 1 m fireplace attached to the

north wall (Fig. 2c). The southern extent of the hut was determined by the presence of a long, straight piece of rotting wood, which appeared to have once been the wall plate. The western extent of the hut was defined by three depressions (probably former post holes) and a line of artefact debris. The east wall was defined by a narrow baulk of hard weathered rock (Plate 1) that had been left between the floor on one side and a drain (0.1 m deep, 0.5 m wide) that had been dug between the hut and the terrace scarp (Figs. 2b,c, Plate 1).

Excavation of the fireplace proved the most interesting, for here was the deepest accumulation of ash and soil. The upper half of the deposit contained lll rusty iron spikes, as well as broken bottles and a few nails. It became clear that the answer to the scarcity of rotting wood on the site lay in the fireplace. Later occupants had obviously used the wood from the derelict hut as firewood and the spikes and nails in them ended up in the ashes. The stones along the east side (Fig. 2c) of the fireplace overlay earlier ash layers and were obviously a late addition.

Excavation of the lower layers of ash revealed further bottles, a broken clay pipe, two bullock ribs and 14 oblong, wax vesta tin match boxes around the perimeter of the fireplace. When fully excavated, narrow slot-like footings (Plate 1) were found around the walls of the fireplace (Fig. 2a), into which the corrugated iron of the chimney had obviously been sunk.

The former flat dirt floor was unearthed over much of the area of the hut, but along the inside of the southern half of the east wall it could not be located. Here a rectangular area  $(2 \times 1.1 \text{ m})$  of slightly elevated, irregularly surfaced dirt is presumed to indicate the location of bunks above (Fig. 2c). The remainder of the south wall (also exactly 2 m long) seems a likely location for further bunks, although no definite evidence to confirm or disprove this supposition could be found.

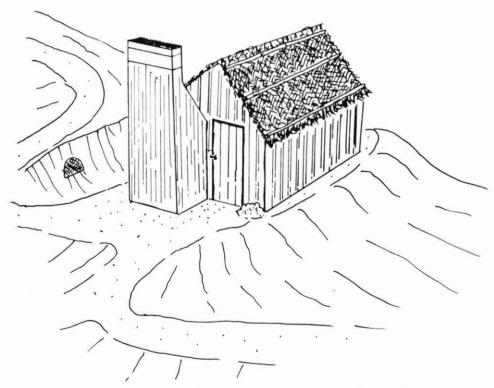
FIGURE 3. Sketched reconstruction of bushmen's hut, based on the excavation and a few informed assumptions.

Rusty door hinges and a chain and padlock were found near the north-west corner and, together with the paths outside, indicate the location of the door adjacent to the chimney (Figs 2 and 3). Fragments of thin window glass, found outside the hut in the middle of the south wall, suggest the presence of a small window in the gable at the far end from the fireplace and door.

The walls were made of vertical overlapping palings and the roof is inferred to have had a high gable with wooden slabs or plaited nikau fronds. The door was at the north end and a small glass window was in the gable at the south. Half the north wall was occupied by the fireplace which had a corrugated iron chimney surrounding it (Fig. 3).

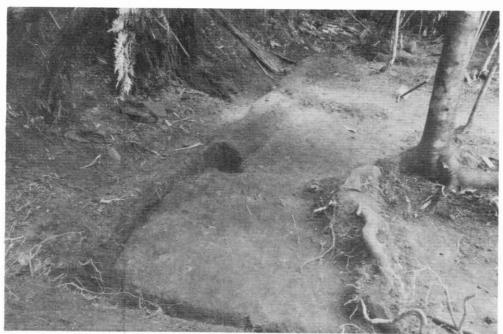
KAURI BUSHMEN'S HUT Plate 1. View south across eastern half of excavated site: slot-like footings for corrugated iron chimney (foreground), east wall baulk and outside drain beyond.

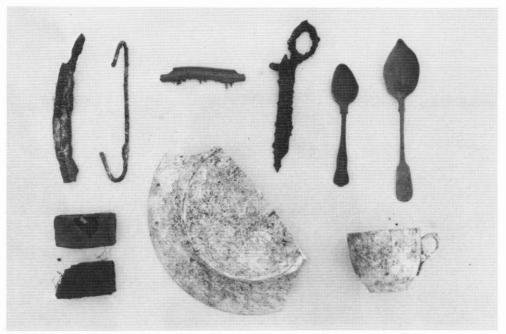
KAURI BUSHMEN'S HUT Plate 2. Artefacts including tin match boxes (bottom left), camp oven fragment (top left), and comb (third from left, top).

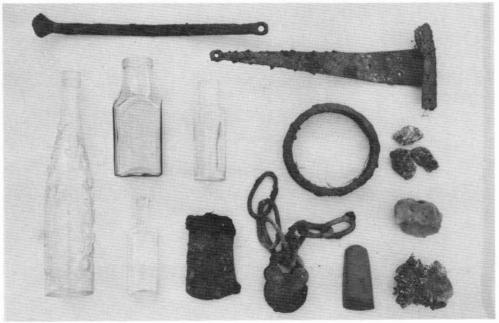
KAURI BUSHMEN'S HUT Plate 3. Artefacts including pot handle (top left), axe head (middle bottom), maul ring, kauri gum, rock specimens and adze (all bottom right).
