## ARCHAEOLOGY IN NEW ZEALAND

# HART'S BLACK HORSE BREWERY, WETHERSTONS, OTAGO

PETER PETCHEY, FRANCESCA ALLEN, JULIA  
LEWIS AND NAOMI WOODS  
OTAGO UNIVERSITY  
ANTHROPOLOGICAL SOCIETY

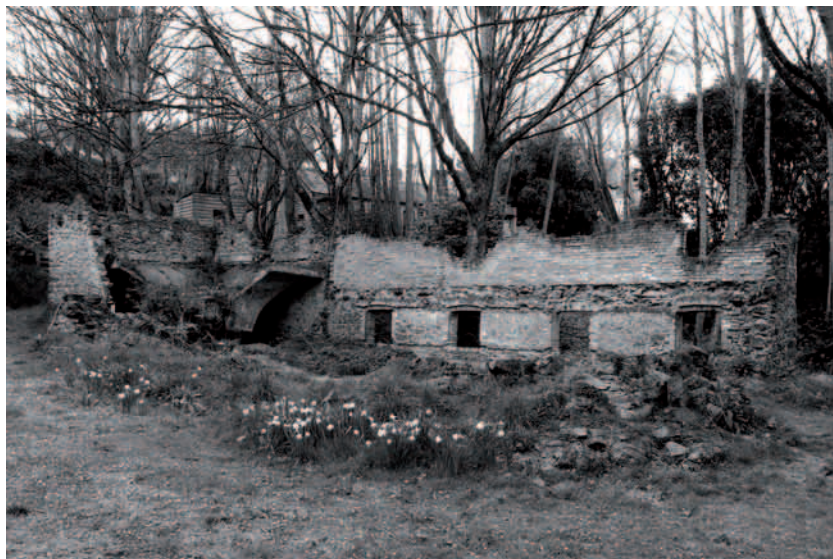
The main stone ruin (Figures 6, 7 and 8) is the remains of the malt house and kiln. The southern wall of the building is still standing, but is leaning outwards, and only the inside elevation of the wall was drawn, while the outside area (under the overhang of the leaning wall) was roped off and made a no-go area.

The building is rectangular (45' x 29', 13.7 x 8.8 m) with a square extension (20' x 18', 6m x 5.5 m) on the eastern end that housed the malting kiln. The building was originally two stories high but only the south and kiln walls still stand above the first floor level. The lower floor walls of the main building are of stone with brick detailing to the window openings, while the second story is of brick. The kiln walls are stone. The kiln section of the building still houses a concrete hopper, which has split (it was probably damaged during the partial demolition of the building), and is leaning on the south wall of the building, causing the lean. A large sycamore tree is fortuitously located on the other side of the wall, and this is presently propping it up.

*Figure 6. The stone ruin of the malthouse and kiln.*

The ground floor of the malthouse is concrete, and six square holes show where posts were located to support the first floor. One iron strap is still in place in the stonework of the south wall, which was probably used to tie the first floor wooden joists into the wall.

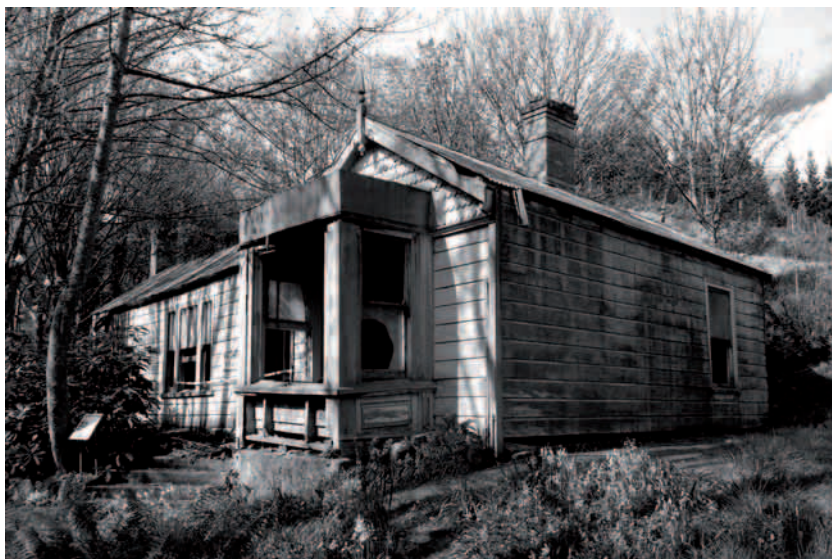
The existing timber house on the site was occupied by the Hart Family, but has been unoccupied since the 1960s. The building is becoming very dilapidated and part of the rear wall has fallen out. The main roof, and front, side, part rear, and internal walls are still largely intact, and the building was sound enough to record safely (Figures 9, 10 and 11). However, its continuing deterioration will probably be rapid. Many of its architectural details, including all doors and mantelpieces, have been removed. A veranda along the front of the house has collapsed.

The house is built of timber, with timber piles, framing, weatherboards and matchboard lining. The foundations for the bay window (a later addition)

*Figure 9. The derelict timber house, showing the bay window.*

It seems likely that the house was originally a small wooden cottage that has been extended on one or more occasions to become a bay villa. The bay window is an obvious later addition, and multiple layers of wallpaper show that the house had been redecorated several times during its life. The general appearance of the building is typical of the 1880s period, which matches the time when the Hart family became involved in the business. However, a detailed forensic analysis of the building would involve examination of the roof framing and some removal of wall linings, and this was beyond the brief of the current survey project.
