ARCHAEOLOGY IN NEW ZEALAND

HAURAKI MISSION STATION: UNEARTHING AN ARCHAEOLOGICAL LANDSCAPE

DAVID WILTON

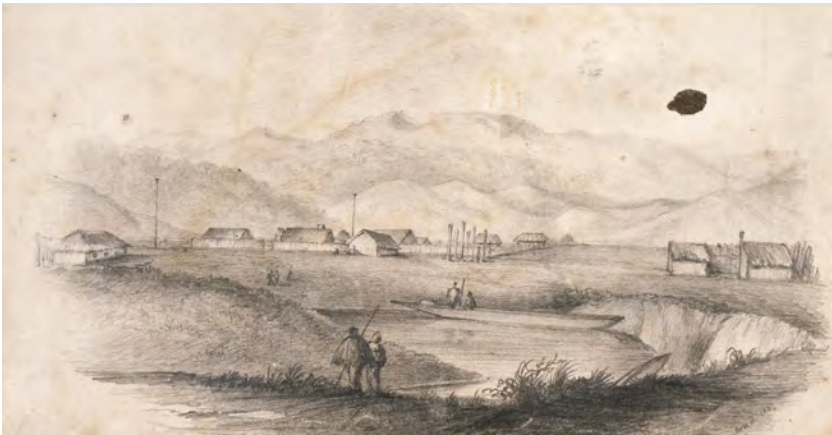
Figure 2. Sketch of HMS Puriri site by William Wade, c.1836 (ATL F-151456-1/2, Alexander Turnbull Library).

The main historical evidence indicating the mission was at the Station Road/Wharf Road site appears to be the Wade sketch (Figure 1), which shows the station located on a prominent loop in the Puriri stream. This probably corresponds to the loop that was adjacent to Station Road prior to the stream being straightened by the Waihou Flood Protection Scheme in the 1990s (Figure 4). In view of the natural changes in the area since the 1830s, however, it may not be prudent to completely discount the acacias site as the location of the mission (nor others for that matter).

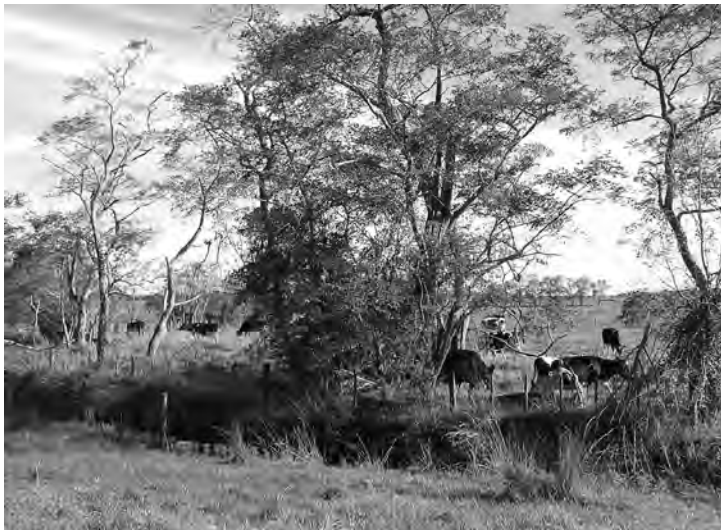
Figure 3. Acacia trees remaining at T12/340. According to Warner Hunter, these were laid out in a distinctive rectangle at the time of his childhood; however, a number have since died.

The Puriri site, as recorded by Simon Best, is marked by a grove of acacia trees. According to Warner Hunter, this is where locals always thought the mission site was (e.g. Clark 2003: 25-26). Warner stated that in his childhood, the ‘acacias’ site (Figure 3) consisted of a complete rectangle of acacia trees, with a raised platform of earth in the middle, indicating it was a site of European origin. Bedford states:

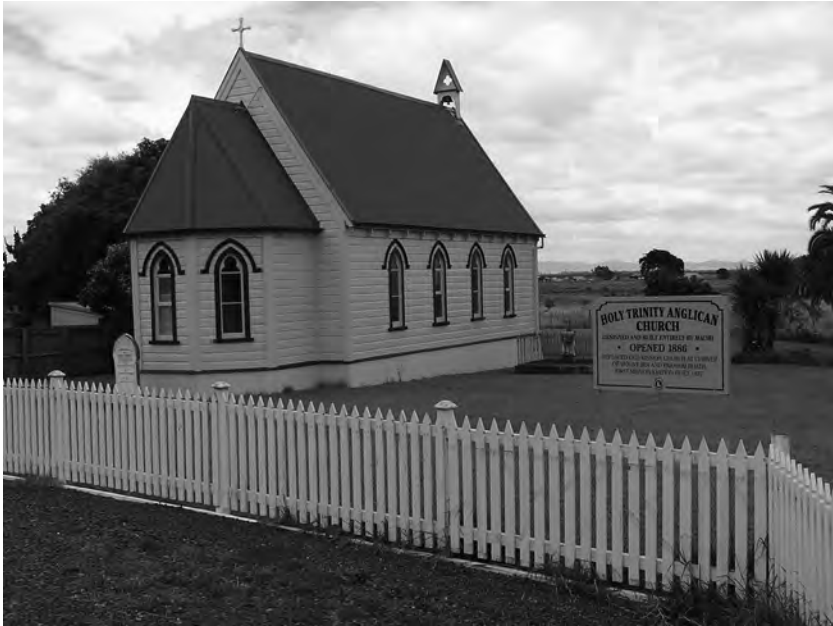
Figure 5. Holy Trinity church, after undergoing restoration in 2010.

Another church, named Holy Trinity, was built further south along Parawai Road in 1886 and is still in situ as at February 2012 (Figure 5). It was consecrated by Bishop William Cowie on 18 May 1886 (Hays 1968: 41) and was also part of the HMS. A building date of 1886 would roughly coincide with the cessation of worship at the 300 Parawai Road site. The Holy Trinity church is

also mentioned in site record T12/898. It underwent extensive restoration in 2010 and is now used for regular church services again. There are two grave stones remaining in the grounds of the church.

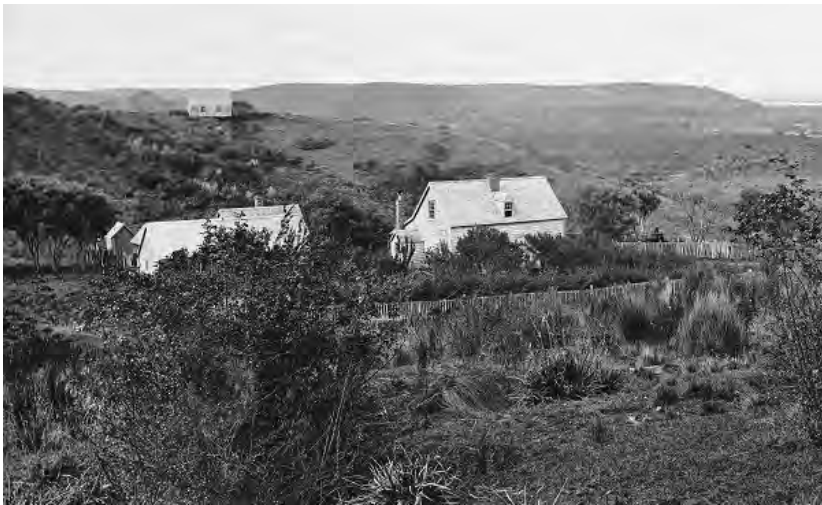
Figure 7. HMS house, late 1860s, thought to be at the 106 Mountsea Road site. (G-96135-1/2, D M Beere Collection, Alexander Turnbull Library.)

house and yard (Figure 7), would seem to indicate that there was another house close to the edge of the escarpment.

Discussions were also held with Earl Cox and his wife, residents of 108 Mountsea Road. Earl and his sons assisted the then-owner to pull down the remains of an old house at 106 Mountsea Road, which was destroyed by fire around 1960 (Figure 11). After viewing the 1867 photo of the original mission house (Figure 7), Earl believed that the old house he helped pull down was the old mission house. The house had been extended, apparently using recycled timber from another old building in Thames. He recalled that there were shingles under the corrugated iron roof. He stated that the current house at 106

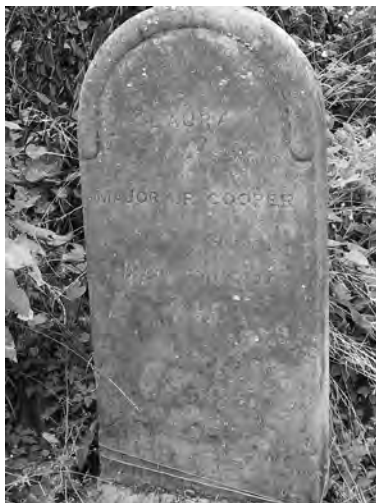
Figure 8. Grave stone at bottom of escarpment, 300 Parawai Road.

The 300 Parawai Road site, owned by Craig and Cathy Bell, was also visited. They pointed out the location of the original HMS wooden church and a few remaining gravestones in a small cemetery at the back of the property (Figure 8). They also supplied a copy of a photo of the original wooden church (Figure 9).

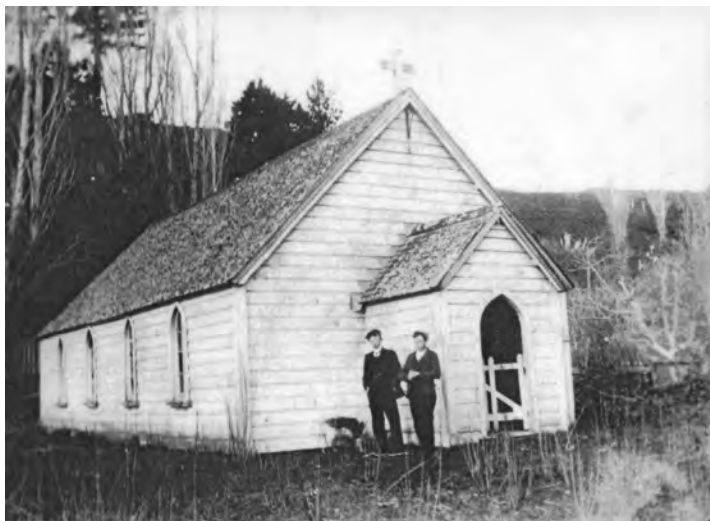
Figure 9. Church at 300 Parawai Road, c.1900.

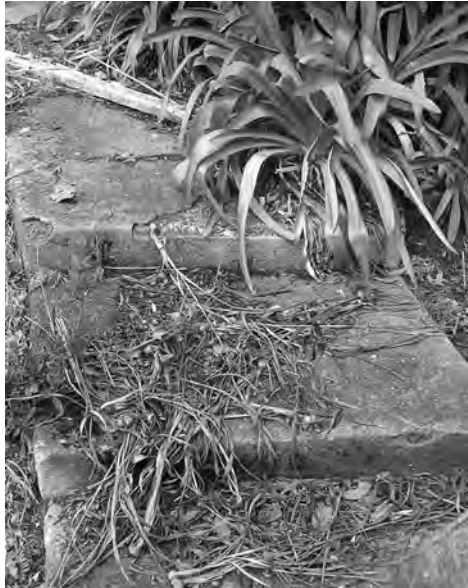
Figure 10. Concrete steps leading across edge of the escarpment at 106 Mountsea Road. The steps lead towards Mountsea Road, and may have been a route from the mission house down to the church below.

A search was also conducted at 106 Mountsea Road. This is at the top of the escarpment, and the likely site of the mission house shown in Figure 4. The then owner of 106 Mountsea Road (Trevor Schon) stated that he had owned the property for about 18 years and could not provide any information about the mission. A search was conducted of the small paddock surrounding the house but no remnants of the mission house were found (no digging was undertaken). There is, however, a set of old concrete steps that leads diagonally across the escarpment towards Mountsea Road, which was probably a route down to the church below (Figure 10).

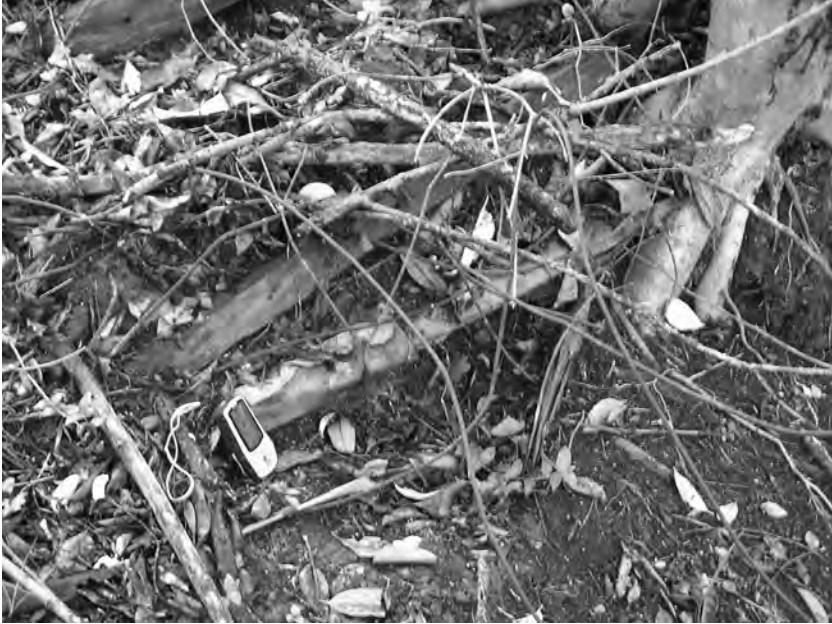
Figure 11. Charred timber and iron on escarpment between 106 Mountsea Road and 300 Parawai Road, thought to be the remains of the mission house at 106 Mountsea Road.

Mountsea Road is built on the site of the house that was demolished c.1960. This adds weight to the photographic evidence that 106 Mountsea Road is the site of the main house at HMS Parawai.

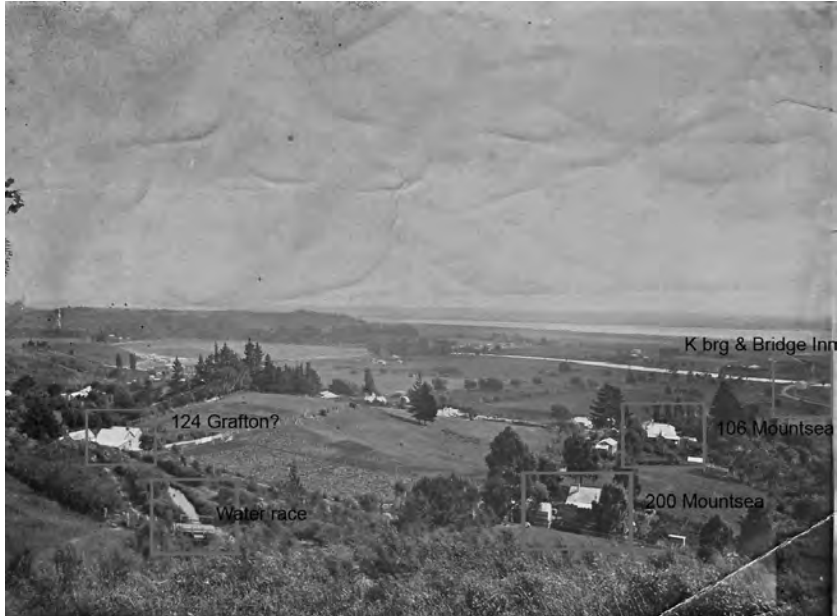
Figure 12. View of HMS Parawai area, taken from high ground to the east, above Mountsea Road, with key locations marked (MC 109 Merv Cunningham collection, Coromandel Heritage Trust Treasury).

The visits and searches mentioned above led to the submission of T12/1291, the original site record form for the HMS Parawai site. A couple of years later, the chance acquisition of a photograph looking west from the foothills above Parawai revealed another view of the HMS, including a possible third house (Figure 12).

Placing a date on this photo is not easy. Historical evidence suggests that the likely date is 1900 +/- 15 years (see the site record form for a detailed analysis).

Local anecdotal information provided to the author in 2007 suggested that the house at 124 Grafton Road (Figure 13) was related to the mission station, but Figure 11 is the first historical evidence to be found indicating that this may be the case. The three houses in Figure 12 look as if they were part

of a farm or garden complex. Figure 12 also shows the Thames water race (opened 1876) in close proximity to the southern-most house. The TUMONZ property map shows the water race passed approximately 70 m east of the house at 124 Grafton Road. Also, survey records show that the current property at 124 Grafton Road was originally CMS land (according to TUMONZ property information: “CMS Grant Allotment 27”).

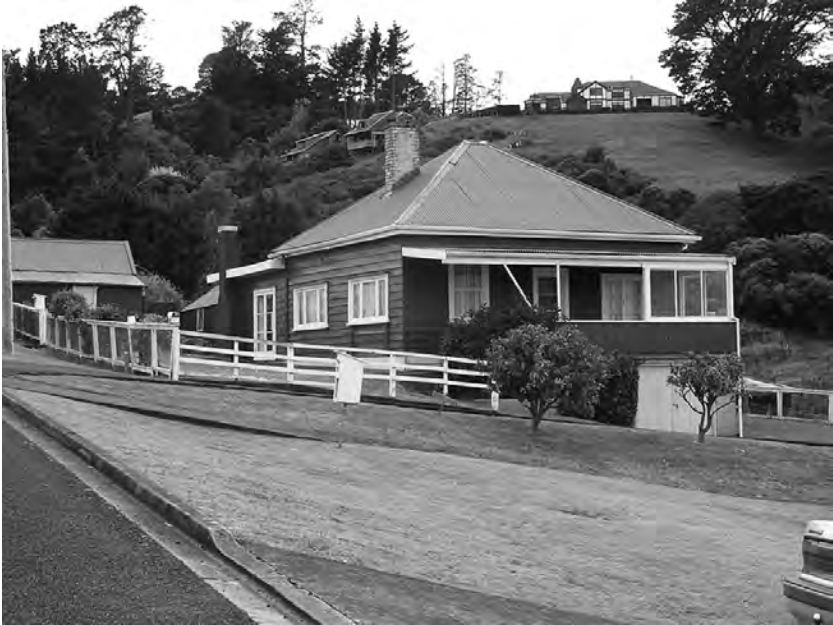
Figure 13. Possible mission house at 124 Grafton Road.

In April 2010, the author visited the property and met the current owner, Don Jonson, and his wife. According to Mr Jonson, he bought the property from a Mrs Cowles in 1974. Apparently Mrs Cowles had done some research on the house and claimed it was 120-140 years old (at that time). There was a pear tree (still standing in 2010) in the garden that was also that old. The house had been modified in 1973, and Mr Jonson has modified it since; however, there remain kauri weatherboards (which look pit-sawn) on the exterior of the house and on two walls of an outhouse, kauri ceilings in the house (since lowered to save heating bills) and a hand-carved kauri fireplace. The roof was corrugated iron when Mr Jonson bought it in 1974. There are several old fruit trees in the

garden (as well as the pear mentioned previously). There are two sets of foundations in the back garden which were apparently both glass-houses and one of which was originally a pigsty. According to Mr Jonson, he has uncovered remnants of another, older, building in the southeast corner of the property at various times over the years.

Although there are obvious modifications (notably the roof) and extensions, the weight of evidence suggests that the existing house at 124 Grafton Road was the third house shown in Figure 12 and was probably part of the HMS Parawai site. Anecdotal evidence puts its age at c.120 years in 1973 (i.e. built c.1853). The year of its construction and exact history, however, were not able to be confirmed.
