Larnach’s Farmstead Survey and Excavations, Hereweka/Harbour Cone, Otago Peninsula

Alana Kelly

University of Otago Anthropology Society

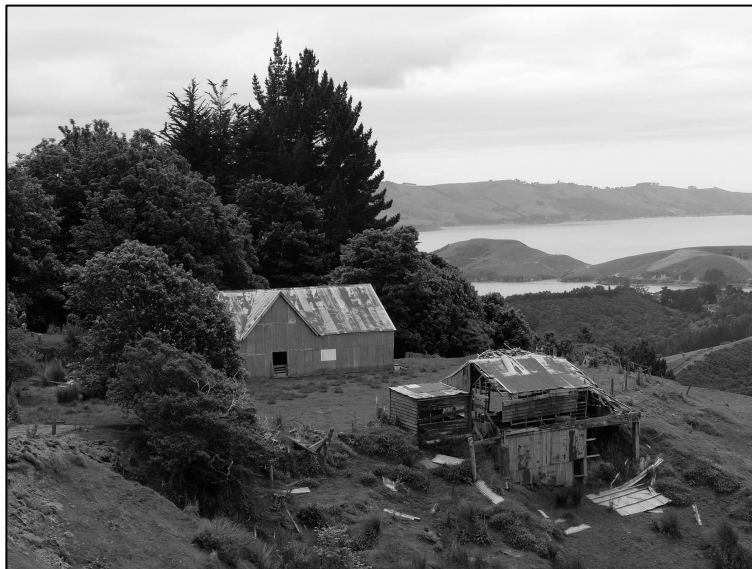
Figure 2. Larnach’s Farmstead (site I44/412) on the Otago Peninsula. The cow byre is the larger building on the left.

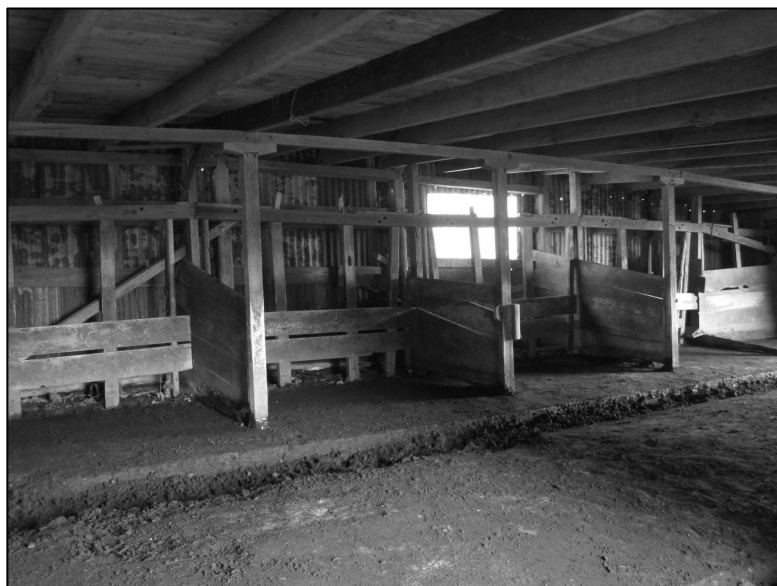
Larnach’s cow byre has a corrugated iron roof and is clad with a mixture of board and batten (the original cladding) and corrugated iron. The byre has a second storey that would have originally stored hay, before it was fed into the below mangers through a gap in the floor. Since its establishment, Larnach’s cow byre has been adapted and repurposed for use as a covered sheep yard, which saw the fitting of a slatted floor. The first step towards uncovering the original floor was removing the slats and some modern fittings. Following this students shovelled out the remaining manure to reveal the concreted floor, which was more than likely originally cobbled. The clearing of the modern floor also exposed two drains which ran the length of the building along the front of the stalls. These drains were cleared out to encourage proper drainage from the building.

The cow byre had a total of 15 stalls, the majority of which had at least partial original head gates and mangers. Most of the stalls had two head gates, which indicate that the byre may have held upwards of 30 cows, a significant number for the time. Additionally, following the clearing of the floor, metal rings running down the centre of the building were exposed, which were likely used to tie the back leg of a cow during milking to prevent the cows kicking the bucket or farmer.

Figure 4. The interior of the byre after the floors were cleared.

Approximately two thirds of the cow byre’s slatted floor and subsequent manure was removed during this trip and further work on the remainder of the cow byre is intended to be completed at a later date.

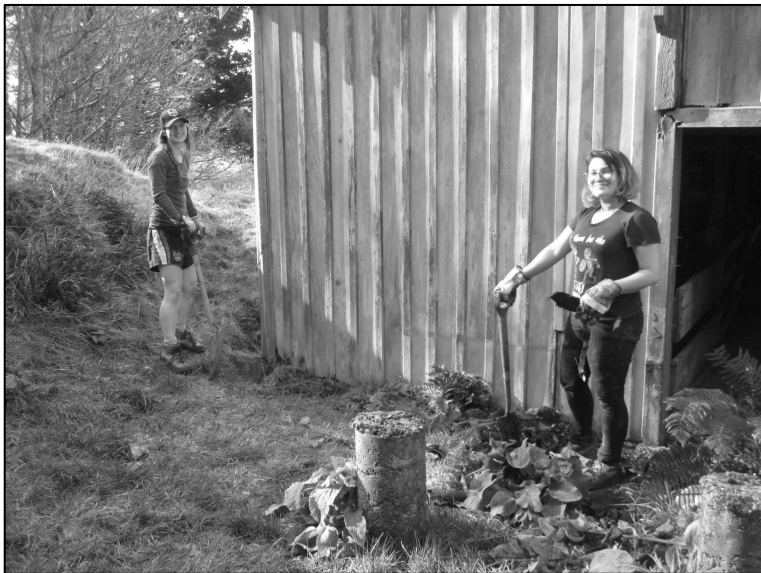
The land on which the farmstead is located tends to retain a lot of water, which poses a significant threat to the foundations of the historic farm buildings. In order to avoid the rotting of foundations or further damage to the historical farm buildings, students cleared the old drains around the edges of the cow byre and towards the slope of the hill to encourage appropriate drainage at the site. This resulted in the uncovering of original cobblestones on the northern side of the byre.

Figure 5. Clearing the drain around the west wall of the byre. This view also shows the original board and batten cladding.

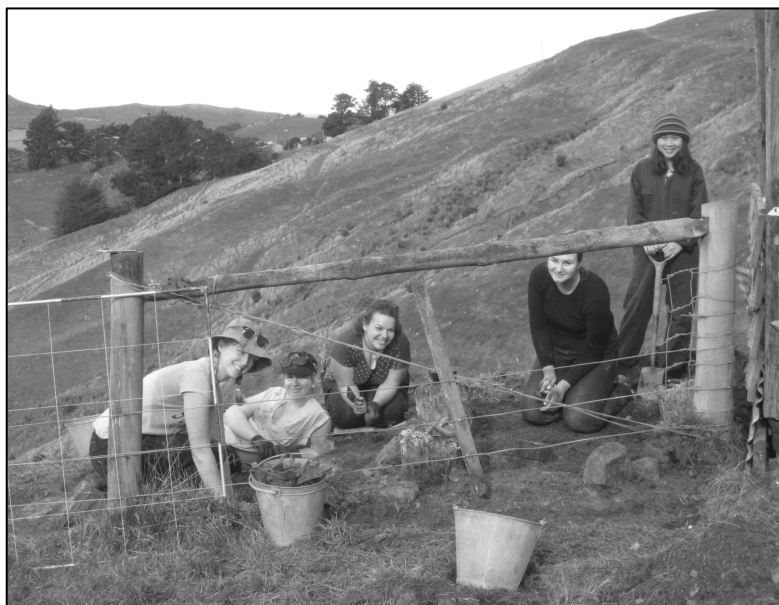
survey, however a more in-depth investigation into the structure was conducted by Gosling (2009). Since it was constructed, the barn has been shortened significantly on its southern side and may have been shortened on its northern side. A group of students conducted an excavation on the northern side of the building to further investigate the original extent of the structure, which resulted in the identification of timber posts that were part of the original foundations. These indicated that the building once extended a further metre (3 feet) in this direction. The original purpose of the building remains unclear, partly because of the many modifications carried out to it over the years.

Figure 6. Excavating to reveal the old foundation piles for the smaller building at Larnach’s Farmstead. The diggers had to work around the modern fenceline.

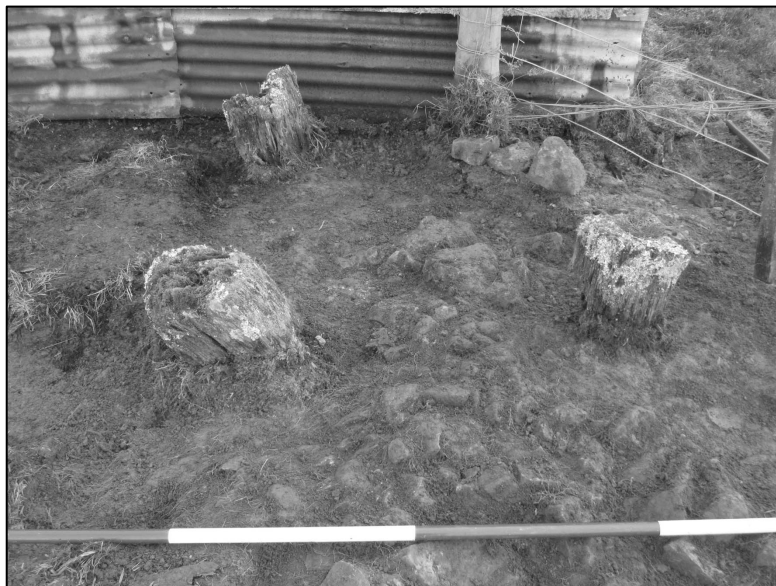
Figure 7. The old foundation piles exposed after excavation.
