## ARCHAEOLOGY IN NEW ZEALAND

MANAGEMENT OF HISTORIC SITES IN NEW ZEALAND'SROSS DEPENDENCY, ANTARCTICA

Neville Ritchie and Alexy Simmons  
Department of Conservation  
Hamilton

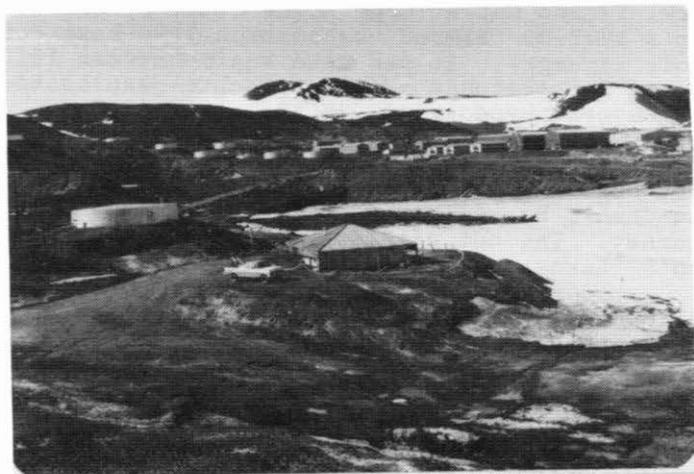
PLATE 1. Scott's "Discovery Expedition" hut (1902-04) at Hut Point, Ross Island, now adjacent to the large United States McMurdo base.

(a) The main structural job at Hut Point involved securing a large section of collapsed ceiling which was resting on and gradually crushing an internal partition composed of empty plywood provision cases. The 'wall' had been erected by members of Scott's 1911 expedition to create an inner living and cooking area within the main structure. Previously, it was thought that the ceiling had been purposefully lowered (by Scott's men) to conserve heat. After inspecting the ceiling structure and reading the available literature in the Scott Base library, we determined the ceiling was brought down by the weight of snow (and subsequently ice) which probably found its way into the ceiling after Shackleton's brief use of the hut in 1907 and prior to Scott's second usage in 1911. A member of the 1911 party noted in his journal (Cherry-Garrard 1965:157) "Atkinson and Crean had cleared the floor of ice in our absence, but the space between the lower and upper roof was solid with blue ice, and the lower roof sagged down in places in a dangerous way ...".

Later he goes on to say " the double roof of the old Discovery hut ...was still full of solid ice; indeed some time afterwards a large portion of it fell ...dripping water was a constant nuisance" (Cherry-Garrard 1965:166). In addition to the provision case wall, a beam from the old magnetic hut (1901 expedition) also supported the collapsed ceiling. Both may have been placed under the ceiling in 1911 to prevent its (further) collapse into the newly created living-cooking area.

To relieve the stress on the provision cases and redistribute the bearing weight, the fallen ceiling section was suspended by wire hangers from the rafters. This is an interim measure until decisions are made on its permanent securement. Present thinking is to leave the fallen section of ceiling at its present level, i.e. as it was when the hut was occupied after 1911 (since the rest of the contents of the hut represent this latter phase of the hut's usage).

(c) A series of survey marks were established on the hut walls to monitor long term deformation or structural movement. Previously only one survey point existed on the SE verandah post, which only provided an indication of movement at that corner rather than insights into overall structural deformation of ground subsidence.

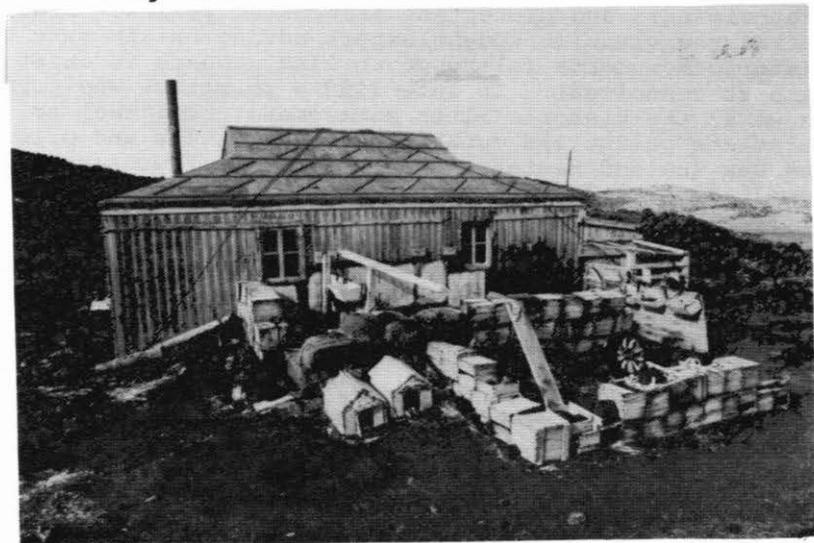
PLATE 2. The NE side of Shackleton's hut (1907-9) at Cape Royds, Ross Island. The structures in the foreground are the remains of the garage and stables which were walled with stacked provision cases.

- the overwintering hut at Cape Royds built by Ernest Shackleton's 1907-09 'Nimrod' expedition (the base for their aborted Pole attempt). It was used again between 1914-17 in the course of Shackleton's transcontinental exploration (the ill fated 'Aurora' expedition) (Plate 2).

(b) Maintenance of the stables and garage at Cape Royds constitutes a major conservation issue which must be addressed in the near future, since the structures, as restored by Quartermain's party in 1961, are beginning to deteriorate. Quartermain (1963:73) noted: "The broken-down walls of provision cases and fodder bales were restored, but not covered, as they were originally with tarpaulin. The garage too was partially reconstructed" (the cases were nailed together and in some instances boards were nailed between them). For discussion of options refer Ritchie and Simmons (1987:24-25).

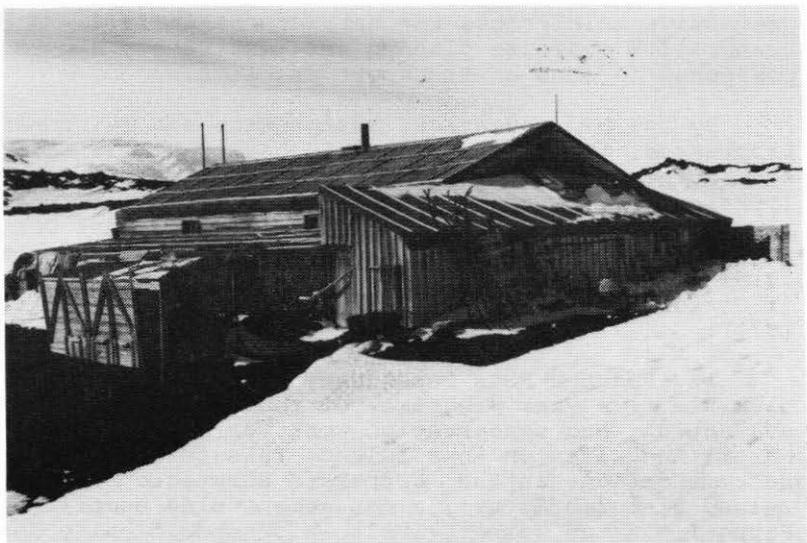
- Scott's hut at Cape Evans established during his 1910-13 'Terra Nova' expedition. Although Scott reached the Pole (after Amundsen), he and his companions succumbed on the return journey. The hut was later used by members of Shackleton's 'Aurora' expedition (Plates 3 & 4).

PLATE 3. The NE side of Scott's "Terra Nova" expedition hut (1901-13), Cape Evans, showing the cold porch (front right), stables, and latrines (freestanding).

(a) The major job of the season involved an assessment of problems resulting from snow accumulation against the SE wall of the Cape Evans hut within the collapsed remains of the 1911 stores annexe. Every year in December-January the snow melts, and the melt water ponds within the trough-like remains of the annexe and gradually seeps into the interior of the hut causing dampness, very high humidity and associated deterioration problems. Short of total reconstruction of the annexe (and hence its weatherproofing) which is not feasible at present, the only immediate remedy is to remove all or part of the structural remains of the annexe to decrease the entrapment of snow and meltwater. The removal of any part of the annexe will destroy a portion of the original fabric, but the work is necessary to improve the micro-climate (and conditions for artefact conservation) within the main structure. It is proposed to undertake this work during the summer of 1987-88 as a systematic excavation

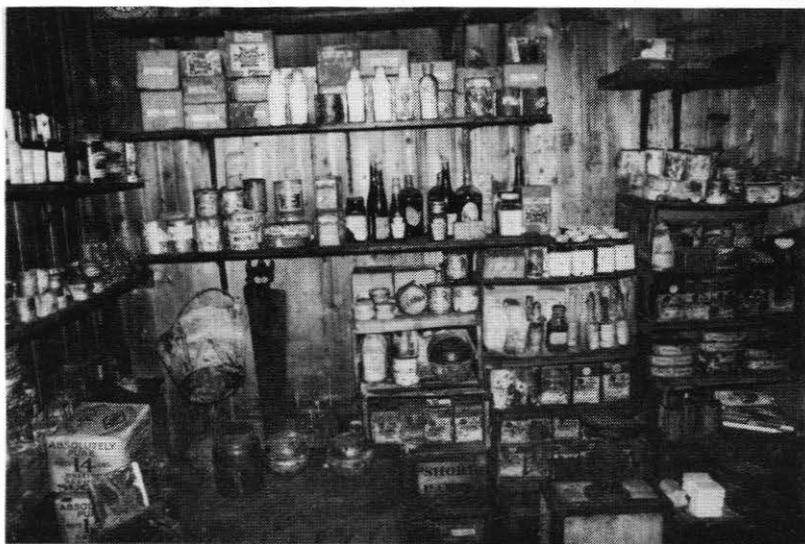
PLATE 4. A corner of the kitchen area in Scott's Cape Evans hut. Many of the provision containers and their labels are in urgent need of conservation.

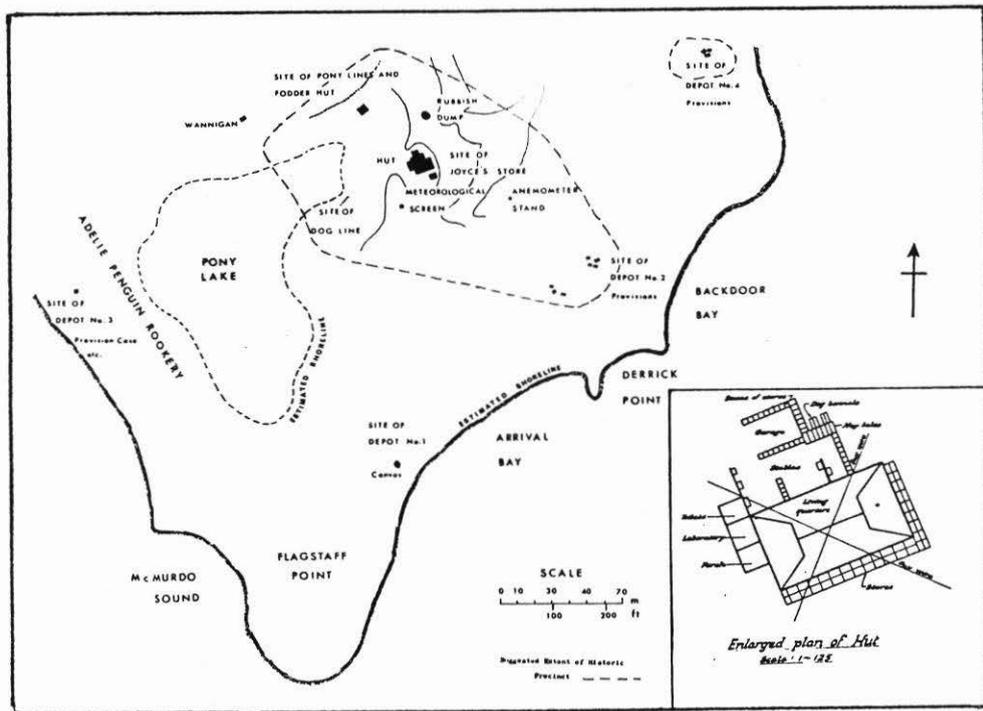
(a) Like the situation at Cape Evans, several cubic metres of provisions (mainly canned foods) are stacked against the outside walls of the Cape Royds hut. Some were left there by Shackleton's men, but the majority have been stacked against the walls by various people over the years, in their efforts to tidy up the site. Quartermain (1963:73), describing the initial restoration work at Cape Royds, noted: "Outside, the heterogeneous mass of food cases lying everywhere was sorted. The better-preserved cases and tins were used as originally, to give protection to the hut walls, while the badly rusted and otherwise deteriorated tins, along with general rubbish, were burned. Samples of the foodstuffs were placed in the hut, and the remainder, except for those still in cases against the walls outside, were placed in two caches."

The stores against the Cape Royds hut present some moisture retention problems but to a much lesser extent than at Cape Evans. In fact, the Royds hut is the driest of the

FIGURE 4. Shackleton's Cape Royds Hut and associated features. After a surveyed plan by N.P. Nalder (L & S 37/76), and Harrowfield (1981:24).

three. A test excavation was carried out on the stores located against the south wall of the hut. It was found that the original line of plywood cases was placed c. 30 cm out from the base of the wall and that this gap is now filled with frozen scoria. However, compared with the situation in the stores annexe at Cape Evans, snow retention at Royds is minimal, no melt water ponding was evident, and only the bottom layer is frozen in-situ. This makes their removal and relocation considerably easier, but again, as at Evans, the plywood provision boxes are in a very fragile condition.

In addition to the stacked stores, it was apparent from surface exposures that other stores are buried at a point about three metres out from the south wall (i.e. the approximate location of Joyce's Store). Some of the can types in the archaeological deposit (e.g. Vezet cheese and French sardines) are not represented in the hut. Thus the recording of these deposits has been recommended as part of any future archaeological work at the hut.
