ARCHAEOLOGY IN NEW ZEALAND

Rogers' Farmstead Survey Otago Peninsula

**Alana Kelly, Alix Muir and Robert Henderson
Otago University Anthropology Society**

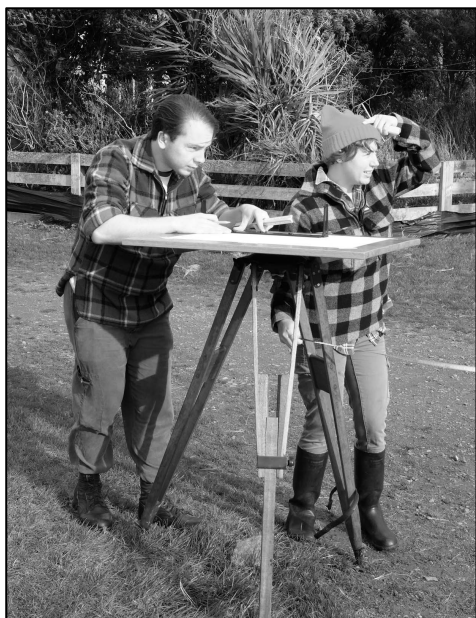
Figure 3. Fran Allen and Jozef Mendrun at one of the plane tables.

also attended, and helped to interpret the site. Three plane tables and alidades (Figure 3) were set up across the site and the students split into three groups. The first group were centred in the cow byre, the second was focussed on the

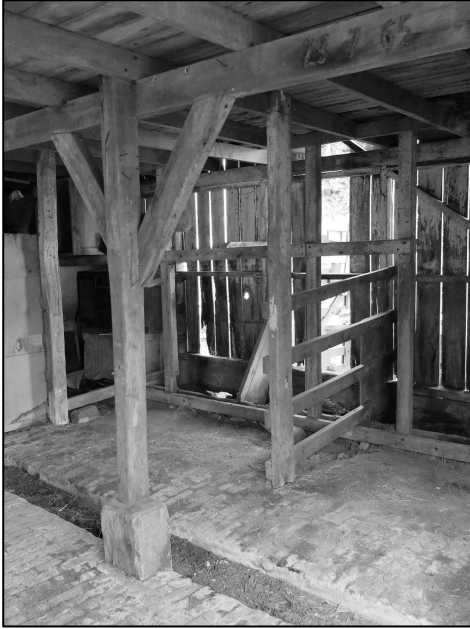
Figure 6. The intact stall in the cow byre.

The brick floor has two parallel drains running the length of the byre and extends slightly into the stalls for drainage. The multiple stalls suggest that up to 12 cows were milked on the property, a considerable amount for the time. After a tidy up of some of the junk in the byre, further investigation into one of the stalls revealed an intact original wooden head gate and manger (Figures 5 and 6). Only one stall was completely intact, and accumulated junk in the rest of the building prevented close inspection to determine what parts of other stalls survived.

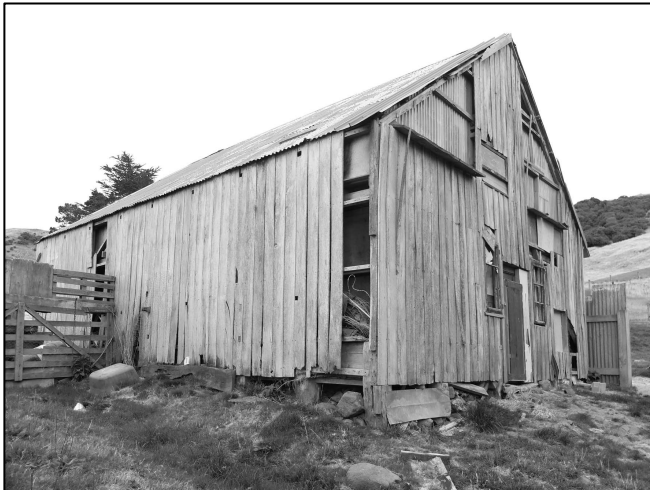
Figure 7. The rear of the cow byre, showing the original board and batten cladding.

The wooden foundations of the byre were probably Totara, matching those in the farmhouse. Original parts of the wooden framing of the byre were identified as pit-sawn by Peter Petchey, who explained the different sawing methods and their means of identification to students.

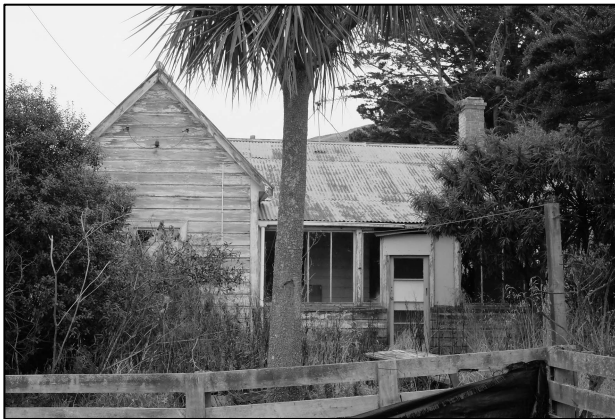
Figure 8. The front of the farmhouse.

The third surveying group also completed a floor plan of the farm house (Figures 8 and 9). This is a wooden building with a corrugated iron roof.

The plan produced the general dimensions of the house and allowed the group to observe some of the alterations and additions to the building made over time (although a more thorough investigation will be needed to fully interpret the building). Although the house has undergone various modifications the tōtara foundations (visible along the east wall) and some original windows still remain. Sadly, the house is showing signs of decay due to its lack of tenancy for almost 10 years. Several windows have been roughly cut out of the structure, leaving large holes in the walls, some of which have been boarded over with sheets of plywood.
