## ARCHAEOLOGY IN NEW ZEALAND

# SOMES ISLAND ARCHAEOLOGICAL SITE SURVEY

Tony Walton  
Department of Conservation  
Wellington

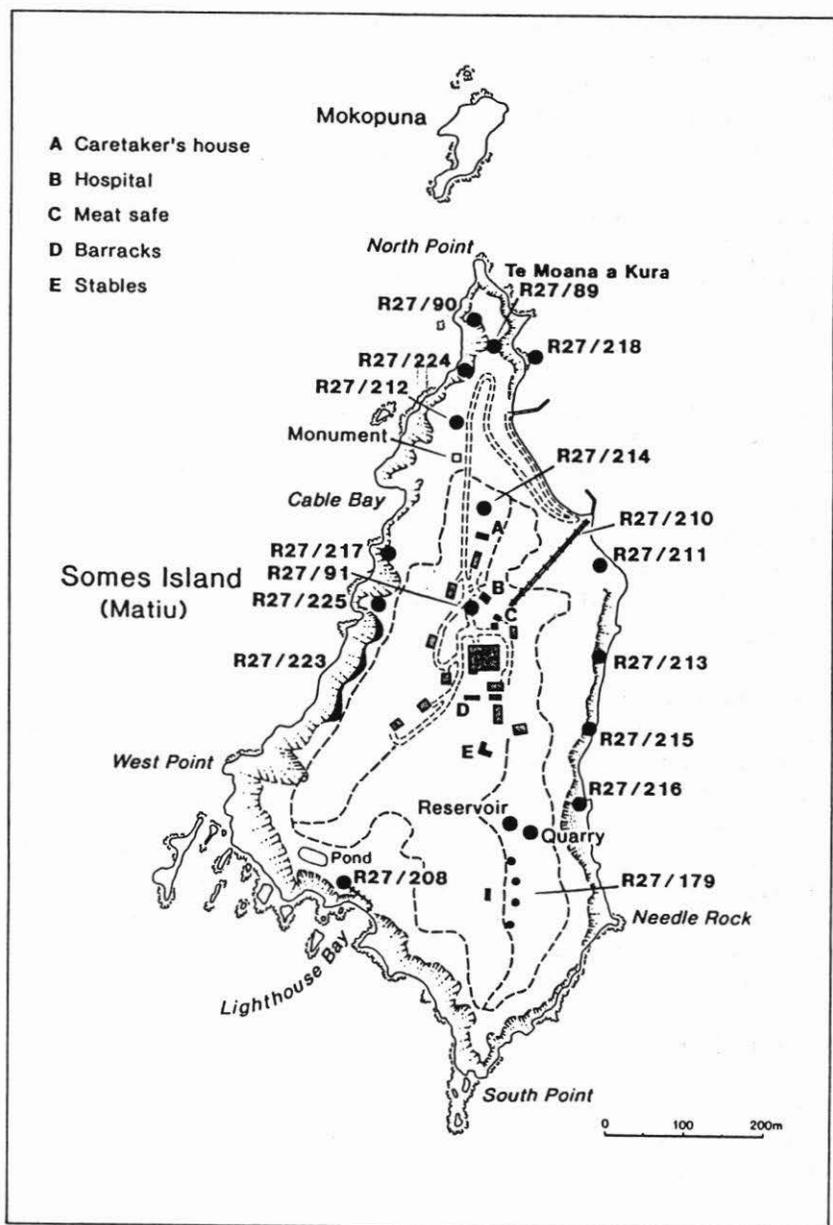
Figure 1. Plan of Somes Island showing the location of recorded sites.

Site locations were marked on a 1969 aerial photograph (RN 4233/22) which had been enlarged to a scale of 1:5000. Grid references were assigned afterwards from NZMS 260 R27 (1:50,000) using the marked-up aerial photograph to establish the correct co-ordinates. Site locations are shown on Figure 1.

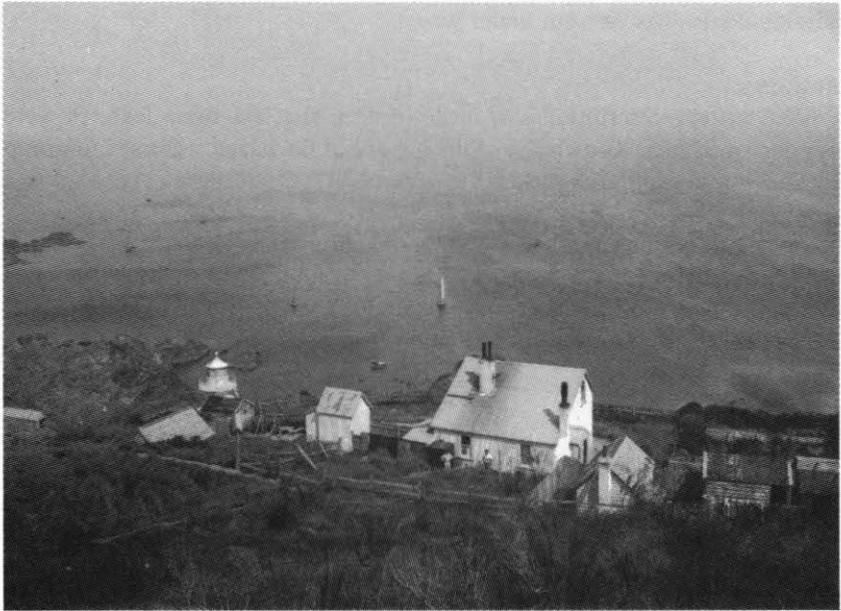
This site contains three sets of features. First, there is the 1900 lighthouse, which still stands. Second, there are the remains of the tramway and other facilities in Lighthouse Bay. Third, there are the terraces for a cottage and other buildings. Figure 2 shows the complex in 1886.

The position of the tramway is still evident and numerous rails are still in place. There is a derelict shed in the bay, alongside of which are the remains of a trolley. Nothing remains of a boatshed which shows on the 1886 photograph. Although the terraces where the cottage and outbuildings were located have been planted in native species, they are still partly visible under the thick vegetation cover.

*Figure 2. Lighthouse and keeper's cottage and outbuildings, 1886. Edgar Richard Williams Collection, Alexander Turnbull Library. Reference G-25715-1/1.*

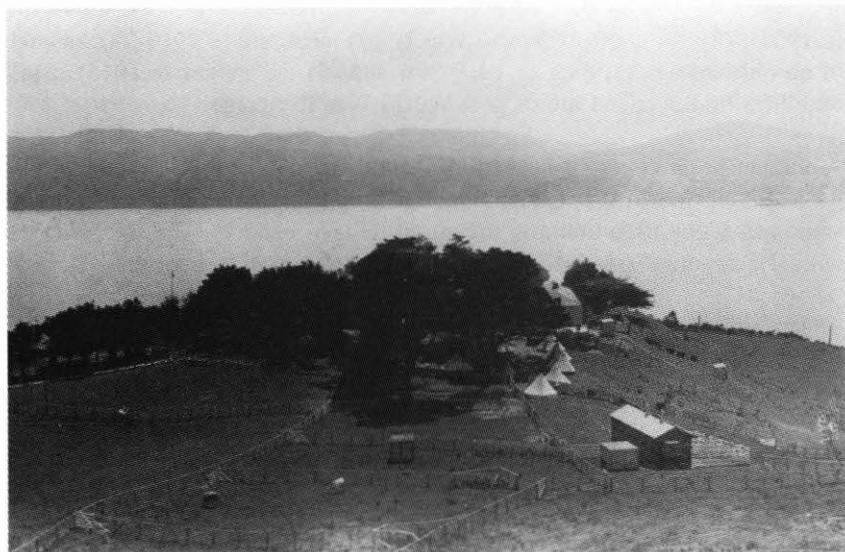
A number of photographs held by Alexander Turnbull Library show parts of the station in World War I, including two long barrack buildings added to the station in about 1916 to house the guards (Figs. 3 and 4). The stables in the animal quarantine area also appear to have been built at this time.

*Figure 3. Animal quarantine area (foreground) and shelterbelt around the human quarantine station in the early part of World War I. Photographer unknown. Alexander Turnbull Library. Reference F-112226-1/2.*

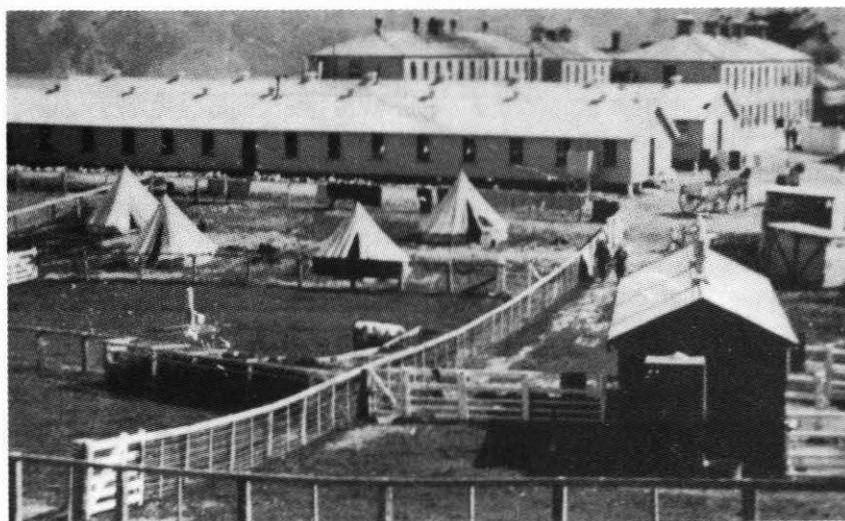
*Figure 4. Quarantine station in about 1917 or 1918. The shelterbelt has gone and two long huts have been added to the station. Photographer unknown. Alexander Turnbull Library. Reference F-38622-1/2.*

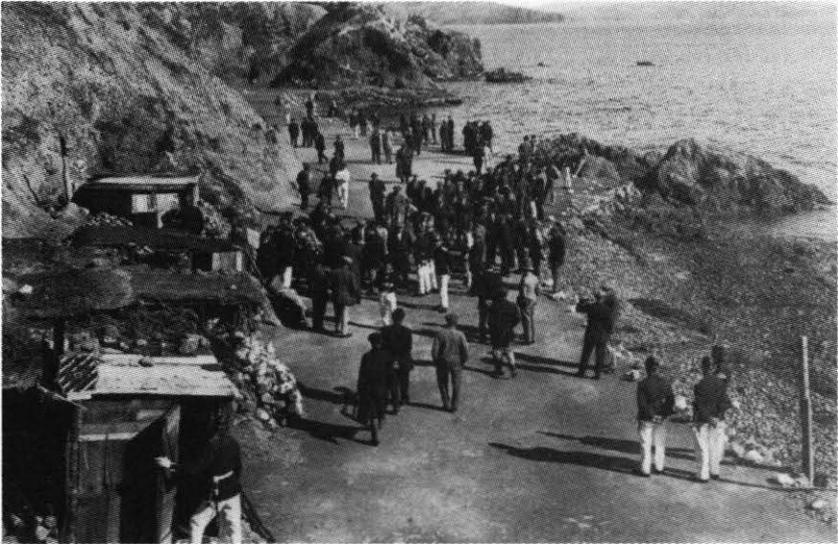
beach on the western side of the island. A number of photographs held by Alexander Turnbull Library show the internees, the reclamation, and huts and terraces along the base of the cliffs. Figure 5 shows one such scene. Two other bays were modified less extensively. The bay southwest of Te Moana-a-kura pa was modified to hold a tennis court (see WDO 10389, August 1942).

*Figure 5. Interned Germans celebrating the Kaiser's birthday. The photo shows the recreational area on the shoreline. Photographer unknown. Alexander Turnbull Library. Reference F-112288-1/2.*

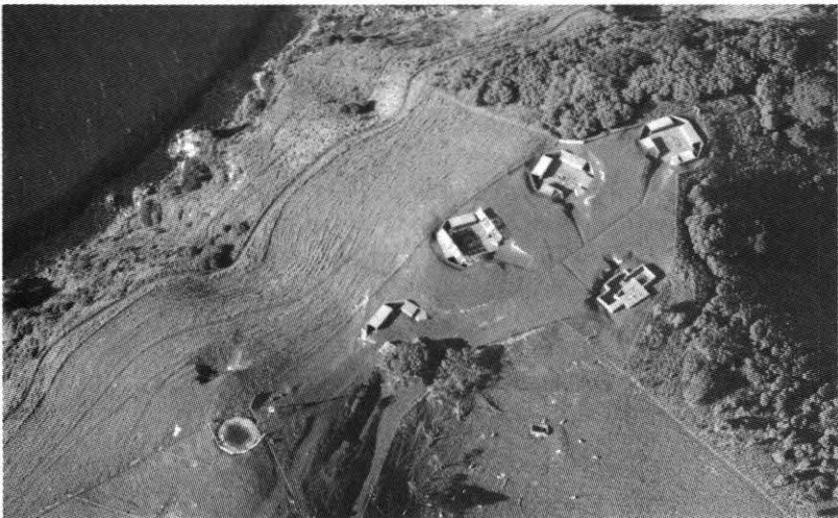
The site, on what was till then the highest point on the island, required 'considerable excavation and building up' (National Archives, Ministry of Works, Series 1, File 23/828, AA Defences:Somes Island 1942-3). The levelling of the hilltop was done by bulldozer and was completed by early November 1942. The contract to build the four emplacements and a command post was awarded to A.G. Wells after another contractor withdrew. The emplacements, which were for 3.7" heavy anti-aircraft guns, were built to 'a new, simplified design' (*ibid.*) and so differ from those at the other two local battery sites (Brooklyn and Point Halswell) which still survive. One emplacement has been damaged but otherwise the site is intact (Fig. 6).

*Figure 6. Anti-aircraft battery site from the air, mid-1995. Photographer Kevin Jones, DOC.*
