NEW ZEALAND ARCHAEOLOGICAL ASSOCIATION NEWSLETTER

STONE WALL DEFENCES AND STONE-FACED PITS

Bruce W. Hayward
N.Z. Geological Survey
Lower Hutt

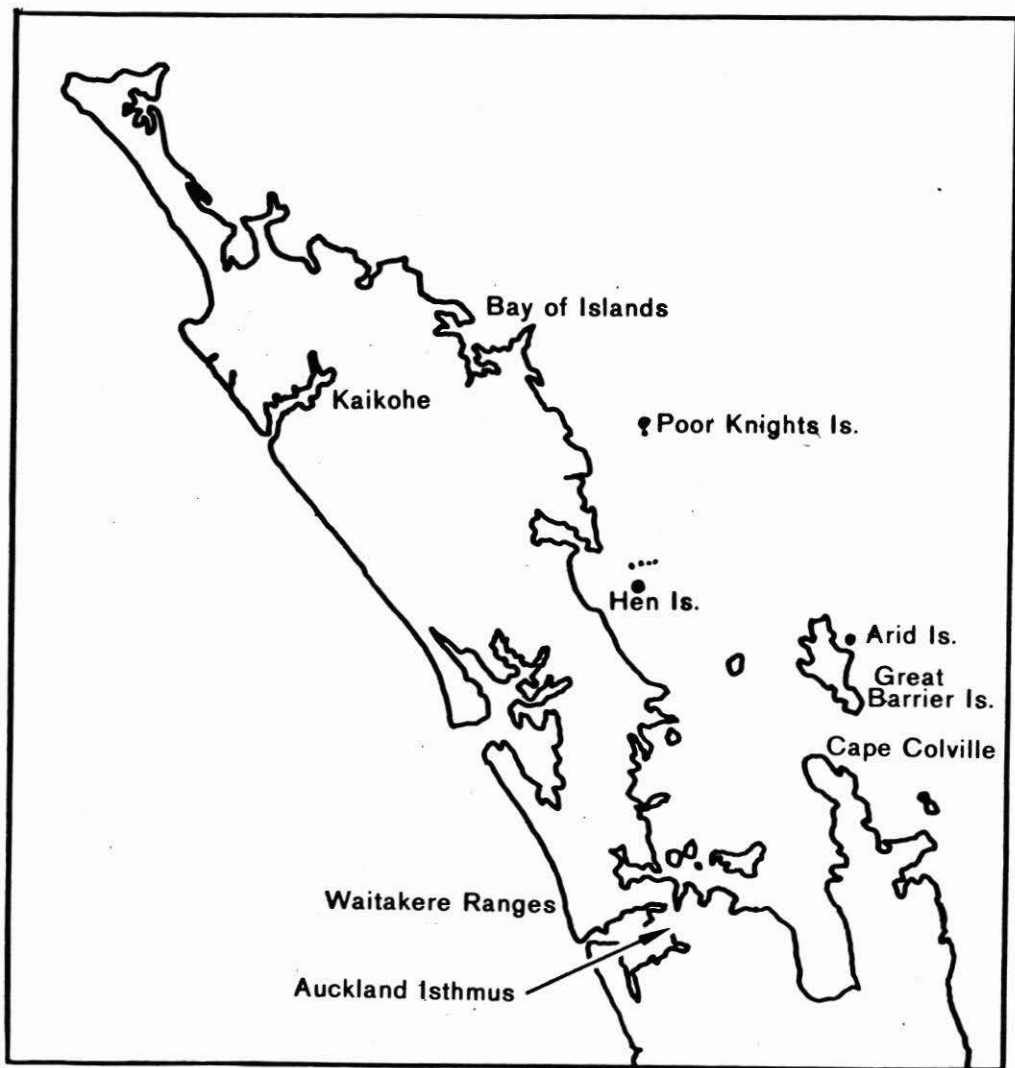
FIGURE 1. Localities in northern New Zealand where stone wall defences or stone-faced pits exist.

Prehistoric stonework in the form of heaps, rows, lines, platforms, pavements, drain covers, retaining walls and free-standing walls, have been described from many parts of New Zealand, especially in the north (Fig. 1), e.g. Three Kings, Whangaroa, Kaikohe-Bay of Islands area, Waipoua, Whangarei, Poor Knights, Hen and Chickens, Great Barrier, Little Barrier, Arid Is, Waitakere Ranges, Auckland Isthmus, Pirongia, Cape Colville, Great Mercury Island, Ohena Island, Whale Island, Aldermen Islands, New Plymouth, East Cape, Lake Taupo, Waitomo, Gisborne, Wairarapa, Kapiti, D'Urville Island, Heaphy River, Kaikoura, Waitaki River and Stewart Island. The majority of these stone structures are thought to have been associated with the clearing of stony ground for cultivation and some had religious significance.

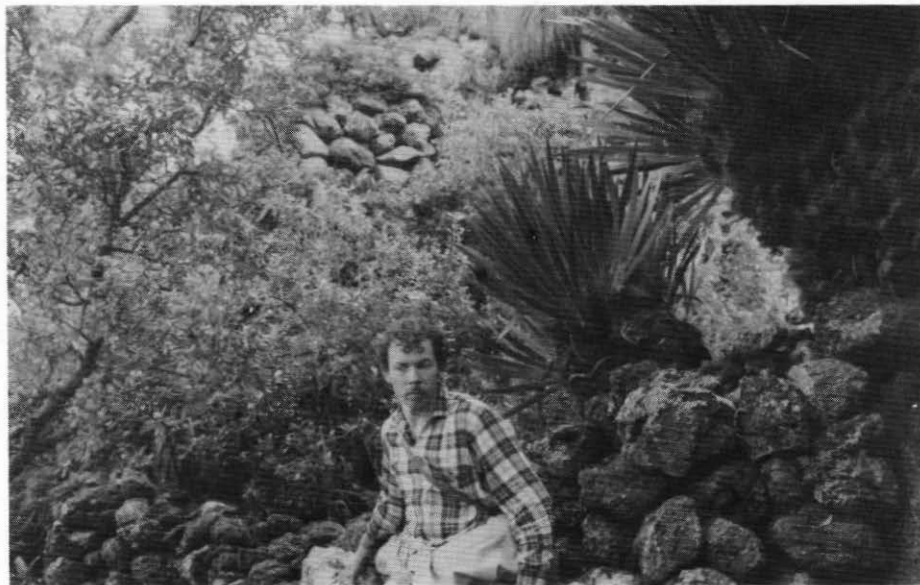
STONE WALL DEFENCES, Plate 1. Defensive stone retaining walls on N17/47, Tawhiti Rahi, Poor Knights Islands.

The defensive part of the pa, behind the ditch, is built over a 30 x 8 m knoll composed almost entirely of solid rock broken into large blocks along fracture planes. Two terraces (each about 20 m²) have been created by the construction of stone retaining walls which would also have played an important part in defence. The retaining wall around the south-eastern side of the lower terrace is an extension of the inner wall of the ditch. It is 1.3 m high and passes upwards into a 0.4 - 0.7 m high free-standing wall around the terrace edge (Plate 1, Fig. 2 A-A', B-B'). The second terrace is 4 m higher than the first and has a stone retaining wall (up to 3 m high in parts) around two sides (Plate 1, Fig. 2 A-A', C-C'). The only way to reach the upper parts of this small pa is to climb this second, partly defensive, retaining wall. On top of the rocky knob, several small terraces have been built up within natural hollows between large blocks, in places with the assistance of small retaining walls.
