Survey of the Canton Battery Site, Waipori, Otago

Francesca Allen, Baylee Smith, Jessie Hurford
University of Otago Anthropology Society

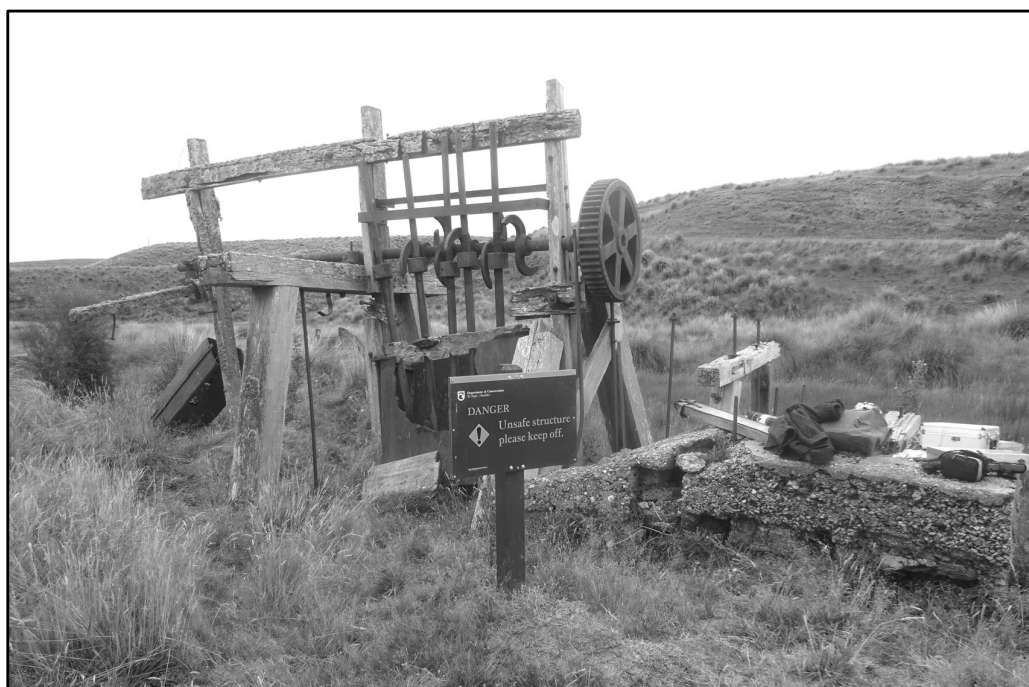
Figure 2. The Canton Battery in 2016 (Hannah Arnhold).

The Canton battery is located on the south side of Mitchell's Flat, close to the Waitahuna-Waipori road. It is signposted with a DOC marker and is easily accessible along a cleared track. The battery site consists of the battery itself, a concrete engine bed, the remains of the small pumping water wheel and the probable site of the main mine shaft (Figure 3). All but the water wheel are located on dry ground, but the land on front of the battery and around the water wheel is boggy due to the choking of the stream bed by weeds.

As the purpose of the site survey was to undertake a more thorough investigation of the surroundings of the Canton battery and water wheel they shall only be briefly described here (for a more thorough description see Petchey 2014 & 2015). The Canton battery is a five stamp mill, but it was built using the camshaft for a larger ten stamp mill. There is no evidence to suggest that the full ten stamps were ever fitted as there is no damage to the camshaft where the extra five stamps would have been mounted and the timber guides are only grooved for the existing five stamps. The mill has a trestle type frame with a heavy timber trestle structure to support the camshaft. Only the centre trestle remains completely intact. The mortar box is a one-piece cast iron item. The projecting flange around the screens and the apron has been broken away and the makers place is also missing. At 63 inches long this is the longest mortar box recorded in New Zealand (Petchey 2013: 208). The Canton water wheel has deteriorated significantly in the past twenty years, being relatively intact in 1995. The wheel is half buried in its original position, on the edge of the Pioneer Stream, with four surviving exposed spokes and a small portion of the shroud visible.

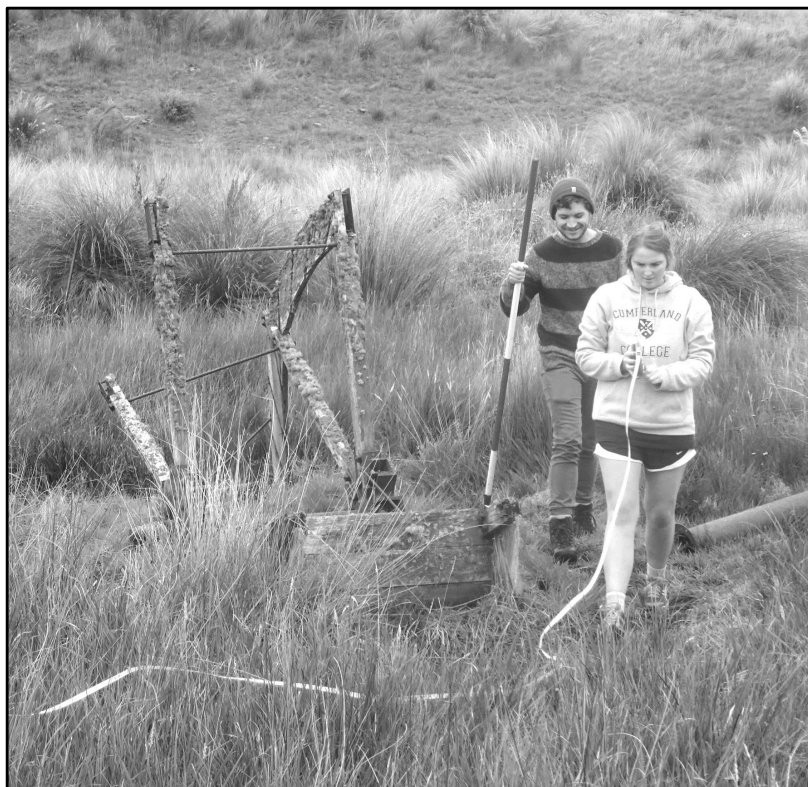
Figure 4. Working around the remains of the Canton water wheel (Hannah Arnhold).

namely the partially buried water wheel (Figure 4), were then mapped. Although infilled (or collapsed) the shaft was still easily identified as a rectangular depression in line with the water wheel, with several upright timbers and vertical iron rods from the shaft head structure still in place. As
