ARCHAEOLOGY IN NEW ZEALAND

THE ARCHAEOLOGY OF A FURNACE: 550 COLOMBO STREET, CHRISTCHURCH

ANDY DODD¹ AND GRAEME RICHARDSON
¹UNDERGROUND OVERGROUND
ARCHAEOLOGY LTD

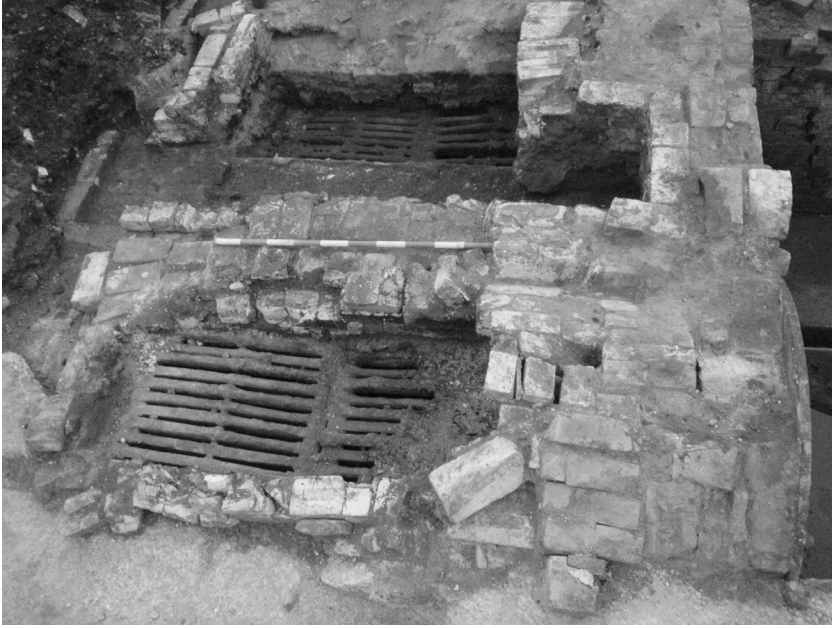
Figure 7. No. 1 (foreground) 2 (rear) furnaces, Area A, showing the fire bars and coke remains of last burning in the No. 1 furnace.

No. 1 and 2 furnaces used nine-inch straight fire bricks from the Brunner brickworks. These fire bricks were designed and used as a heat-resistant material to line areas subjected to flames or high temperatures. The fire bricks on these structures were used to line the furnaces, flues and oven floors. Unlike bricklaying on buildings, fire bricks are set in a very thin layer of fire clay mortar.

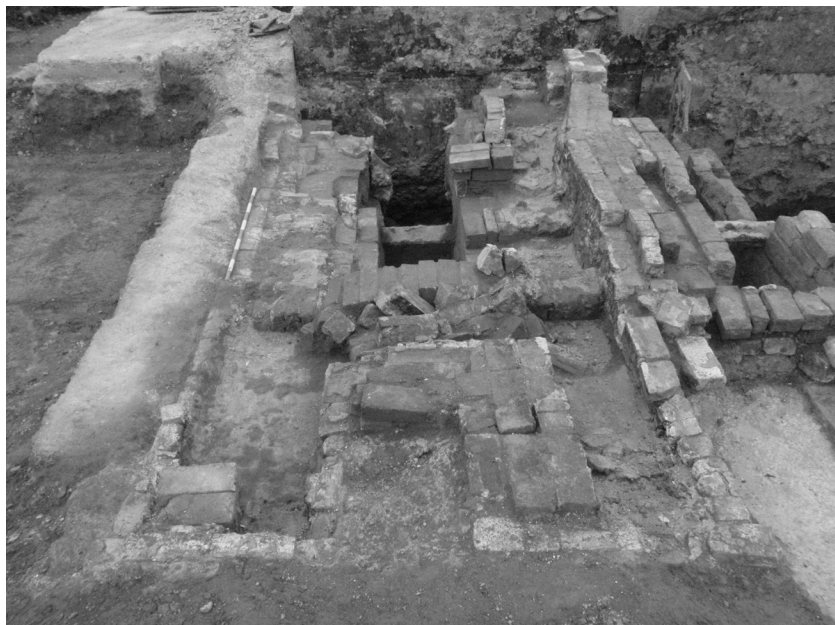
Figure 8. Looking south across Area B. Note the recessed flues at the rear of the furnaces. This photo shows the addition of two rows of bricks in the eastern flue (right) as well as bricks added to the western flue to reduce the flue size.

Area B (Figure 8) was similar to Area A, both in design and function, comprising a split-level furnace, two fire bars deep. Area B was a later addition to the original furnace layout. The brickwork was laid onto rough concrete footings, and a recess on the eastern side was incorporated into the design to provide for the continued use of the western flue inspection door of Area A. The brick work was of a noticeably different design to that of Area A, with cast iron doors set back into the face, and rounded bricks on the corners.

The furnaces in Area B show evidence of being modified during their operational life. The first alteration was the reducing of the width of the flue in the rear of No. 4 furnace by adding two additional rows of firebricks. A further modification was to furnaces No. 3 and 4, which had been re-bricked with Todd bricks above the grate level and tapered through to the doors. The furnaces had not been fired since the re-bricking and replacing of the fire-grates. The fire bars would have been replaced fairly often when in use.

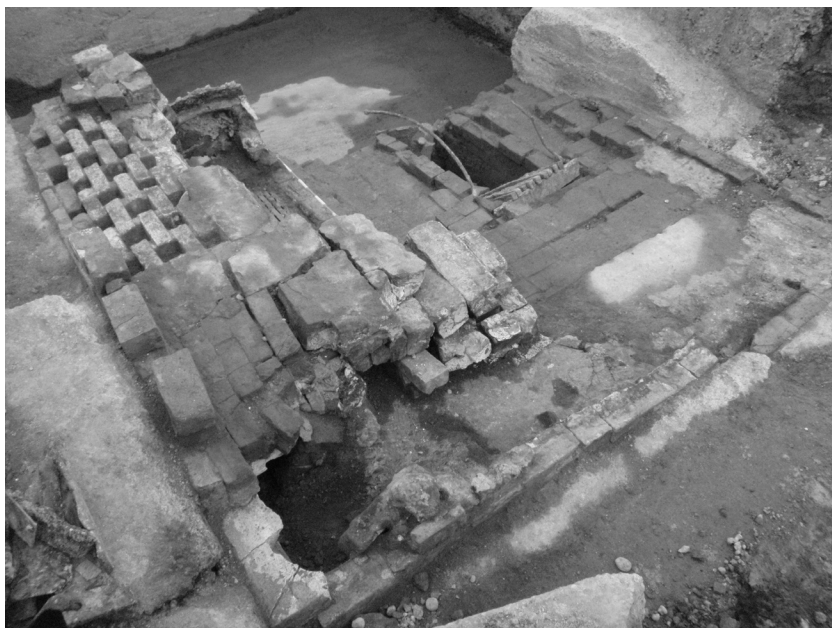
Figure 9. Area C from the northwest. Note the direction of flue splitting from the back of Furnace 6 and the lattice brickwork flue vents (left).

Area C (Figures 9 and 10) also comprised two furnaces, both on the same low level, directing all their heat on the underside of the oven floor before passing through vents into the oven. The fire grates were shorter than in Areas A and B and were only a single fire bar deep.

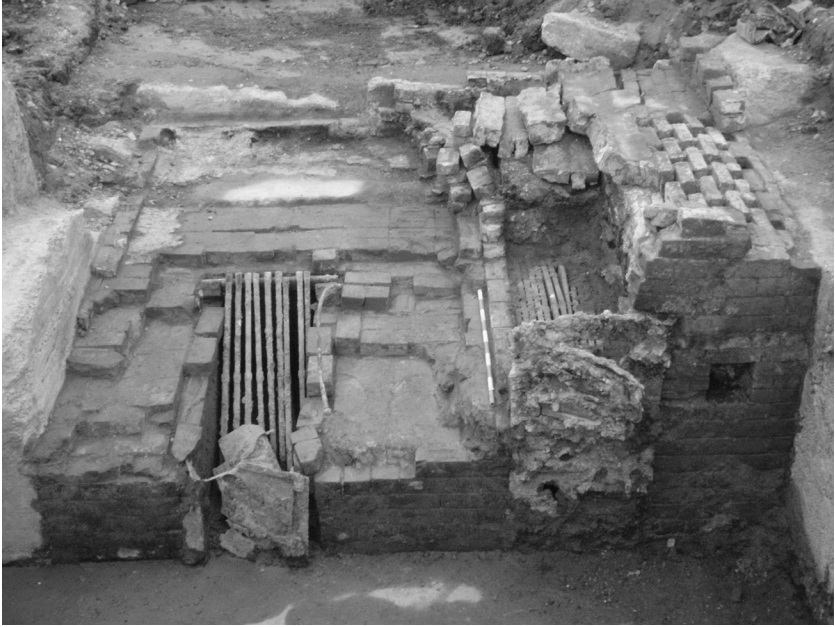
Figure 10. Area C showing the remains of the cast iron furnace doors and inspection doors.

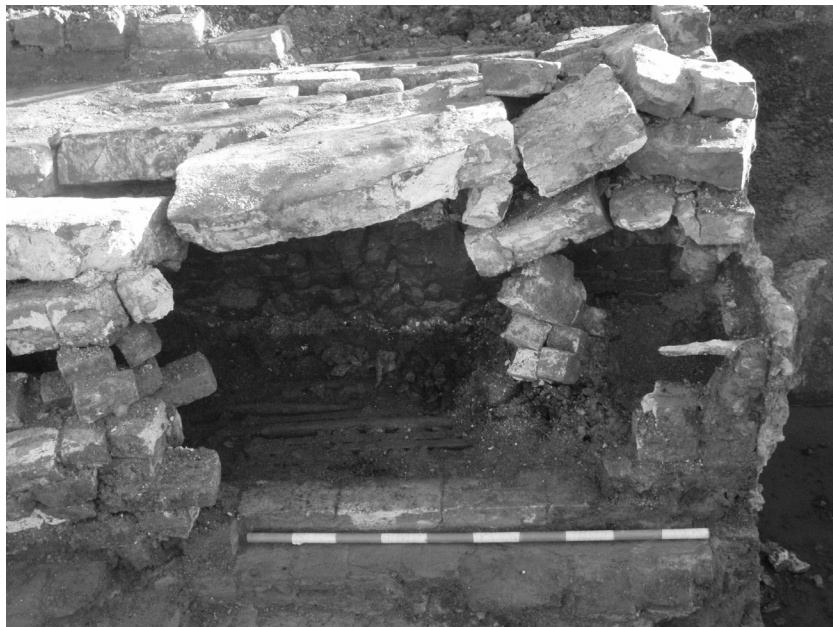
Figure 11. Detail of the No. 6 furnace showing slagging on bricks and the remains of coke along back of furnace. The cheek plate (right) has burnt away.

The fire door dead plate and cheek plates on No. 6 furnace were burnt away, which only happens when too much heat is held back in the furnace (Figure 11). This occurs when the dampers are closed right down to hold the heat in the oven, causing the fire to burn back to the fire door.

Furnaces 1, 2 and 6 had a fuel bed of coke still covering the grate from their last firing. The coke found in the furnaces on this site had high levels of volatile matter, thus the coke would have come from coke ovens or an early, less efficient gasworks. Scott's would have been using large quantities of coke as it was required in their blacksmith forges, rivet-heating furnaces and foundry cupolas (for melting metal).
