NEW ZEALAND JOURNAL OF ARCHAEOLOGY

The Form and Construction of the Makotukutuku House, a Pre-European Dwelling in Palliser Bay, New Zealand

Foss Leach¹
Janet Davidson¹
Rod Wallace²

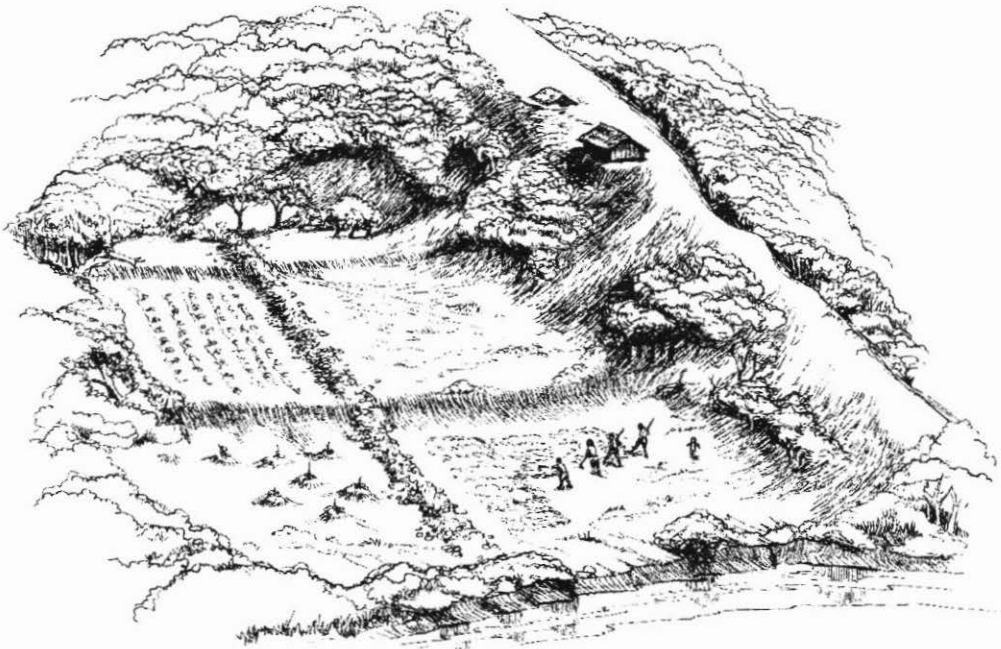
Figure 1: Artist's view of the Makotukutuku house site and associated garden area (from Leach and Leach 1979b).

rim pit and a terrace visible on the surface (Fig. 1) (Leach 1976: 249 ff., 1979: 122 ff.). The terrace, which proved to be the site of the Makotukutuku house, was excavated as part of a major integrated programme of archaeological research in the southern Wairarapa between 1969 and 1972 (Leach and Leach 1979a). The excavation exposed the plan of the house, which had been burned down. The reason for the fire is unknown.

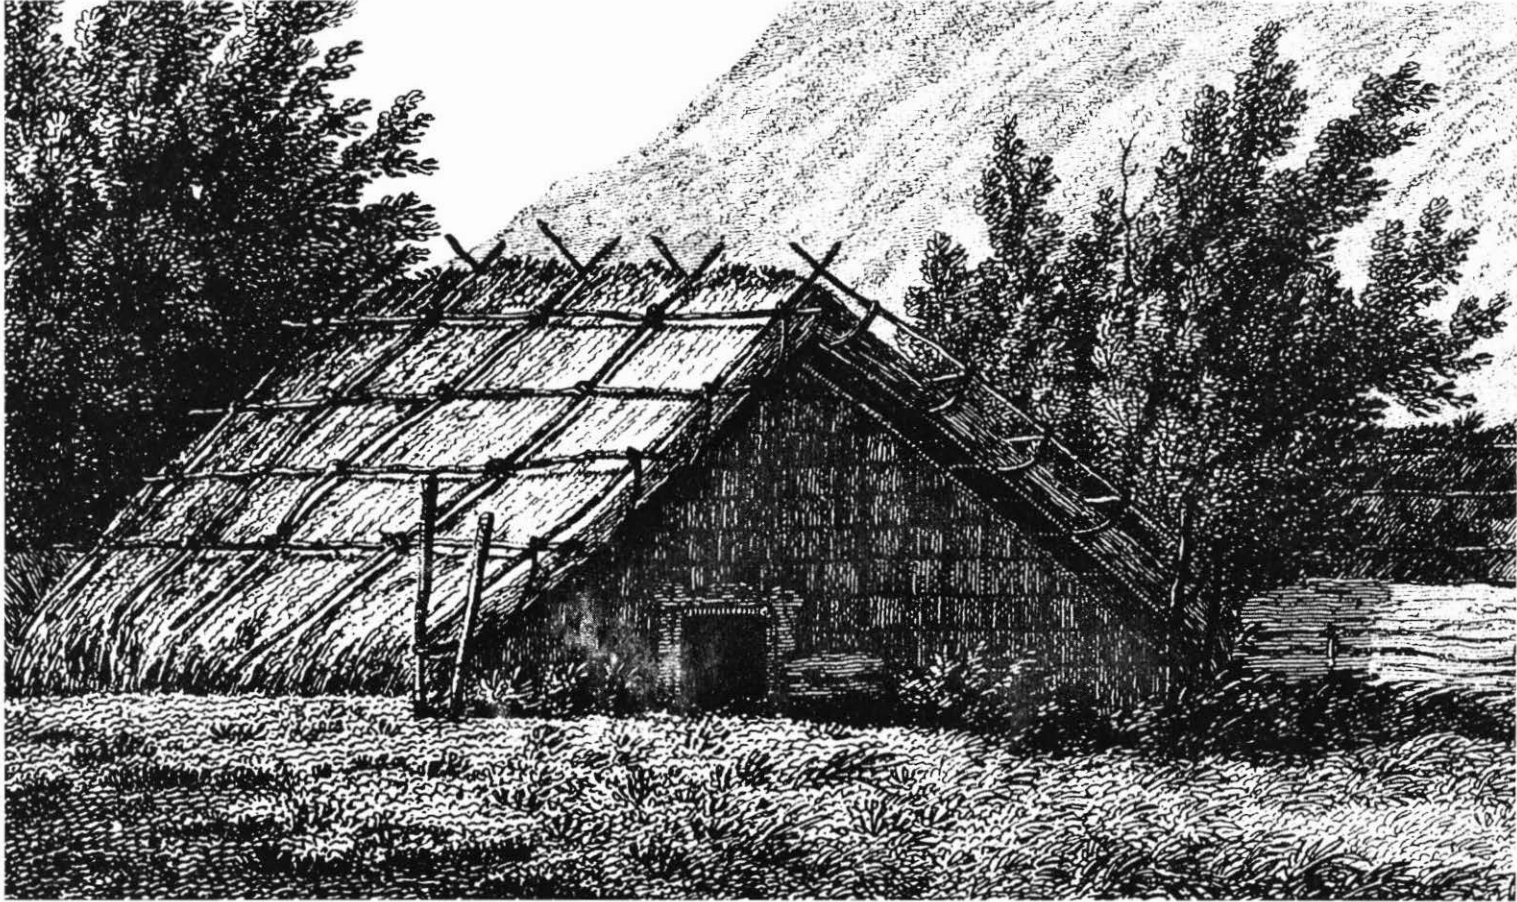
Figure 2: Engraving after John Webber's sketch of the interior of a pā in Queen Charlotte Sound in 1777, with a whare puni at the left.

Roux's description refers to a specific location almost as far away from Palliser Bay as it is possible to go in New Zealand. Banks' account, on the other hand, is a summary of houses seen in several parts of the country, including Queen Charlotte Sound, just across Cook Strait from Palliser Bay. Unfortunately, no detailed drawings of houses survive from Cook's first voyage, but John Webber, the artist on Cook's third voyage, made an excellent sketch of a house on Hippa Island in Queen Charlotte Sound (Fig. 2).

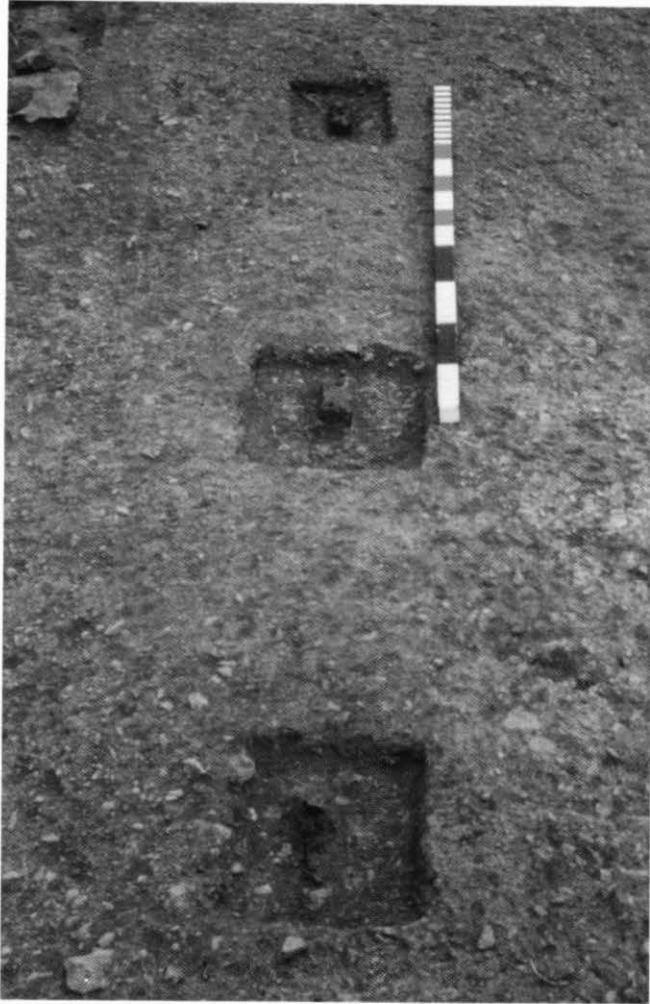
Figure 3: View of part of the excavation of the Makotukutuku house showing three carbonised post butts at the floor level of the house.

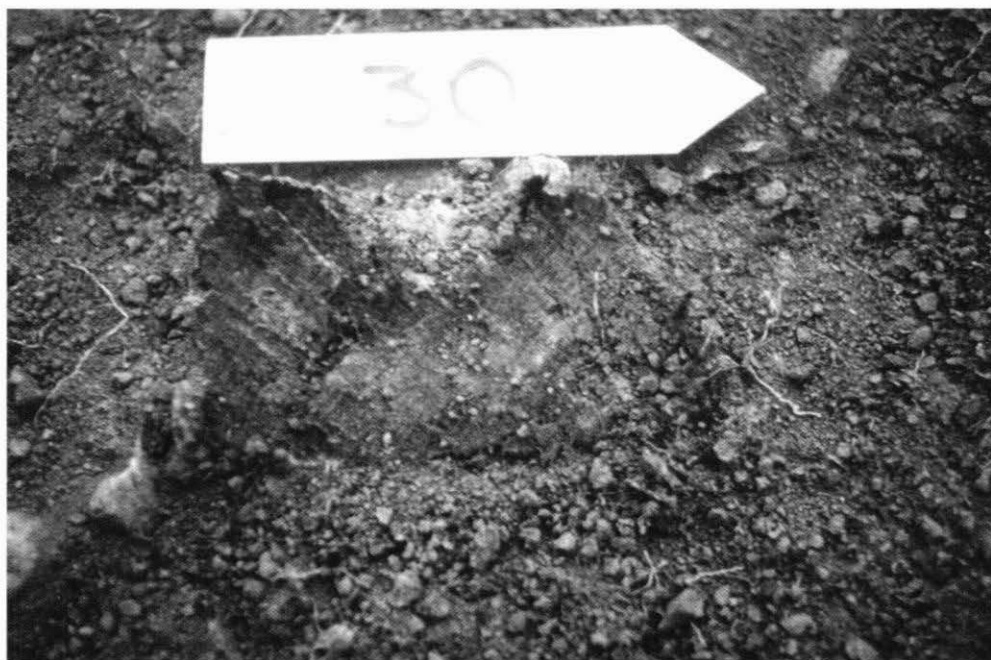
Figure 4: Close-up of post butt 30 showing the thin layer of preserved wood immediately underneath the carbonised cap.

The precise plan of the building is known from archaeological evidence. A thin layer of soil covered the natural bedrock (shattered deeply weathered greywacke) which had been levelled to form the terrace and the floor of the house. In most cases the actual posts of the house were represented by a very thin carbonised cap at the level of the floor or just below (Fig. 3); in remaining cases, postholes were located which sometimes contained charcoal fragments in the fill. It was concluded that the house had burned down either when it was still occupied or after it had been abandoned. The superstructure had been reduced to ash, which had long since disappeared from the exposed ridge top, presumably as a result of wind action. At the point where the posts reached the floor, however, charcoal had formed and remained in position. Beneath the charcoal, in most cases, where there had been no air to permit the buried part of the post to carbonise, there was an even thinner layer of bright red wood (Fig. 4).

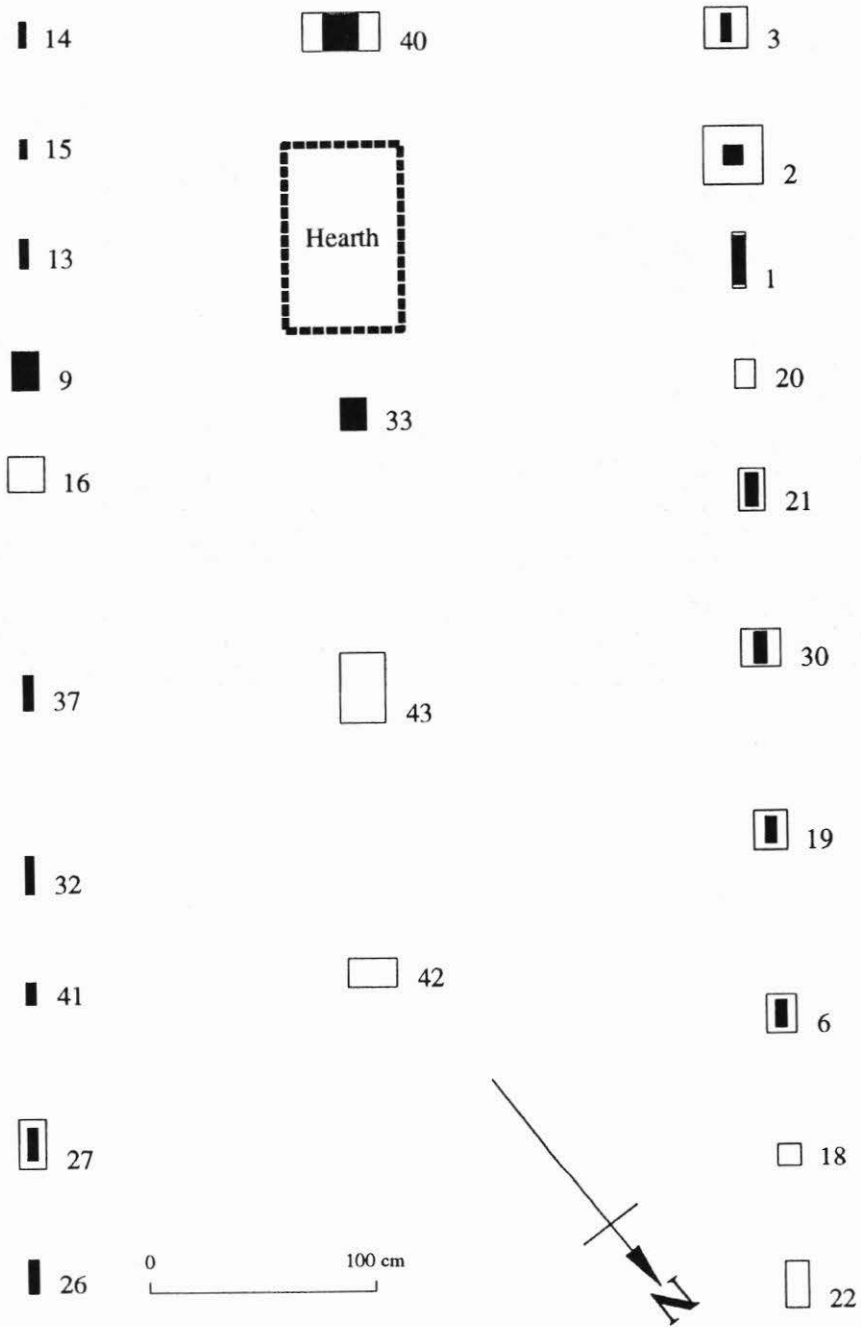
Figure 5: The floor plan of the house, with details of post numbering.

The house faced up ridge. It is approximately rectangular in plan, with a porch at the front, like historical examples of *whare puni*. It is not symmetrical; the front is 250 mm wider than the back, and the west wall is 90 mm longer than the east wall. The placement of the posts and the stone-lined hearth is illustrated in Figure 5. A simple method of laying out the positions of the posts is given in Appendix 1.

Except for the two stakes in posthole 2 on the west wall, the side wall posts were all rectangular, with their long axes aligned with the house walls. They varied considerably in size: the smallest measured 60 x 20 mm and the largest 100 x 40 mm.

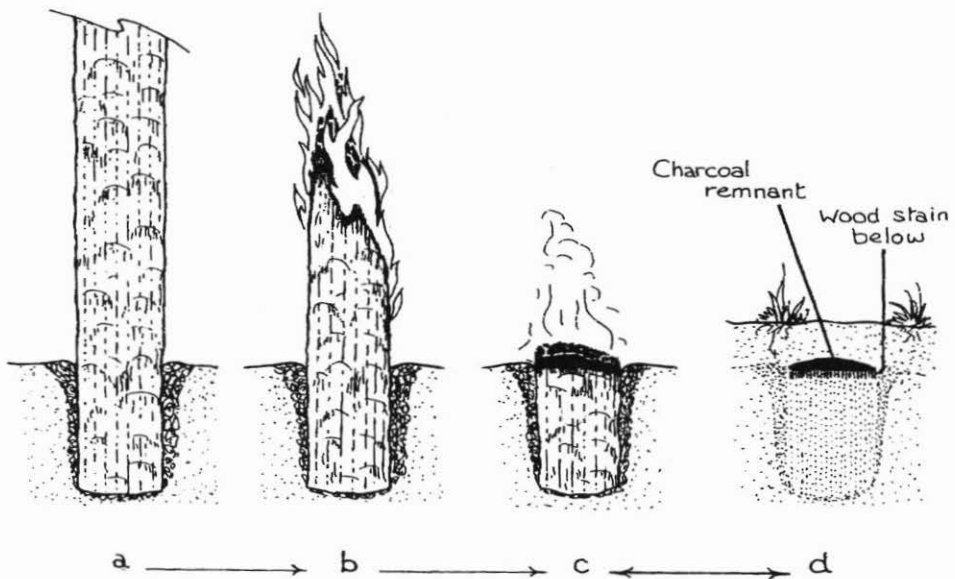
Figure 6: Diagrammatic interpretation of the transformation of a post to a carbonised butt found during excavation.

The sharply rectangular shape of the carbonised butts supports the view that they do indeed represent the actual posts. If larger, carefully shaped posts had burned and the outer parts of them had somehow weathered or eroded away, the remaining cores might not have been so sharply rectangular. Could the carbonised post butts themselves have shrunk during the process of burning? To answer this question, we need to consider the life history of a typical post from the time it was standing and supporting the roof of the house to the time when the excavation took place (Fig. 6). In Figure 6A we see the complete post buried in its post-hole and standing. During the fire which razed the house (Fig. 6B) the post is progressively burnt away, temporarily leaving charcoal remnants which themselves burn down as far as the ground surface. When the fire has completely burnt away the structure (Fig. 6C), the wooden part of the post inside the posthole still remains; it cannot burn because of lack of oxygen underground. This wood is capped by a thin layer of charcoal. Since the charcoal is attached to the wood underneath it cannot shrink to a dimensional shape and size which is smaller than the post (Buchanan 1997 pers. comm.). Instead, fissures and cracks form in the surface of the charcoal, and stabilise in this form. In the course of time, the wood rots away and dust and soil fill in the gaps (Fig. 6D). Some

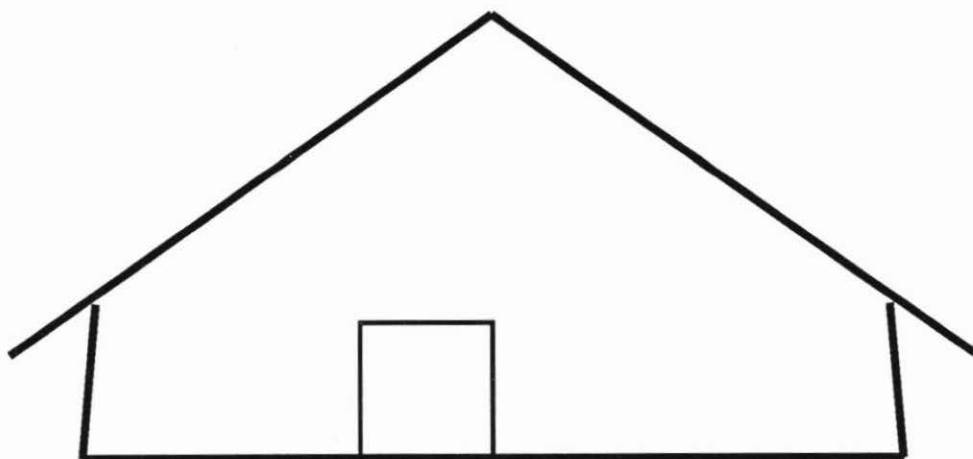
Figure 7: Suggested front elevation of the house. Estimated values are: house width = 3280 mm, wall height = 607 mm, wall angle = 5°, rafter angle = 35°, door width = 533 mm, door height = 533 mm. Derived values: house height = 1755 mm, ridge angle = 110°.

McCracken (n.d.) collected ridge angles for 44 historically recorded Māori houses (Table 4). These range between 101 and 131°. The simple mean of these data is 118°, equivalent to a rafter angle of 31°. Wallace and Irwin found a wooden roof joint which enables the ridge angle of the Kohika house to be measured directly at 110°, with an associated rafter angle of 35° to the horizontal. Clearly, the prehistoric house had angles similar to the historic ones. In the absence of direct evidence at Makotukutuku, a rafter angle of 35° to the horizontal is considered to be a reasonable choice (Fig. 7).

$$607 + (3280/2) * \tan (35^\circ) = 1755$$

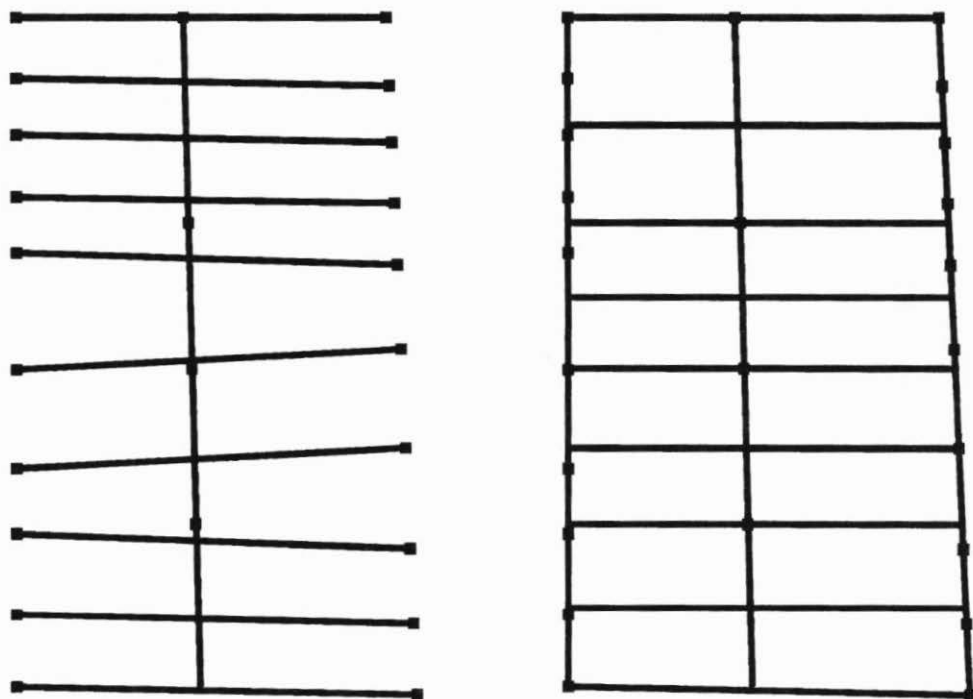
Figure 8: Two possible alignments of rafters, using mortise and tenon (left) and a top plate (right).

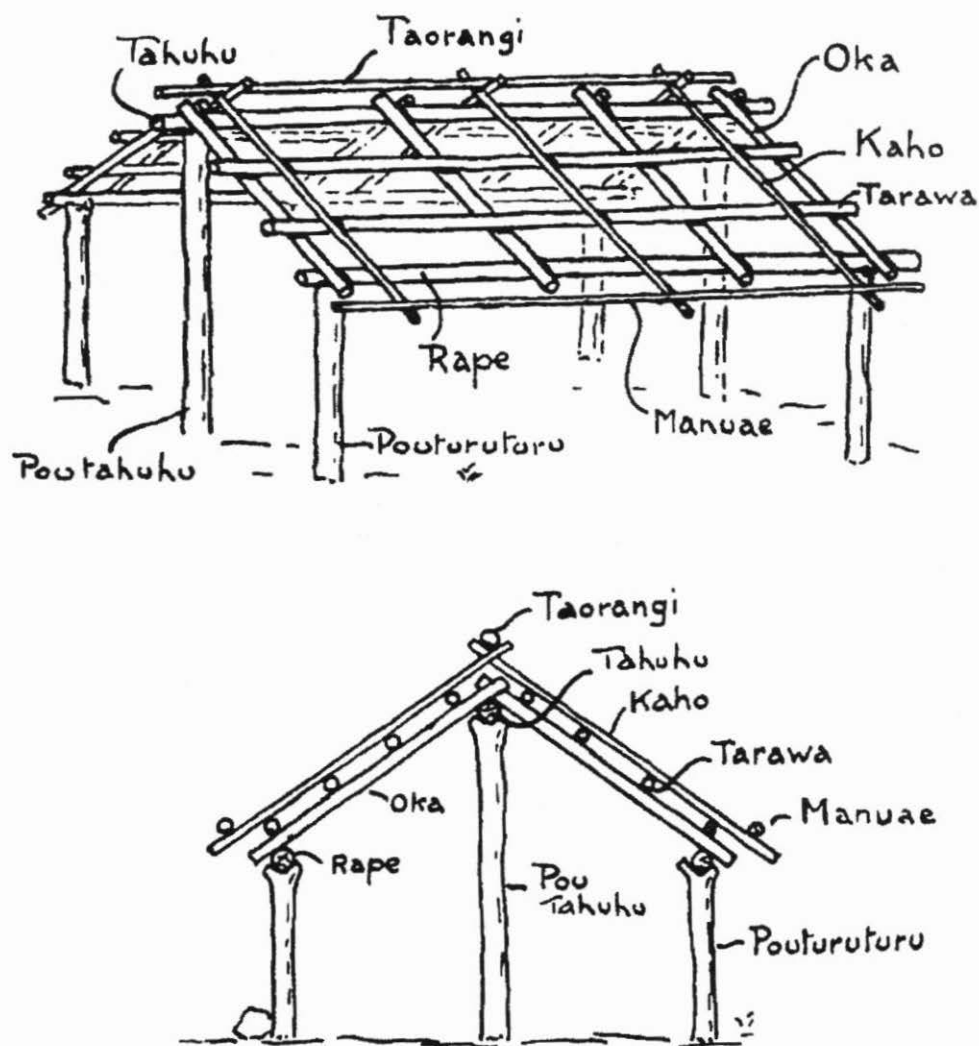
Figure 9: The framework of a rectangular house in Aitutaki, southern Cook Islands (after Buck 1927).

The simple rectangular houses of Aitutaki in the Southern Cook Islands (Fig. 9) and Tongareva in the Northern Cook Islands (Fig. 10), described by Buck, may be not unlike the early New Zealand rectangular house in their construction. The principal differences between these Cook Island houses and the *whare puni* are the lack of a porch and numerous side posts in the Cook Island houses and the fixed position of the entrance at one end in the *whare puni*. These changes could have been early adaptations to the climatic conditions in New Zealand.

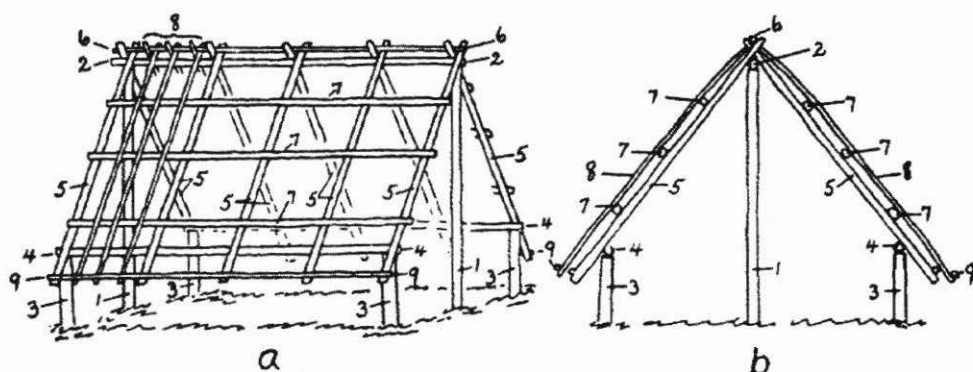
Figure 10: The framework of a rectangular house in Tongareva, northern Cook Islands (after Buck 1932). 1, supporting posts of ridgepole (*pou*); 2, ridgepole (*tahuhu*); 3, wall posts (*pou*); 4, wall plates (*hapai*); 5, principal rafters (*oka*); 6, upper ridgepole (*tamaiti*); 7, purlins (*torotoro*); 8, thatch rafters (*rau oka*); 9, eaves rod (*torotoro hiohio*).

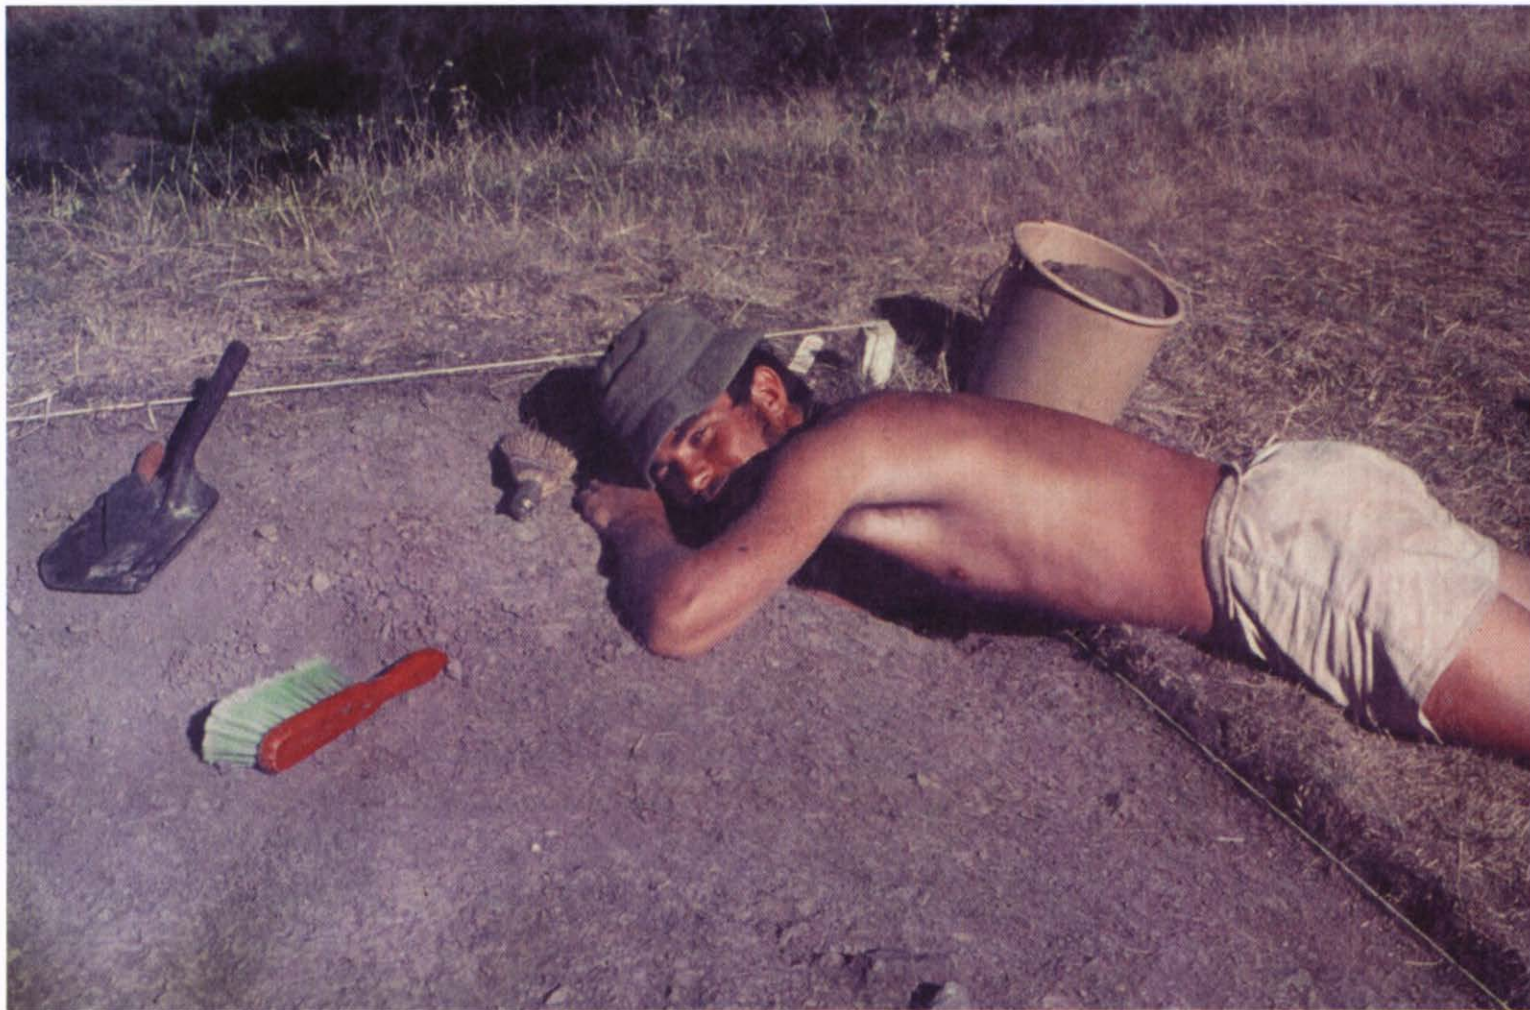
The Makotukutuku house during excavation. Doug Sutton has his arm down a tree root hole, not a posthole.
