NEW ZEALAND ARCHAEOLOGICAL ASSOCIATION NEWSLETTER

THE HISTORICAL ARCHAEOLOGY OF NEW PLYMOUTH FLOUR MILLS

Robyn Oliver
New Plymouth

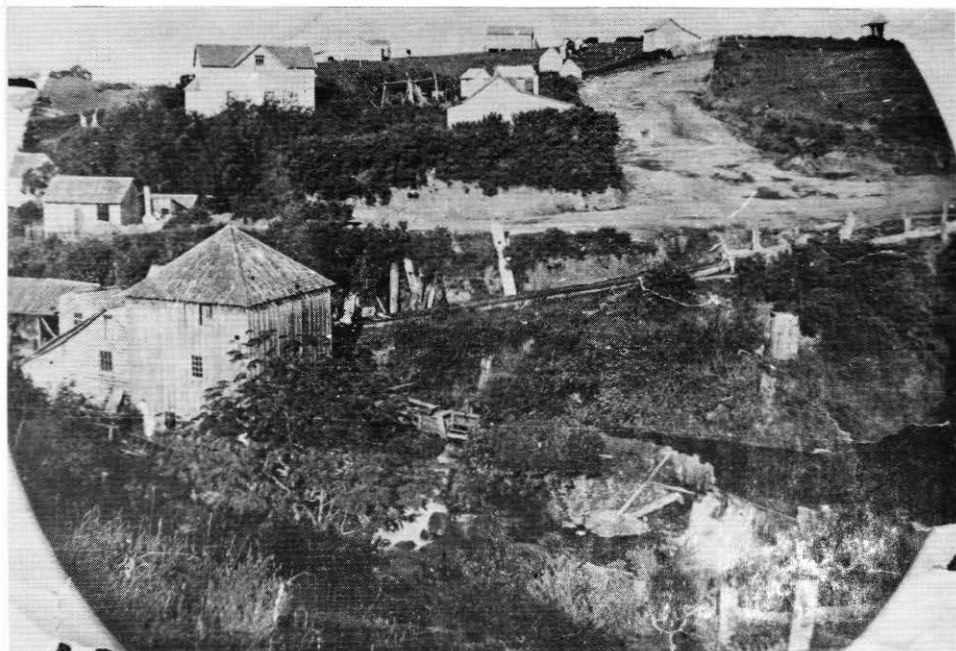
NEW PLYMOUTH FLOUR MILLS Plate 1. The Alpha Mill.

The first flour mill to be built was the Alpha, on the Huatoki Stream, near the centre of the town (Plate 1). It was begun in 1843 and commenced operation in February of 1844. This makes it one of the earliest mills in New Zealand. The first was built about 1834 at Waimate in the Bay of Islands (Hargreaves, 1961).

2. A lower stone wall of the same type, which runs from the bank towards the first wall (length of 3.5m visible, one course in height and breadth visible). This may have been connected with the dam seen in Plate 1. A number of large boulders embedded in the stream at this point may have also been utilised for the dam.

3. Towards the northern end of the first wall is a small ditch. Although by no means clearly dating to the mill period this may have been connected with the sluice gate seen in the photograph.

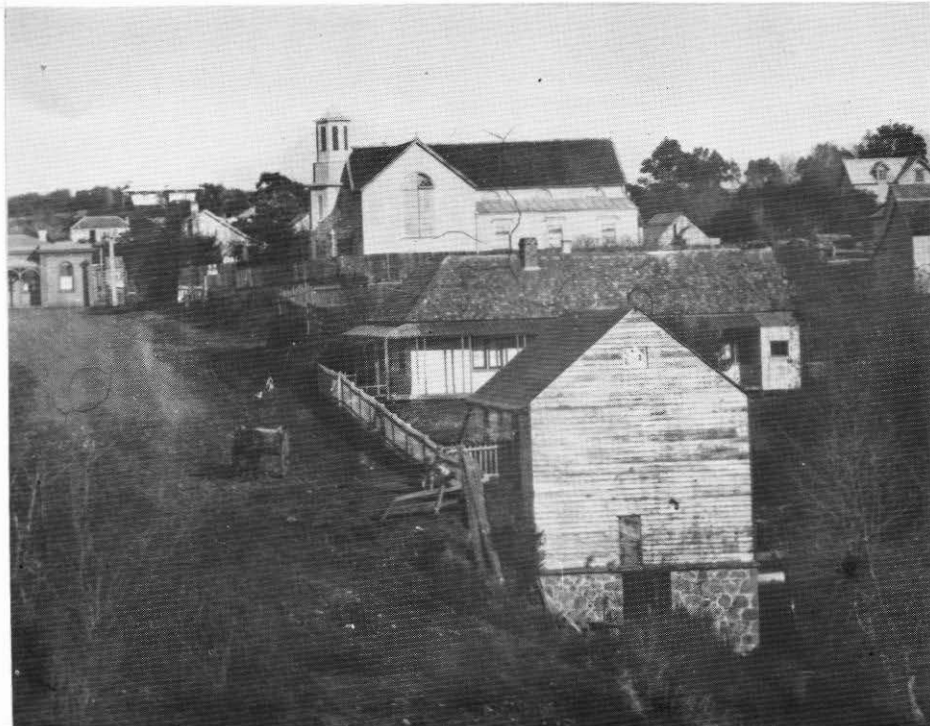
NEW PLYMOUTH FLOUR MILLS Plate 2. The Union Mill.

The Union Mill was situated on the Mangaotuku Stream near the main business area of town (Plate 2). It was built because of local resident's dissatisfaction with the Alpha and Victoria mills, and there is quite a saga of wheelings and dealings between the conception of the idea in late 1845, and the opening of the mill in March 1849. Much of the mill had in fact been completed by early 1847.

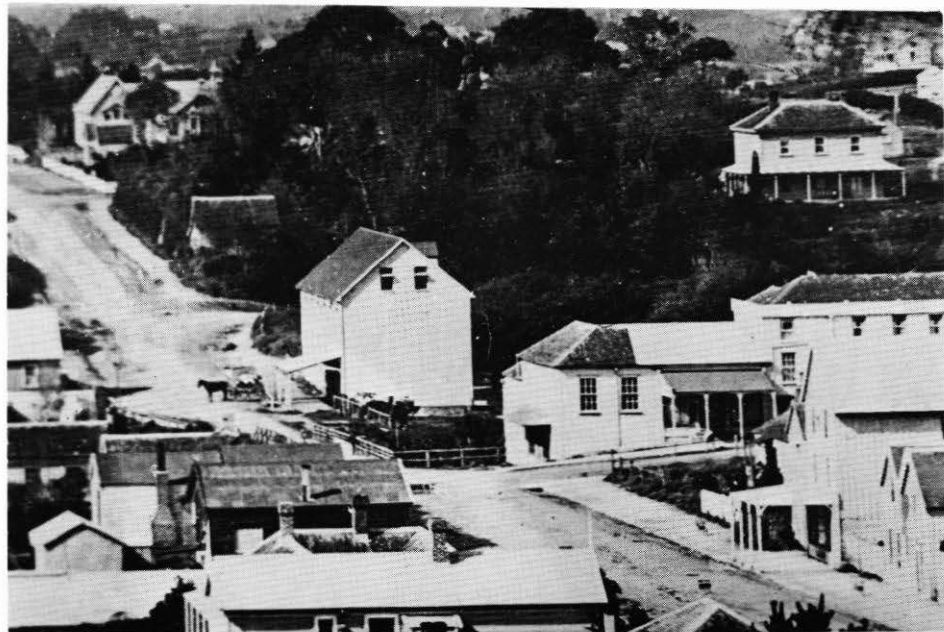
NEW PLYMOUTH FLOUR MILLS Plate 3. The Egmont Mill.

In spite of the declining grain growing industry around New Plymouth and the increasing availability of imported flour, the owners invested £7,000 in the mill which commenced operation in 1867 (Plate 3). By 1880 the mill was in difficulty. Although Egmont flour was cheaper than imported, local people rejected it because of its darker colour, due either to excess moisture in the grain or to a fungus called 'smut'. In 1885 the mill business was bankrupt although the mill continued to operate for a few more years under the management of its previous owners.
