ARCHAEOLOGY IN NEW ZEALAND

THE HISTORY AND ARCHAEOLOGY OF THE MAKATOTE TRAMWAY, ERUA

JOANNA WYLIE
NEW ZEALAND HISTORIC PLACES
TRUST, WELLINGTON

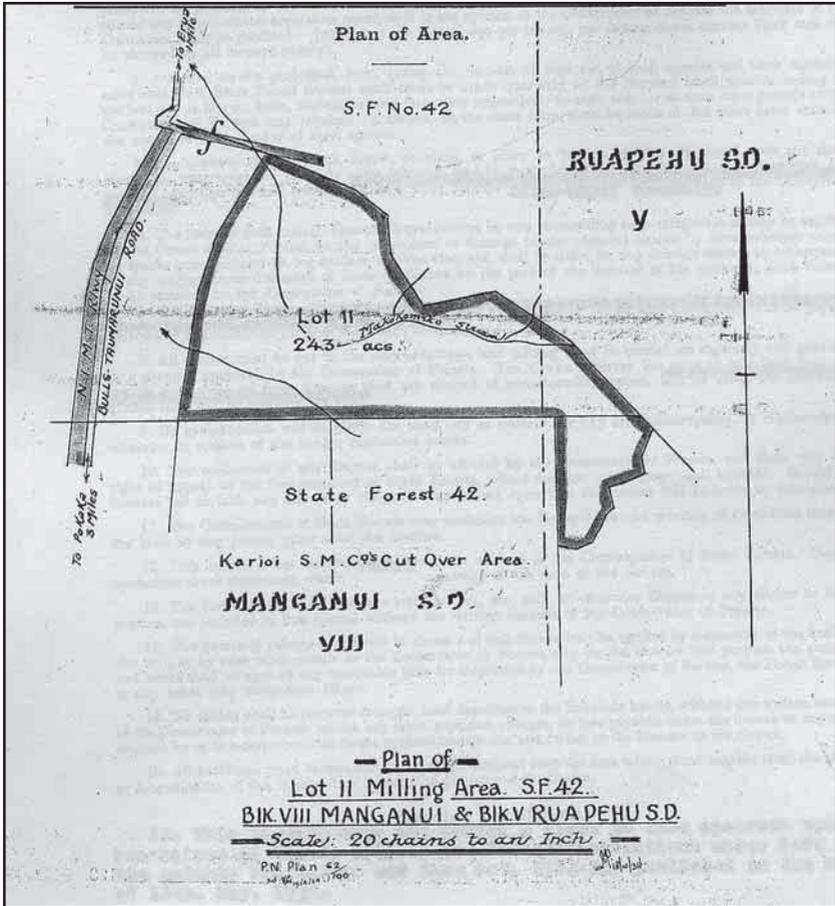
Figure 2. Plan of Lot 11 Milling Area, State Forest 42. Attached to Sawmill License No 328, File F23/3/42/8, Archives NZ, Wellington.

Dinwoodie subsequently formed the Dinwoodie Timber Company with the Glendinning brothers, and in November 1934 he was issued with a sawmill license (No. 16/42/72) for Lot 11 of State Forest 42, Block VIII Manganui and Blk V Ruapehu Survey Districts, as shown in Figure 2. The license covered the period 18 October 1934 to 17 April 1939, and had a purchase price of £5100 (Archives NZ File F1 23/3/42/8). The license allowed for the erection of a sawmill and the cutting of rimu, matai, kahikatea, totara and miro, estimated contents totalling 3,347,600 ft board measure and 500,810 ft cubic measure (Archives NZ File F1 23/3/42/8).

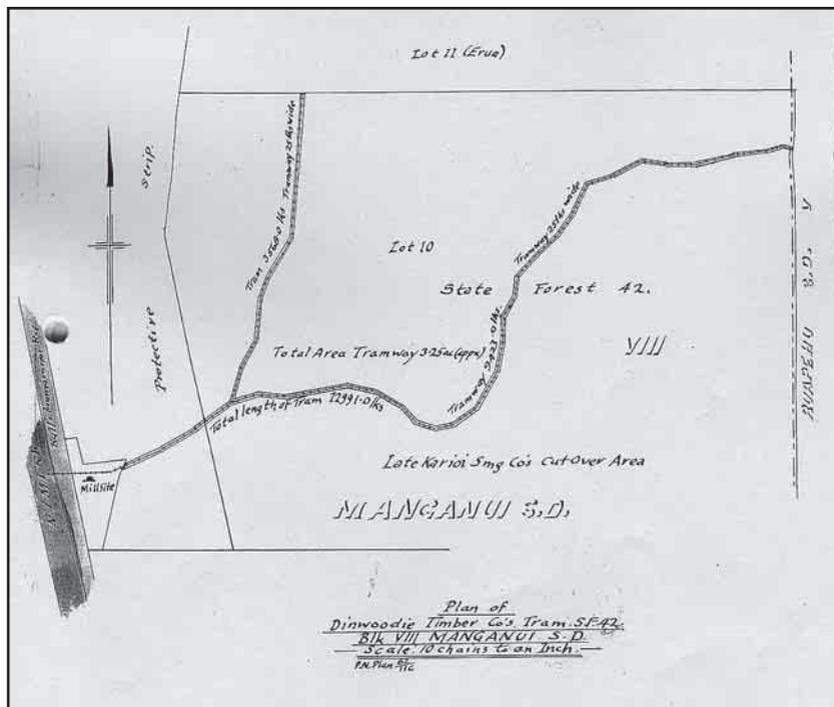
Figure 3. Plan of Dinwoodie Timber Company's Tram in State Forest 42. Attached to Tramway License, 24 September 1935, File F23/3/42/8, Archives NZ, Wellington.

The first evidence of the Makatote tramway is the mill site, which is accessed via an unmarked track that crosses the road reserve into the Tongariro National Park.¹ The mill site is in a relatively flat, open area and although there is no structural evidence of the mill, there is a metal plate (possible boiler plate) and artefactual remains such as billies, pails, metal drums and a spade. The size and structure of the mill is unclear, but its position is verified by historical maps/ plans (refer to Figure 3).

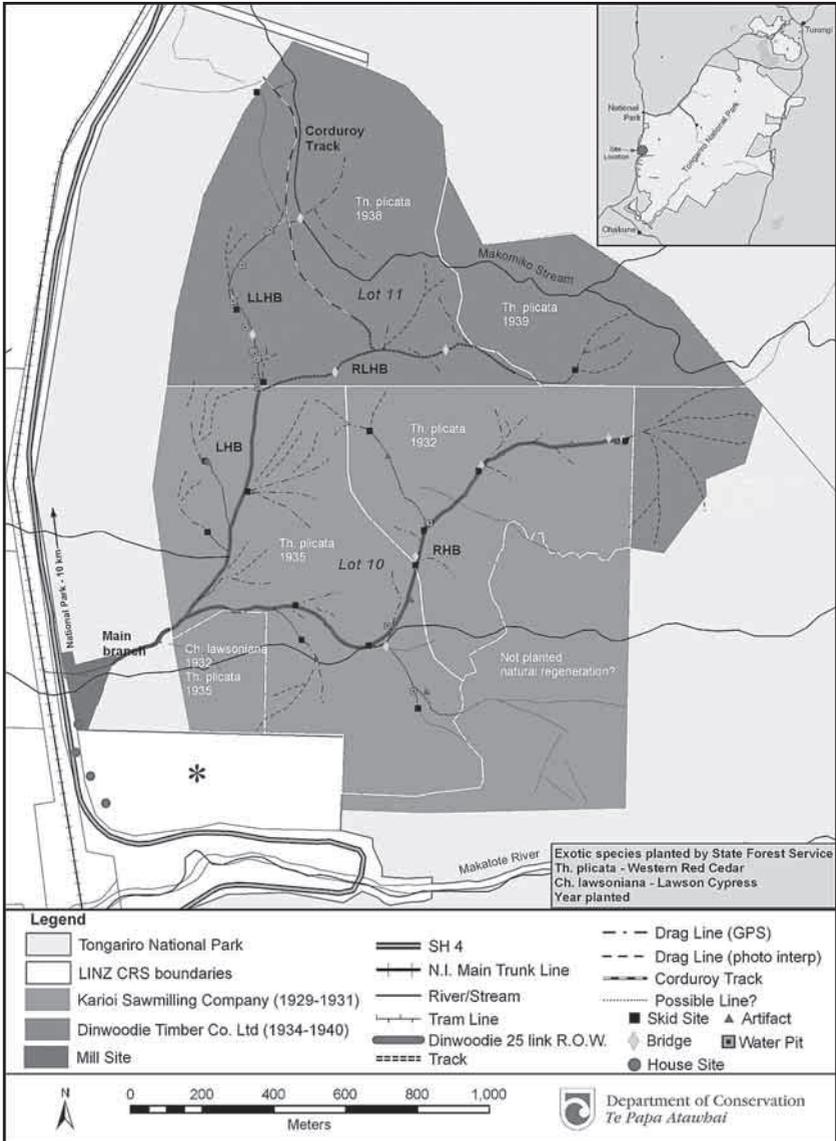
Figure 4. Map of Makatote tramway site, produced by Department of Conservation Tongariro/Taupō Conservancy, February 2006.

The Makatote tramway was surveyed over a total of six and a half days in July and October 2005. Key features such as tramway junctions, artefacts, bridge crossings, draglines and skid sites were photographed and recorded using a GPS (with an aerial attachment) where possible, and measurements were also recorded if considered appropriate. The survey data was then utilised to produce a map of the site as shown in Figure 4.

A corduroy track begins at the junction on the RLHB and continues in a north-westerly direction as far as the western edge of former Lot 11, as shown in Figure 4. There are two distinct draglines off this track to the north-east, and both run down to the Makomiko Stream. The southernmost dragline has a bridge across the Makomiko Stream and continues on the other side, but there was no clear crossing for the dragline at the north-western end of the corduroy track. The latter dragline was of particular note as parallel logs had been placed on the upward slope to assist with the hauling of logs. A large skid site was located and recorded to the northwest of the corduroy track, almost at the western edge of former Lot 11. The exact age and function of this corduroy

National Park) as being the former house sites, as marked on Figure 4 (Williams and Mercer 2005: Noel Heath interview). These clearings were inspected as part of the archaeological survey of the site, and relevant features were recorded. A pit was noted in the northern most clearing and various artefacts were observed, including a white china plate with the inscription “Victoria/China/Czechoslovakia.” The next clearing to the south contained a number of pit features, and further pits were recorded in the bush to the north of this clearing, as were artefacts such as ceramics, bottle glass and an enamel billy. Two *in situ* wooden posts and a metal pipe were also recorded in this clearing. Two pits and a wooden post were recorded in the third clearing heading south towards the Makatote Gully, and a fourth, much larger clearing contained a pit filled with twentieth century European artefacts, including broken ceramics and glass.

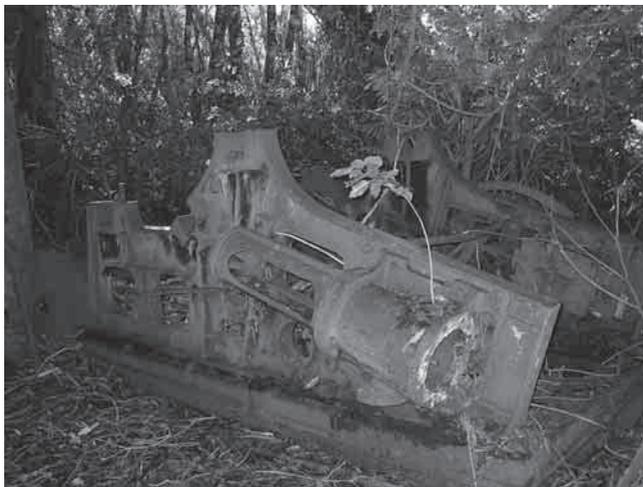
The LHB runs in a northerly direction from the main branch junction and has several side branches to the east and west. The second side branch to the west of the LHB is notable for its *in situ* rails, bearers and sleepers, and it also has a points change. It leads to a skid site and log hauler, which is imprinted with the name "S. Luke and Co Ltd, Wellington", one of the 13 principal log hauler manufacturers in New Zealand (Mahoney 1998: 21). The log hauler has a noticeable crack in the side, and is likely to have been abandoned here as a result (Figure 5).

Figure 5. Close up of log hauler, Makatote tramway. Photo Department of Conservation Tongariro/Taupo Conservancy, August 2004.

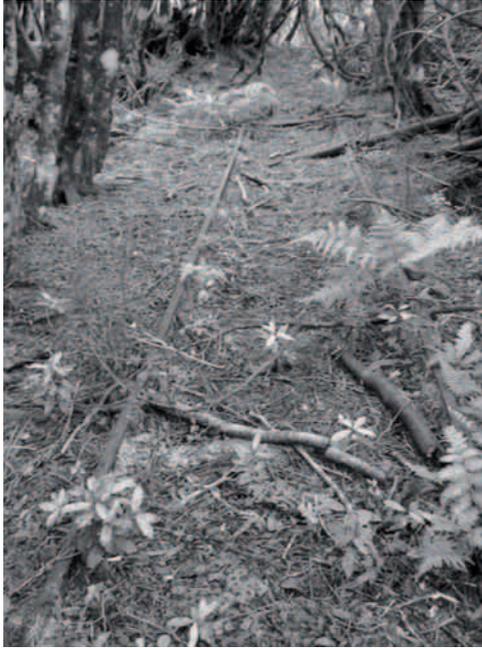
Figure 6. Section of metal rail on right hand branch, Makatote tramway. Photo Department of Conservation Tongariro/Taupo Conservancy, March 2005

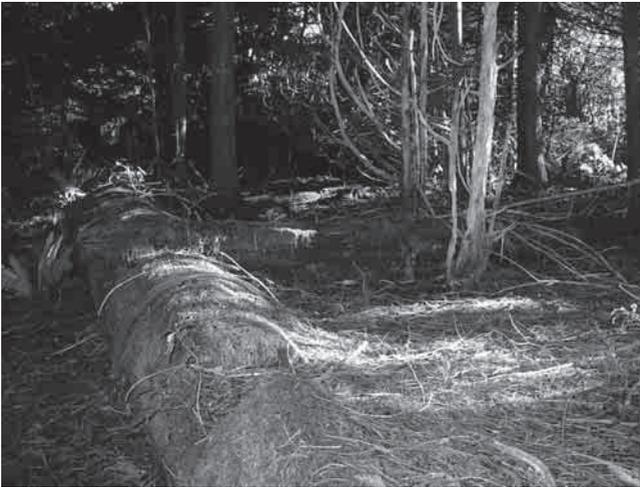
16 skid sites have been recorded within the Makatote tramway site, either adjacent to the main branches, or at the end of side branches. These skid sites are of varying condition and size, but they all have the same basic construction, with a series of notched base lateral logs supported several cross beams which the logs were hauled onto (Figure 8). Wire rope was frequently observed around tree trunks in close proximity to the skid sites, and scaffolding marks were also recorded on two tree trunks. Associated draglines also varied in their length and depth; some were difficult to detect while others were clearly visible with a depth of 1–1.5 m. In some cases the draglines also forked, as seen with the dragline that runs off the corduroy track down to the Makomiko Stream and continues on the other side. This dragline is 2 m wide, 0.6 m metres deep and has a length of 243.5 m before it forks into two branches. The left hand branch continues for another 49 m while the right hand branch continues for a further 229 m.

Figure 8. Skid site, Makatote tramway. Photo Department of Conservation Tongariro/Taupo Conservancy, August 2004.
