**THE LAST ROAST: ARCHAEOLOGY OF THE HISTORIC COPPER INDUSTRY
ON KAWAU ISLAND 1843-1855.
EXCAVATIONS 1991**

Rod Clough
Department of Anthropology
University of Auckland

THE ARCHAEOLOGY OF THE SMELTING HOUSE (R9/642)

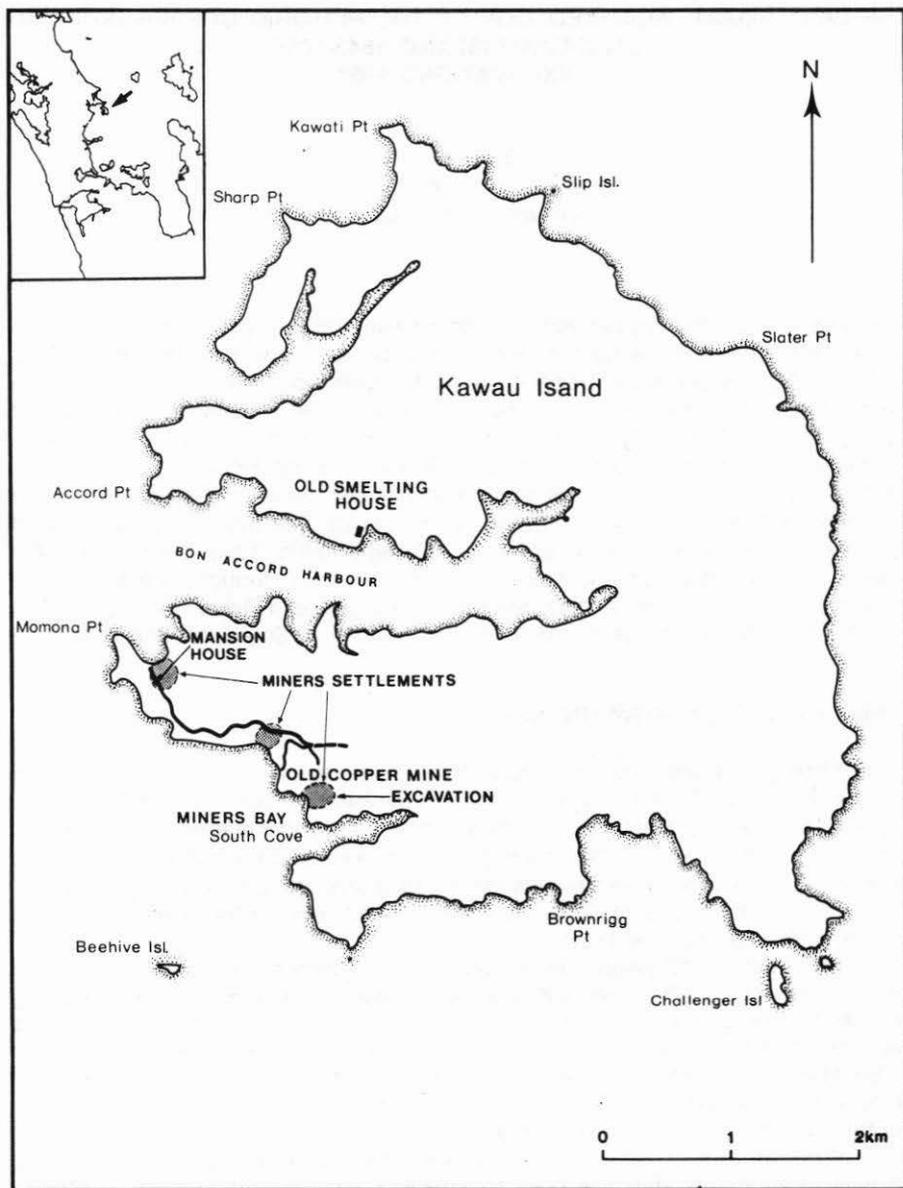
Fig. 1. Location of sites related to the mining industry on Kawau (exact location of settlement in Bon Accord Harbour unknown).

Mining on Kawau began in early 1842 for manganese. Private prospecting by the miners, at this time, revealed the copper-bearing lode in South Cove (Fig. 1) and after assessment by Kingshorne (the then superintendent of the Great Barrier copper mine) in 1843, mining of the Kawau deposit began in 1844 and continued erratically under various mine managers for approximately 12 years. There were attempts to re-open the workings and dewater the mine c.1900, but these were even shorter lived.

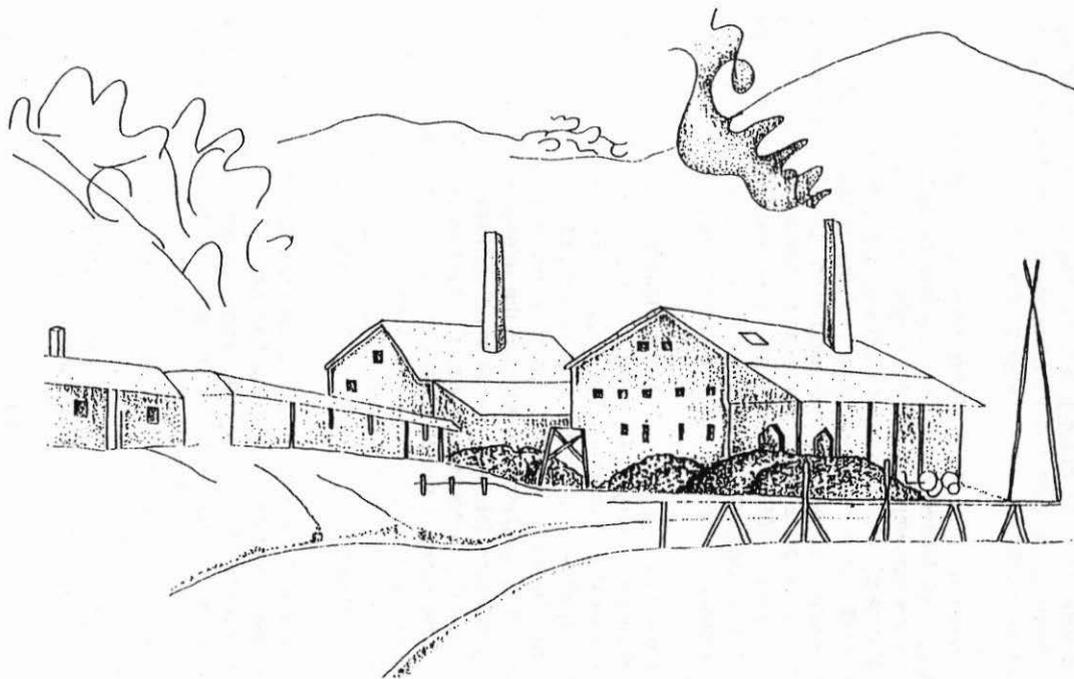
Fig. 2. Smelting House, Kawau, after Heaphy sketch of the 1850s (Heaphy Sketch Books, Auckland Institute and Museum).

Of particular interest was a sketch by Charles Heaphy, probably drawn in 1851 when Heaphy applied to survey Kawau Island (Fig. 2), which relates to the extant remains of the smelter and the surrounding area. It reveals not only the location of small cottages/offices, but also a large building of similar size to and immediately behind the Smelting House. There is no mention of such a structure in the documentary evidence, apart from the reference by McDonald to a battery of roasting furnaces (above, 'The smelting complex'). It is possible that it was used to house the furnaces and was demolished with them on the arrival of Mr Berger. The Heaphy sketch clearly indicated that today's lonely Smelting House was, in the middle of the 19th century, just part of a large industrial complex. For this reason, the 1991 season focussed the bulk of its efforts at this site, with investigation of Miners Bay continuing on a smaller scale.

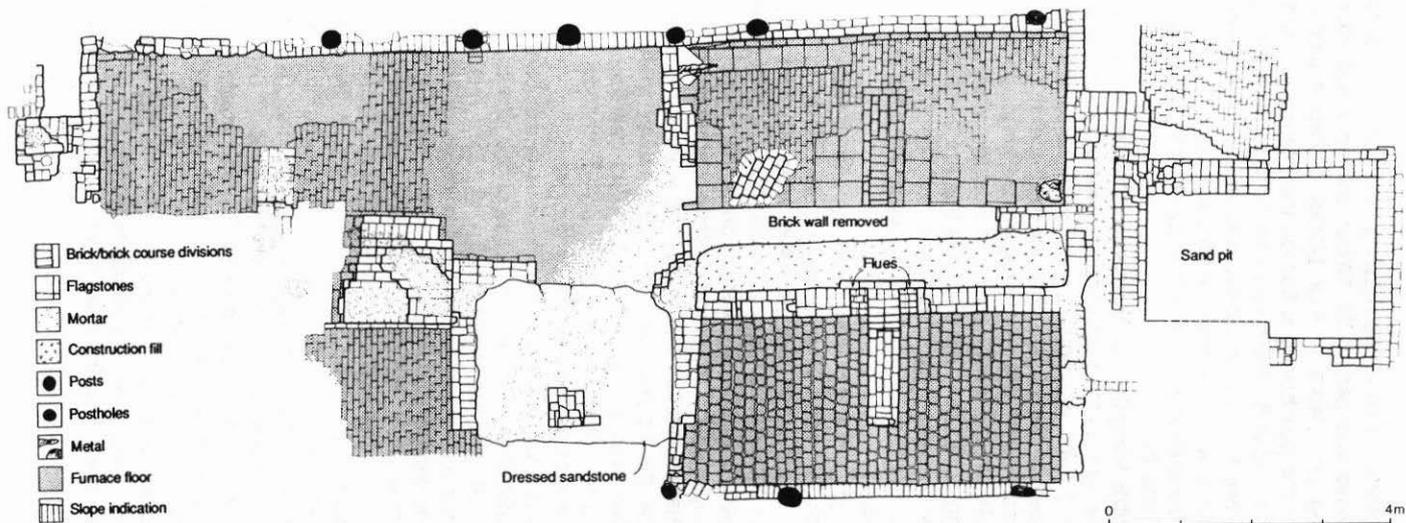
Fig. 3. Plan of the remains of the roasting installation excavated in 1991 (north at right).

roasted just prior to demolition. Two of the roasting cells were in a better state of preservation and had flues and part of the timber superstructure intact (Fig. 3, Plate 1). The roasting cells were in four blocks of two interconnecting furnaces, each member of the pair having a flue on the interior wall and being divided from the other by a half-wall. Each pair was back to back with another pair, though separated by two thick internal brick walls and a rubble-filled cavity. The two units of four roasters were separated from each other by a substantial sandstone block which undoubtedly formed the foundation for heavy plant, possibly crushing gear (Plate 2).

A further structure with solid metre deep brick walls and a brick floor was attached to the roasting installation, but had no sign of fire damage, nor were the bricks refractory (Fig. 3). It was, however, full of fused firebricks, which undoubtedly represented the remains of one of the smelting furnaces rather than the roasting installation, as temperatures required in the roasting process are much lower and would not result in the degree of fusion observed. In smelting processes it is customary to dismantle furnaces at intervals and reconstruct them, replacing the more damaged bricks and relining the remainder. Underneath this furnace debris was a thick deposit of fine white quartz sand, the lower levels of which had been stained orange by iron objects corroding in the pit. The structure had no doorway, and had obviously been used for sand storage, with access to the pit being from above. Probing suggested that the walls of this storage structure continued under the baulk and it is possible that a similar cell or cells remain to be excavated.

It is hoped that the remains of the roasting installation exposed by excavation (Fig. 3) can be consolidated and preserved for display to the public. This would considerably enhance the value of the Smelting House as a historic and educational resource.

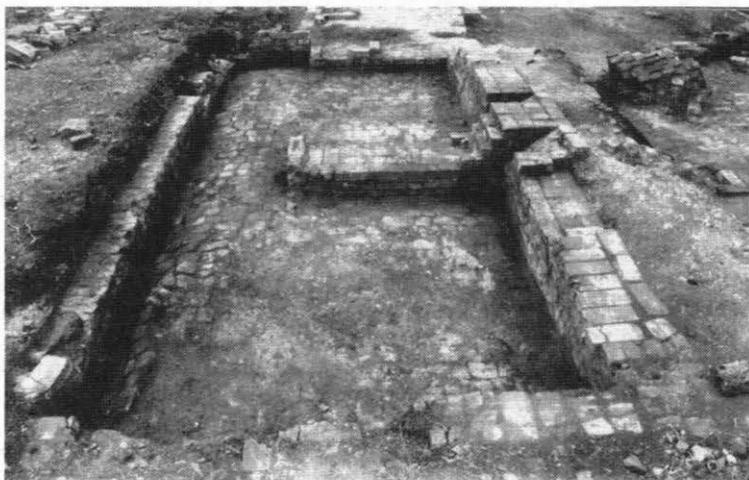
Plate 1. A pair of roasting cells (shown in Fig. 3, lower right), viewed from the north. Note the two flues either side of the partial dividing wall.

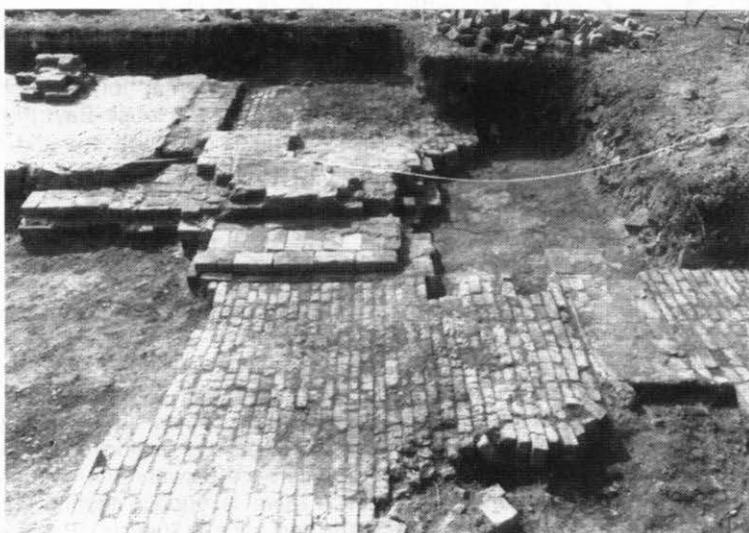
Plate 2. Partially demolished cells (right) and sandstone (crushing?) floor (top left), viewed from the west.

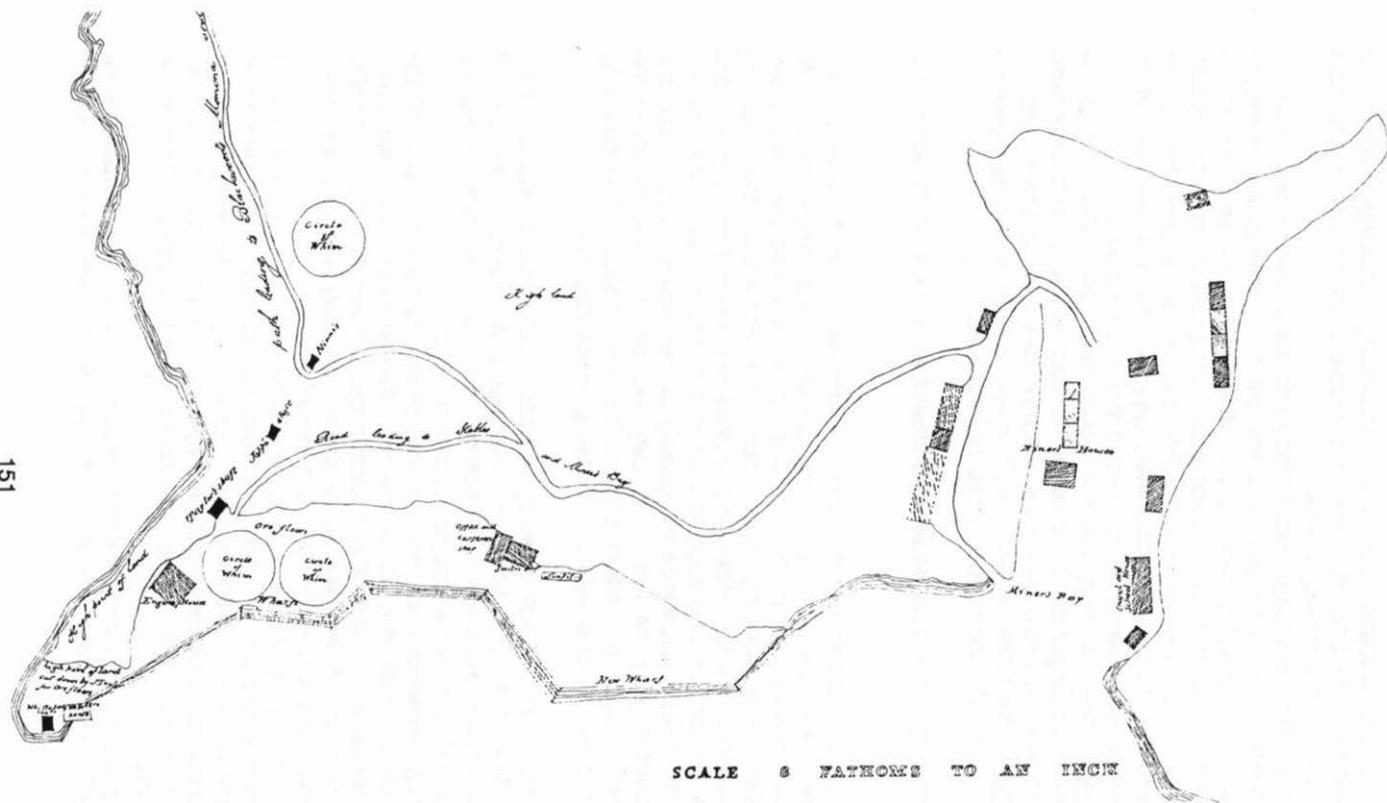
Fig. 4. The mine (left) and miners settlement (right) in South Cove in 1848. Detail from a map by Captain Ninnis (mine manager 1846-1851), National Archives.

1. Mining brings the ore to the surface where it is then processed.
2. Beneficiation, or enrichment of the ore, is usually carried out by a process of mechanical or hand breaking followed by hand selection of the richer pieces. This is facilitated by the colour difference between the copper-rich as opposed to the iron-rich sulphides. There is good evidence for this sorting and breaking process adjacent to the mine at Kawau. Preparation floors were located on the artificial embankment between the mine and the miners' settlement on a map of 1848 by Captain Ninnis (Fig. 4). The ore was then transported by sea to the smelting installation (by lighter barge),
