ARCHAEOLOGY IN NEW ZEALAND

THE USE OF MULTI-RESOLUTION LASER SCANNING/WHITE LIGHT SCANNING TO RECORD THE HISTORIC HUTS OF SCOTT AND SHACKLETON IN ANTARCTICA

Introduction

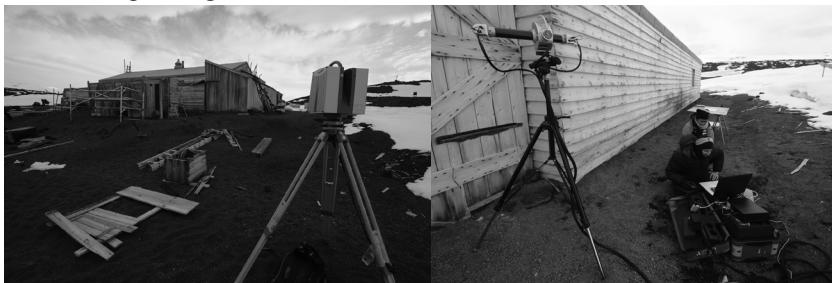
Figure 2. Exterior scanning using the Leica 6100 (left) and the Breuckmann3D-HE (right) at Terra Nova Hut.

Two scanning instruments were selected for the surveys: a Leica 6100 phase scanner for recording exteriors, interiors and topography, and a Breuckmann3D-HE structured light scanner for detailed high-resolution recording (Figure 2). Although both instruments are technically scanners, they operate in fundamentally different ways. Phase-based laser scanners record point clouds based on the shift in phase from the emitted and returned continuous light signal while structured light scanners measure the distortion of a known projected pattern by a surface. The recording resolution for the Leica 6100 is ≤ 3 mm at 90% albedo up to 50 m with the ability to collect 508,000 point of three dimensional point data per second (Leica 2010). The Breuckmann3D-HE can record field of views up to 1200 mm with resolutions down to hundreds of microns, depending on the lenses used.

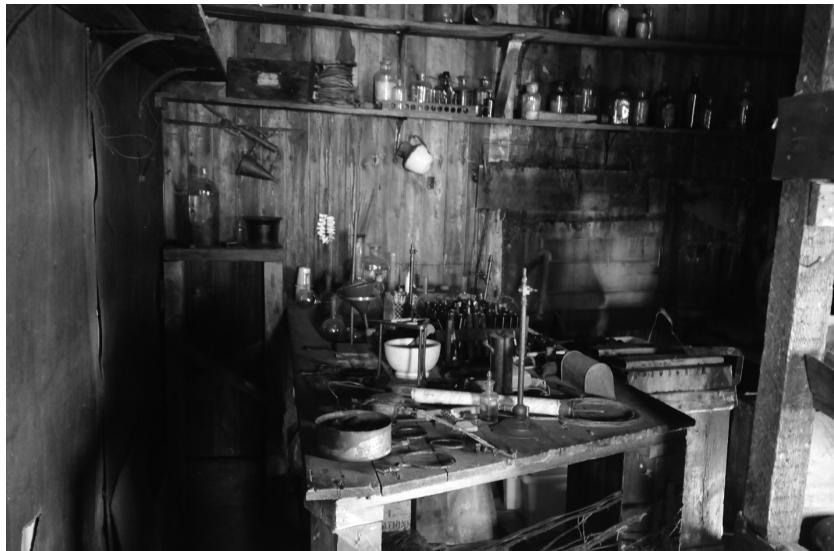
Figure 3. Laboratory table, Terra Nova Hut.

from the previous scans. This is an iterative process that sometimes involves hundreds of scans registered together to achieve optimum coverage. Complex structures like the huts, with their confined interiors full of artefacts (Figure 3) and their exteriors littered with detritus, present numerous challenges for recording, not in the least the requirement for large numbers of scans to survey the complex spaces in their entirety. A direct consequence of this is more time in the field and the resultant requirements for extra fuel for generators and camping supplies.

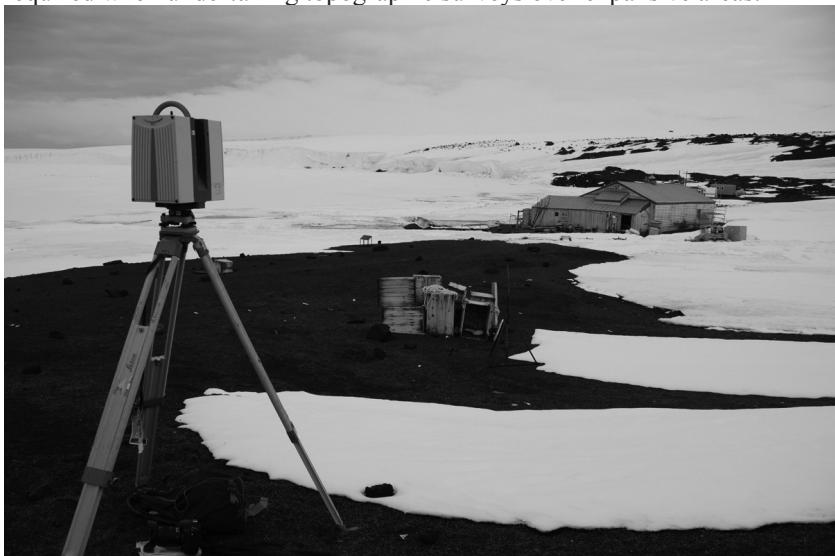
Figure 4. Scanning the topography and abandoned stores around Terra Nova Hut.

housings still brave the elements (Figure 4). The topography surrounding each hut in part governs the affect of the local environmental conditions and how each hut in turn is affected, thus topography and locality is a significant factor in the degradation of the huts. Away from the huts the scanner was traversed over the landscape to provide the best coverage. Unfortunately phase scanners do not have a great range – the Leica 6100's range extends from 50-100 m depending on the conditions and required resolution – so multiple set-ups are required when undertaking topographic surveys over expansive areas.

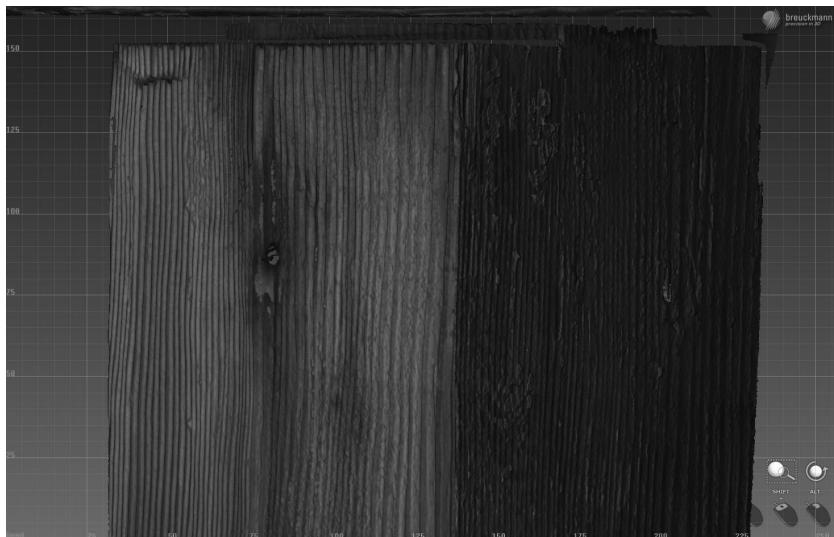
Figure 5. Section of ablated surface from a veranda post, main entrance of Discovery Hut.

here as this area has been modified by McMurdo Station operations. During the return visit high-resolution scans were taken of exterior timbers to record ablated wood surfaces (Figure 5).

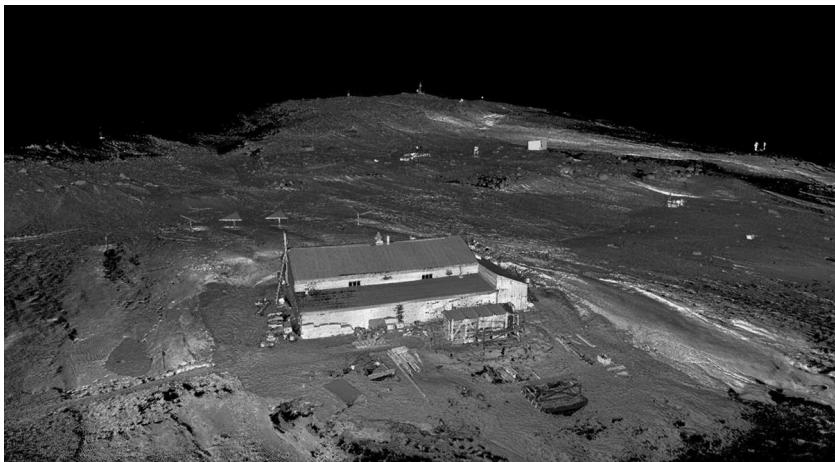
Figure 6. *Terra Nova hut and local environs consisting of sixty point clouds registered together.*

Scanning at Terra Nova was restricted to the recording of all exterior surfaces and associated curtilage and the localised topography due to the presence of Antarctic Heritage Trust conservators inside the hut. Sixty scans were made to record the exterior and a large area surrounding Terra Nova (Figure 6). High-resolution scanning of several artefacts was also tested, using the structured light scanner. This was undertaken to test the efficiency and results of the scanning and registration process in a cold, dark environment. Two metal food cans (one of which had been conserved, and one of which had not; Figure 7), a complex scientific instrument (Figure 8), and a metal artefact were selected for scanning. The cans were selected as a control study to measure future conservation and the others were selected to test the ability of the structured light scanner to record surfaces with different form, detail and reflectivity values within a cold environment.

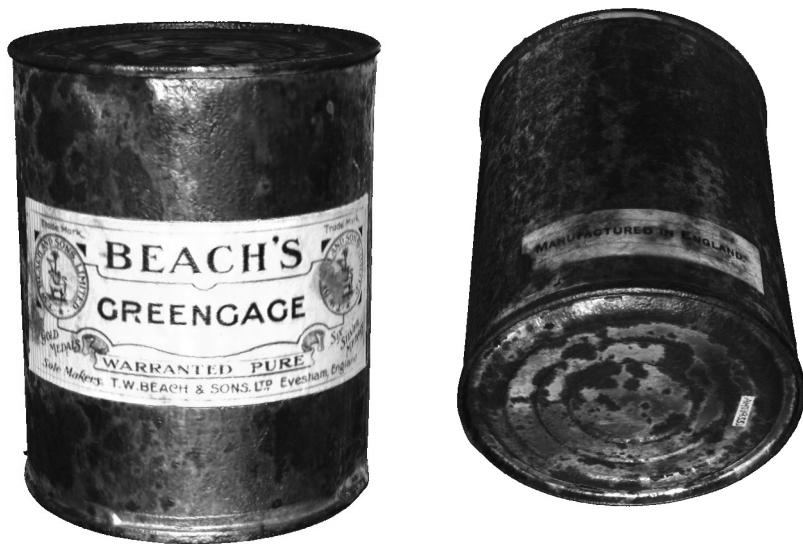
Figure 7. *Raw scan data consisting of approximately 10 million mesh triangles recorded with the Breuckmann3D-HE.*

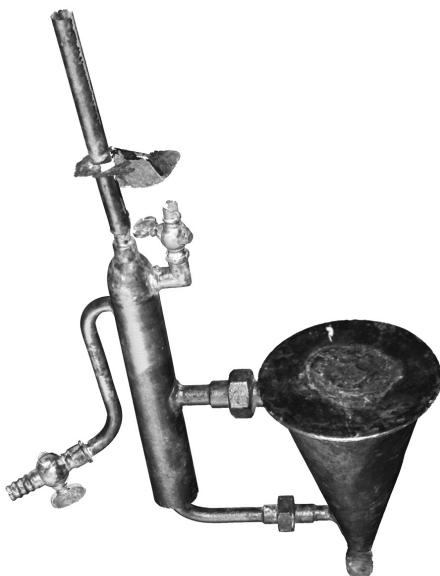
Figure 8. Scientific instrument scanned with the Breuckmann3D-HE.

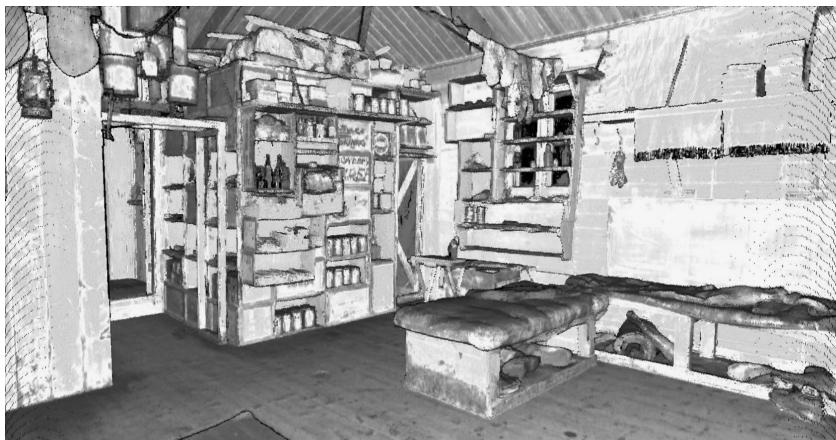
Figure 9. Point clouds showing a section of the interior of Nimrod Hut

At Nimrod Hut, detailed recording of the exterior, interior and topography was carried out, along with high-resolution recording of weathered surfaces, areas of defibration and areas of fungal growth. An almost full coverage of Nimrod was surveyed with 42 interior scans (Figure 9) and 28 exterior scans (Figure 10). Within the interior space there are a small number of occlusions, mainly resulting from materials stored on shelves. High-resolution scans of sections of internal timbers exhibiting signs of defibration and Shackleton's stove have been recorded. A series of high-resolution test scans of a largely intact wall of original stores has also been recorded.

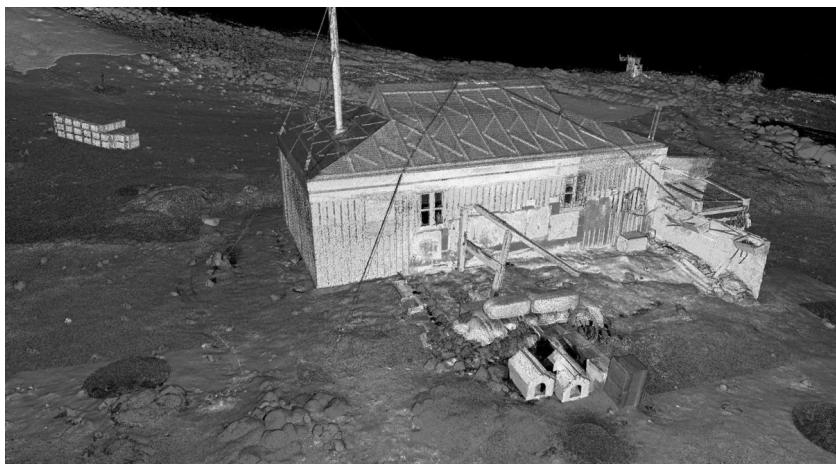
Figure 10. Exterior of Nimrod Hut with abandoned stores and kennels.
