# RECORDING THE HUTTON STREET CEMETERY, OTAHUHU

ARDEN CRUICKSHANK AND MATTHEW  
CAMPBELL  
CFG HERITAGE

In 2012 unconsented fills were dumped in the Roman Catholic cemetery at Hutton Street, Otahuhu, in the gully that ran through the cemetery, and several graves bordering the gully were damaged. The Catholic Diocese of Auckland agreed to remediate the damage by removing contaminated fill, landscaping the balance and repairing damaged graves. CFG Heritage were commissioned to record the damage to graves and their repair, as well as monitor fill removal and contouring (Judge and Mallows 2012; Campbell 2013; Cruickshank 2014).

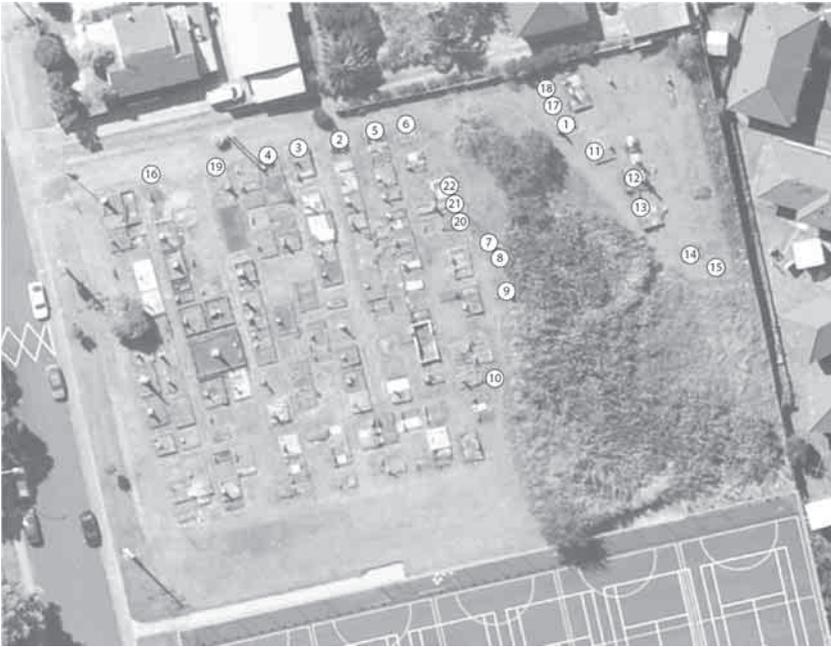
*Figure 2. Aerial photo of the Hutton Street cemetery, with graves that had been damaged, or potentially damaged, numbered. These numbers are referred to in the text.*
