Recycling & Working Class Architectural Respectability

The Buildings Archaeology of 38 Richmond Street, Dunedin

**Peter Petchey
Southern Archaeology Ltd.**

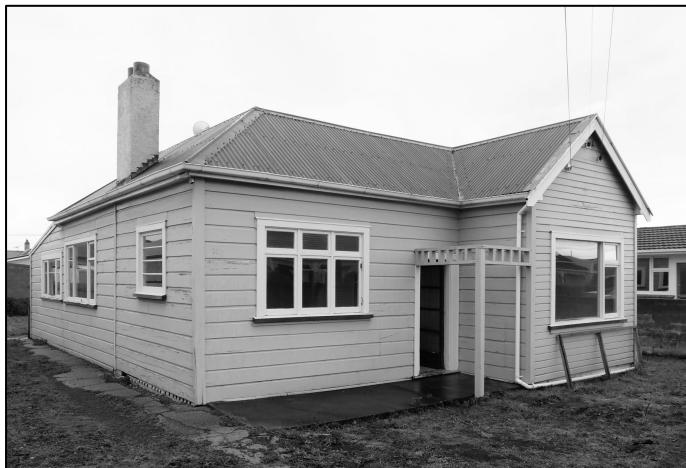
Figure 1. The house at 38 Richmond Street in August 2016.

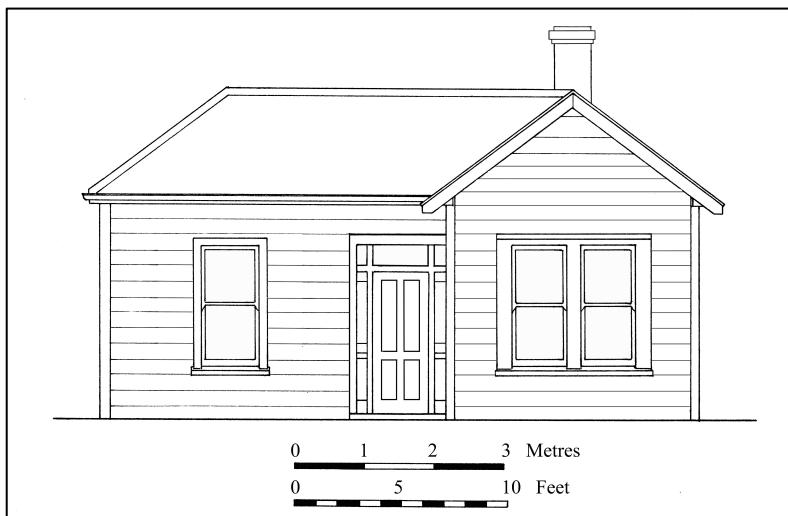
But despite the second hand materials and structural shortcomings, the small cottage at 38 Richmond Street was finished off to conform with contemporary design aesthetics, with its bay window frontage, sash windows and front door with sidelights and fanlights (Figure 10), details shared with middle-class villas. These details immediately too it one step past the plain rectangular box cottage with simple door and windows (such as the Class E cottages discussed by Clarke 1962). Another nearby 1890s cottage at 13 Braemar Street that has recently been examined in detail (Moyle & Petchey 2015) had been modified during its life (in 1905) by the addition of two bay windows on the front, transforming it from a simple box cottage to a double bay cottage or even a small villa street: appearance was important even in working class South Dunedin. The implications of appearance and respectability in domestic houses are explored further in Petchey & Brosnahan (2016).

Figure 10. The possible appearance of 38 Richmond Street when it was built, based on structural evidence in the house. Compare this to Figure 3.
