## NEW ZEALAND JOURNAL OF ARCHAEOLOGY

# Archaeology of the Katherine Mansfield Birthplace, Wellington, New Zealand: “It’s all memories now... .”

Kevin L. Jones<sup>1</sup>

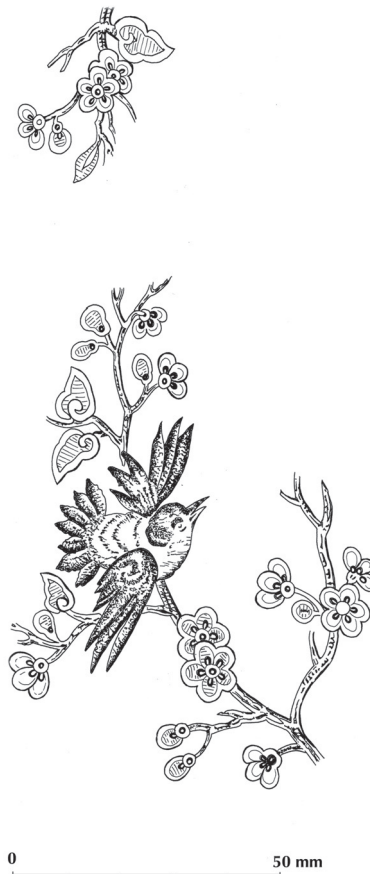
Figure 9: The design on the brown under-glaze Japanese blossom and bird mug, a typical example of Japonisme. Separate fragments were recovered from the base lenses of the rear yard layer 2 fill, and from the driveway cinders fill. Drawing by Jadwega Karas.

glass, some ceramics and a piece of the Japanese cherry blossom with bird china mug, the other part of which was found in the Layer 2 fills in the rear yard (Fig. 9).
