NEW ZEALAND JOURNAL OF ARCHAEOLOGY

Bedggood Buildings, Te Waimate, Bay of Islands: Excavations on the Site of the Blacksmith's Shop, 1986

Archaeological excavations carried out at the blacksmith's shop on the Bedggood Buildings property, Te Waimate, Bay of Islands, are described. The building was erected some time after 1845 and collapsed in 1979. The excavations were necessary in preparation for its reconstruction, to recover evidence to be destroyed in the rebuilding process and to provide information to enable the rebuilding to be accurate. Blacksmithing sites and tools of the early nineteenth century in the Bay of Islands, and archaeological evidence of other blacksmithing sites in New Zealand and Australia are discussed.

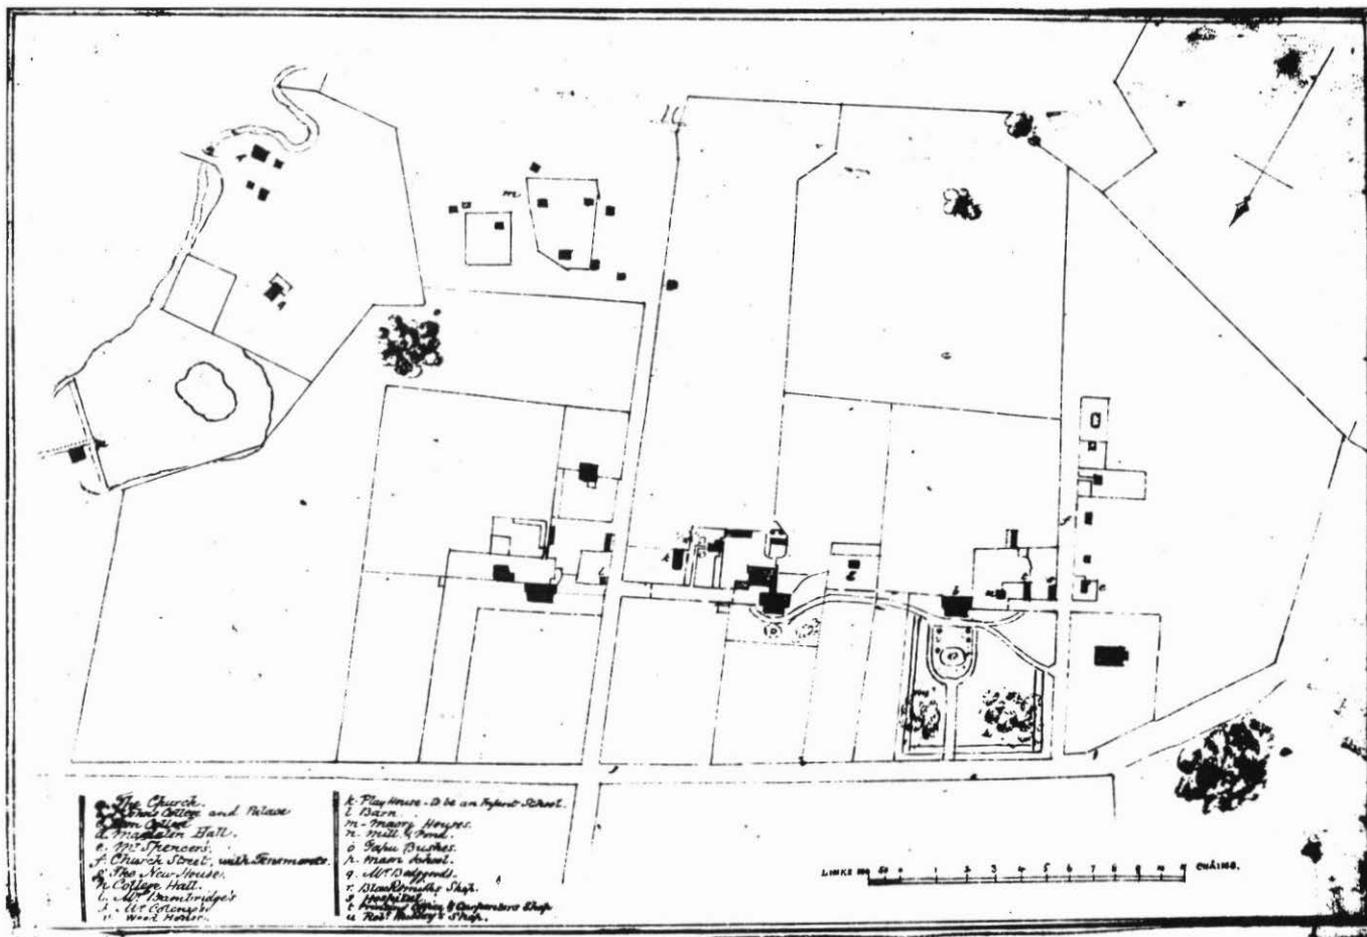
Figure 2: A plan of Te Waimate, 1843, by W. Bambridge, from the Journal of the Rev. W. C. Cotton (Cotton 1841–48: vol. IV f.106B, D.L. ref. MS 36). Reproduced with the permission of the Dixon Library, State Library of New South Wales. Note 'Mr Bedggood's' house (q), 'Blacksmith's Shop' (r), and 'Maori Houses' (m).

The New Zealand Historic Places Trust acquired the Bedggood Buildings property in 1977, because of the antiquity of the buildings and their significance as remnants of early rural industry. Their proximity and relatedness to Te Waimate Mission House (location (b), Fig. 2), already owned by the Trust, was an added factor. The Bedggood Buildings had fallen into serious disrepair over the 50 years prior to New Zealand Historic Places Trust acquisition. Part of the house survived as a ruin, but the wheelwright's shop collapsed some time after 1966. The blacksmith's shop collapsed in 1979. In 1983 the positions of its corners were marked with pegs, and surviving structural materials were taken into storage.

Two postholes (24 and 25) with clean loose fill, beyond the wall line in the corners of squares B and C, appeared different from others encountered during the excavations. Postholes associated with the blacksmith's shop were found to be irregularly dug oval holes about 600 mm across, within which posts had been placed; earth had then been rammed around the posts, so that the posthole packings and the post remnants or the post positions were all clearly and separately identifiable by excavation. However, postholes 24 and 25 were encountered as the positions of completely decayed posts only, without identifiable wider dug holes or packings, indicating that the postholes were of different origin and may have been of greater antiquity. It is suggested that they are unrelated to the smithy and that they indicate earlier structures on the site, possibly Maori houses (location (m) on Fig. 2; seen in the background on Fig. 3).

In 1985, blacksmith's or household tongs were found exposed in the surface of the first Bedgood blacksmith's shop site, scuffed by cattle (Fig. 2, location (r); see also Fig. 4). These tongs (Fig. 9C) are of the round-nosed type (Bealer 1984: 85), and are thought to pre-date 1845, given that the site was abandoned at that time. The similarity of the tongs to others in the Bedgood Museum Collection at Te Waimate Mission House is striking (Fig. 9D). Their discovery demonstrates the potential of this site, and other mission-related sites in the Bay of Islands, for the archaeology of early nineteenth century technology in New Zealand.

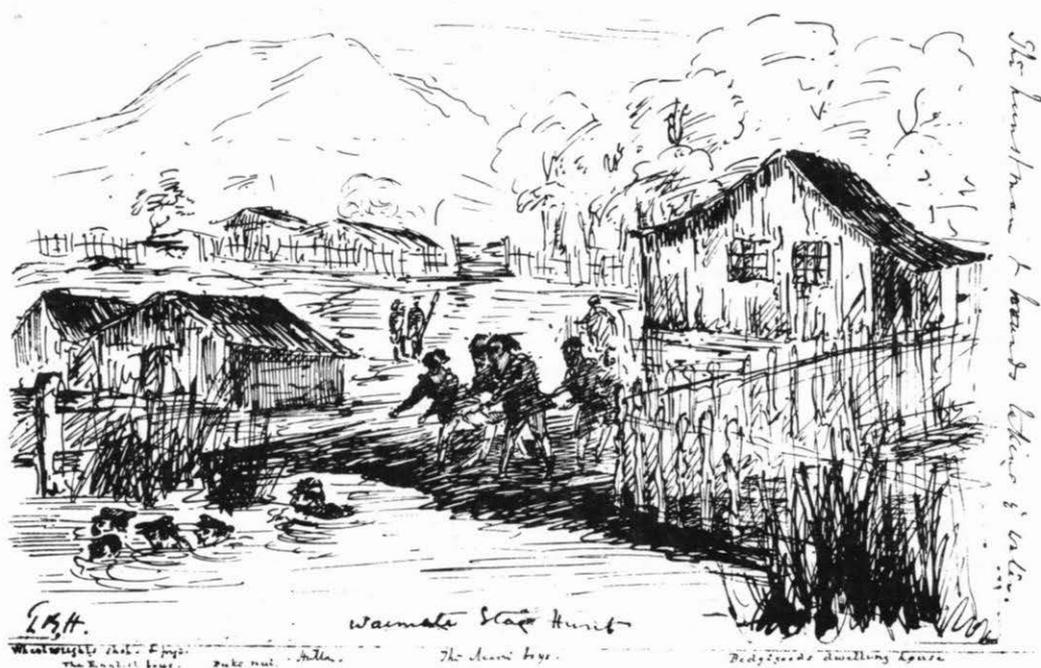
Figure 3: Ink sketch, 'Waimate Stag Hunt', 1844, by T. B. Hutton, from the Journal of the Rev. W. C. Cotton (Cotton 1841-48: vol. VII f.64A, D.L. ref. MS 39). Reproduced with the permission of the Dixson Library, State Library of New South Wales. In comparison with Figure 2, note 'Wheelwright's shop and forge' to the left, 'Bedggood's dwelling house' to the right, and Maori houses to the rear.

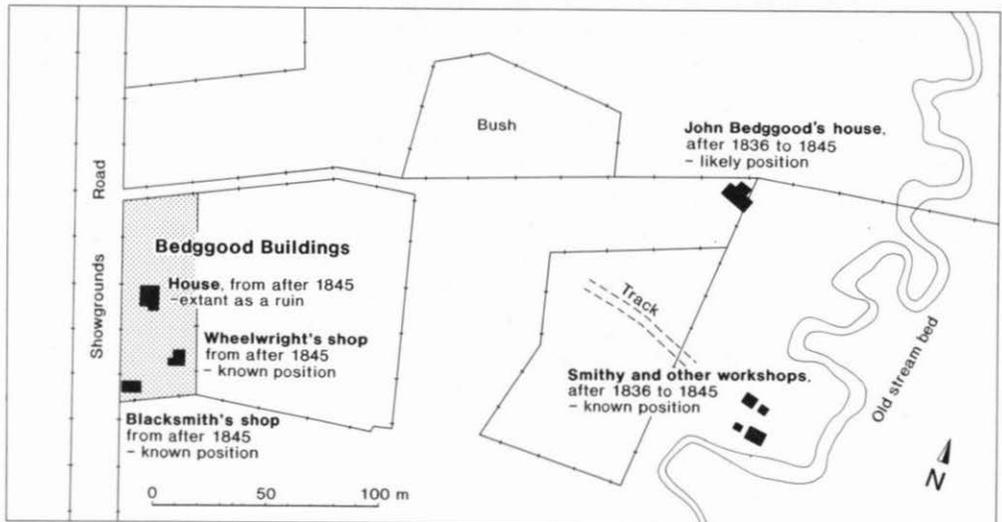
Figure 4: The residences and workshops of John Bedggood, Te Waimate. The Bedggood Buildings property acquired by the New Zealand Historic Places Trust in 1977 is shaded.

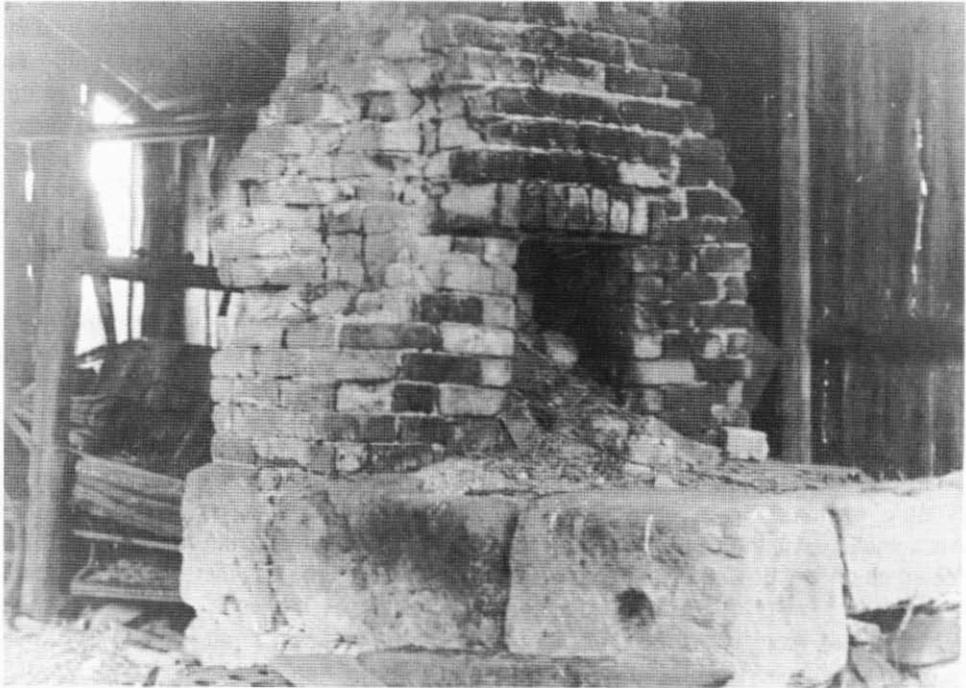
Figure 5: Photograph of the interior of the blacksmith's shop, Bedgood Buildings, Te Waimate, 1966 (Fenwick Barrett's collection: F. Barrett, Court House Lane, Waimate North).

The form of the hearth and chimney, located towards the south side, is clearly evident in a photograph taken in 1966 (Fig. 5). The stone hearth survives but the brick chimney, which originally stood to a height of about 4.8 m, had been demolished before 1977. The fragments of hand-made bricks which remain are commonly 210 x 100 x 60 mm and orange in colour, frequently with a single 60 x 30 mm centrally-impressed diamond shape or frog, or rarely with thumb prints in diagonally opposite corners. The hearth stones are of light blue-grey partially vesiculated basaltic rock, thought to be of local origin. Brick and iron structures are visible in the hearth surface but have not been investigated. The tuyère hole approached from the west end. The bellows, seen in Figure 5, have unfortunately not survived.

In the interior, supports for the western end of the bench (18 and 19) remained standing. The drill-press post (11) was located, surviving below ground level. A post (27) thought because of its position to have been one of two supports for massive horizontally mounted bellows (seen in Fig. 5) was located east of the forge, close to the large south wall post (12). Its hole (27) had a black fill with coal, ash, scale, slag and iron fragments, as if the hole had been repeatedly dug in the floor of a working shop and the successive posts packed with floor debris. This contrasted with the fill of other postholes excavated, which was relatively clean (with the exception of posthole 26). Adjacent to the bellows support post, the heavily trodden floor of the shop was encountered: a compacted 100 mm layer of ash, coal, scale, slag and iron fragments 100 mm beneath the surface. Posthole 26, in the north-west section of square D, contained coal fragments in the fill, and appeared to post-date the adjacent corner post (4). It may have been associated with workshop benches, shelving or other structures along the east wall.

No items of blacksmithing equipment or artefacts other than pieces of brick and highly corroded iron fragments, scrap and offcuts were recovered from the excavations. However, an anvil stood in the blacksmith's shop prior to acquisition by the Historic Places Trust (partly visible on the bottom margin of Fig. 5; see also Fig. 7). This anvil is part of the Bedgood Museum Collection (Stacpoole 1971: 29), now accessioned in the collection at Te Waimate Mission House. It is said to have been previously associated with the Kerikeri Church Missionary Society (Barrett and Lee 1976: item 67). The form of the anvil is consistent with a mission period origin. It is a large example (423 lb, 192 kg) of London type without a maker's mark. Handling holes are present at both ends of the waist and in the base. The feet have been grooved by heavy attachment to a timber post when in use. The table and face are much used, but have not been abused, and show some concavity and well-rounded edges. There appears to be a deliberately manufactured pig's snout at the end of the horn. (For terminology, see Bealer 1984: 66-67.)

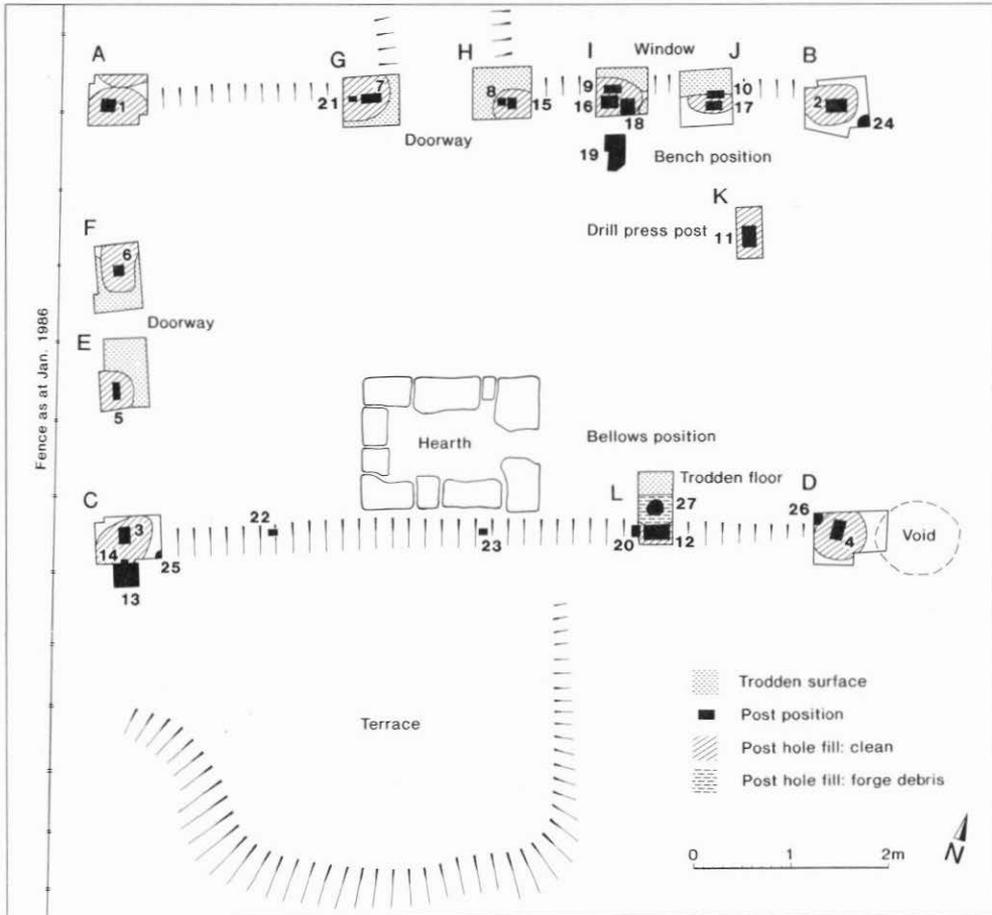
Figure 6: The blacksmith's shop, Bedggood Buildings, Te Waimate. Plan of excavations, 11–14 January 1986.

Square excavations, initially 450 x 450 mm, were dug in the structural post positions measured from the collapsed building (Fig. 6): at the four pegged corner positions (A-D) and at the places measured for four door posts (E-H), two window posts (I-J), and two additional posts (K-L). In all positions, unequivocal evidence of former posts was encountered. The excavation squares were extended where necessary to centre upon the relevant structural posts, as it was intended that the new posts on the wall lines should be erected in concrete in exactly the original positions.

Stratigraphy on the wall lines generally consisted of a top layer of about 100 mm of loose debris and turf, with fragments of fallen bricks from the chimney, very corroded waste and scrap iron fragments, coal, slag, scale and ash. Beneath this was a 300 to 400 mm layer of soil containing a small amount of fragmentary ash, coal, slag and scale. There were occasional lenses of denser coal or ash (north section of square B; north section of square C; south, east and west sections of square D). Except in two cases (posts 26 and 27), posthole fills were relatively clean, and were not composed of shop floor debris. (The fill around post 26 was too small in extent to show on Figure 6.)

1976: items 73 and 62): a bolt header (Fig. 8D) and a large drilling brace (Fig. 9A). The brace is designed for use in a beam drill or press, with pressure being applied by a lever attached to an upright post. Post 11 of the Bedgood Buildings blacksmith's shop (Fig. 6) was used in this way (cf. Bealer 1984: 103).

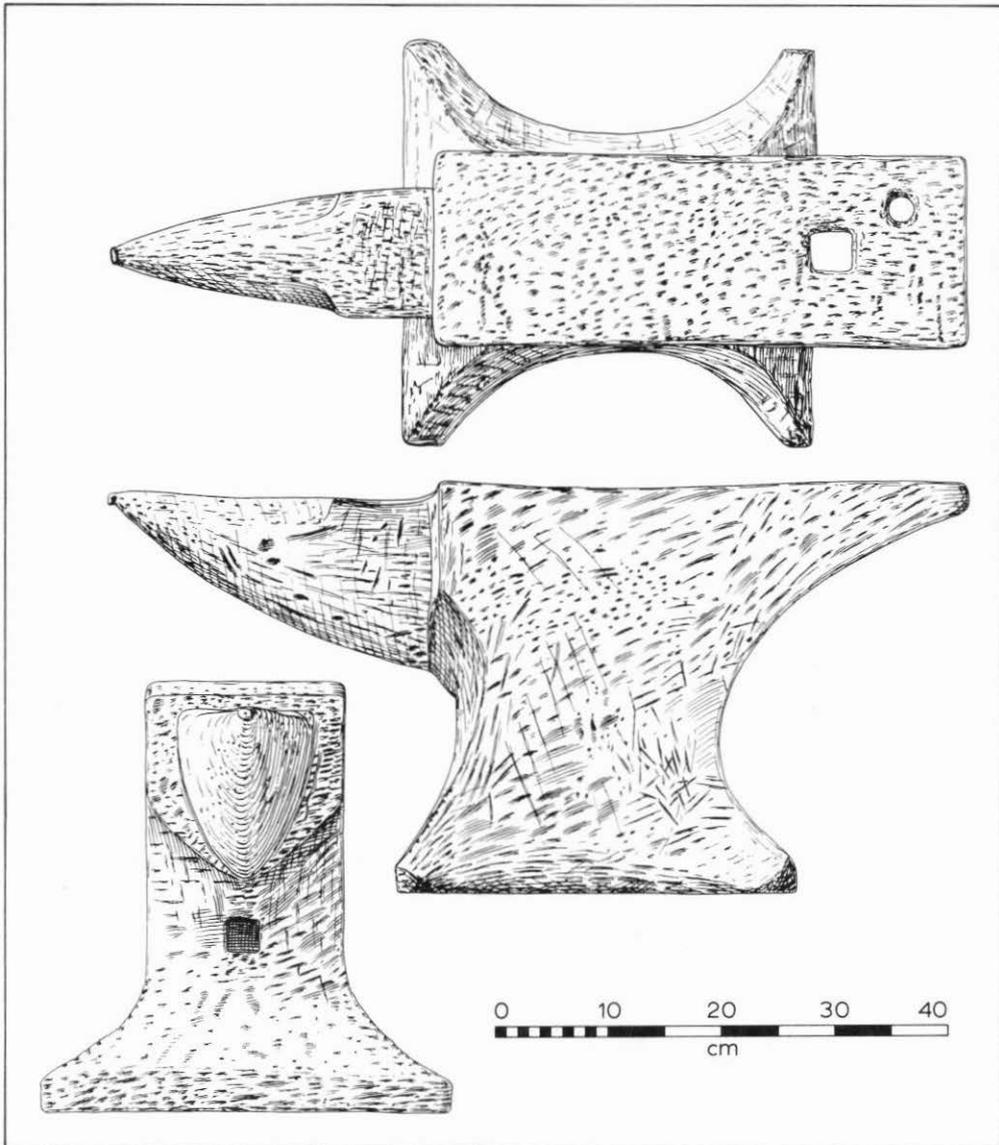
Figure 7: Anvil. XWM 982. For Figures 7, 8 and 9, XWM denotes an accession number at Te Waimate Mission House, XSS at the Stone Store, Kerikeri, and C98A (Figure 9C) at the Conservation Laboratory, Department of Anthropology, University of Auckland. All artefacts are owned by the New Zealand Historic Places Trust.

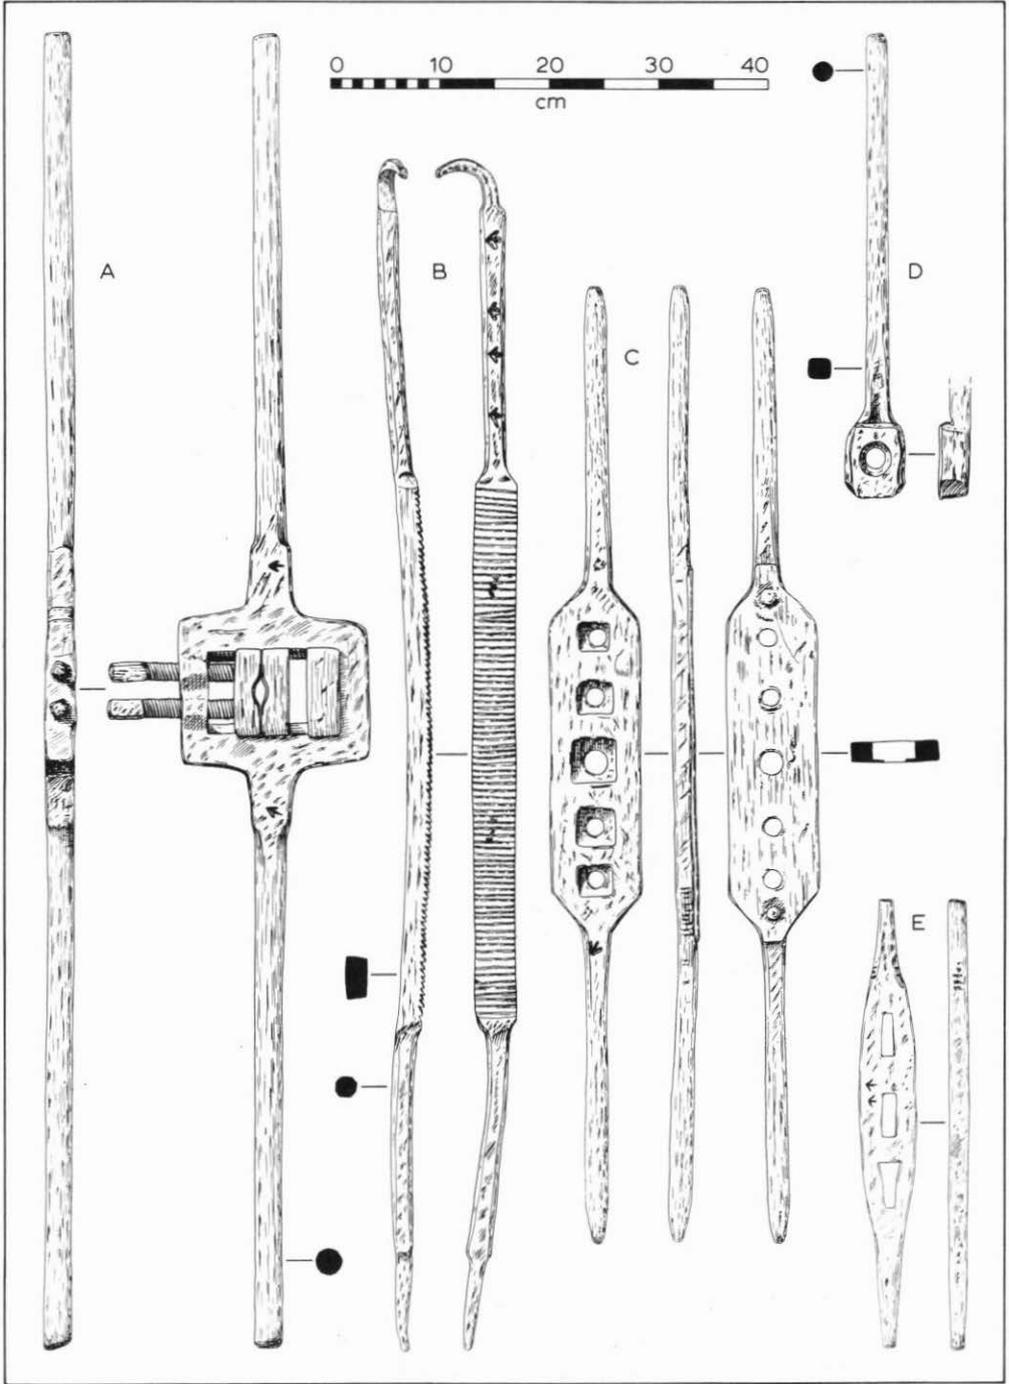
Figure 8: Blacksmithing tools. A, Die-stock, XSS 120; B, File, XWM 972; C, Bolt-header, XSS 402; D, Bolt-header, XWM 936; E, Bar-twister, XSS 403.

In the Historic Places Trust's collection at the Stone Store, Kerikeri, are further blacksmithing tools marked with arrows, which may have missionary connections. These include a bolt header (Fig. 8C), a die-stock used for cutting threads in bolts and screws (Fig. 8A), and a tool for twisting iron bars of various cross-sections (Fig. 8E).

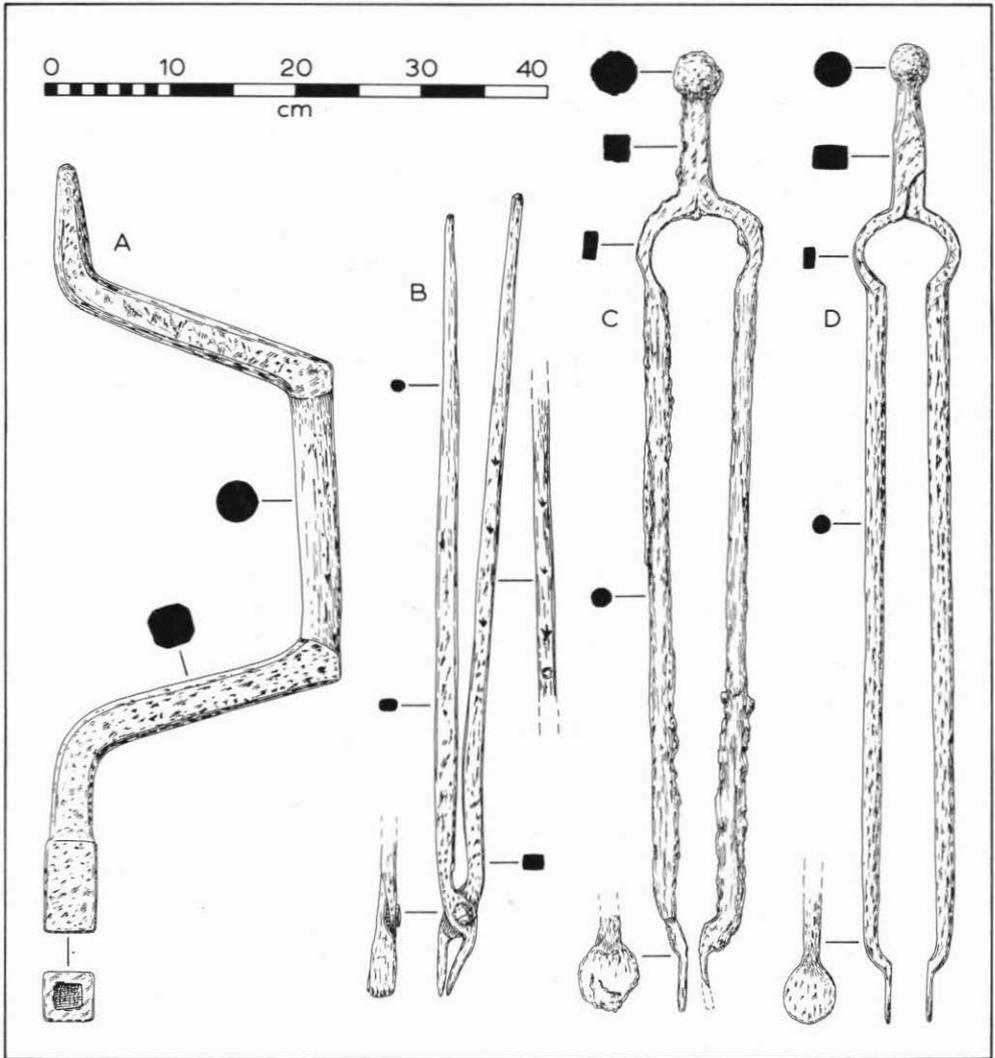
Figure 9: Blacksmithing tools. A, Drill brace, XWM 976; B, Tongs, XWM 933; C, Tongs, C98A; D, Tongs, XWM 932.

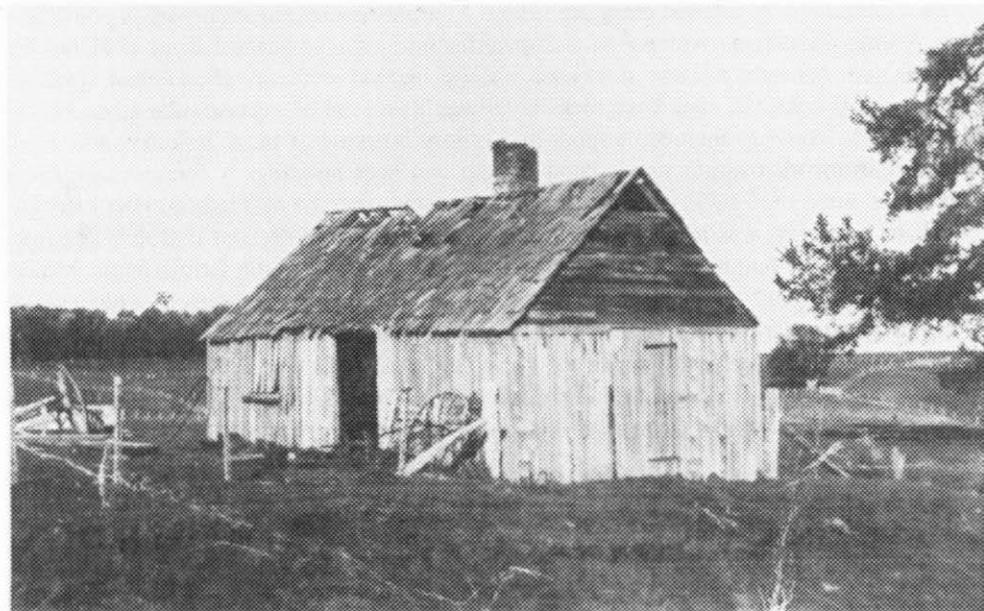
Figure 10: Photograph of the blacksmith's shop, Bedgood Buildings, Te Waimate, c. 1910 (Douglas Bedgood's collection: D. O. Bedgood, P.O. Box 82, Paihia).

Many details of the construction of the blacksmith's shop are apparent in a photograph of the building taken in about 1910 (see Fig. 10) and in others taken in the 1950s and 1960s (Te Waimate Mission House collection, New Zealand Historic Places Trust collection at Antrim House, Wellington, and Mr Fenwick Barrett's collection; see Fig. 5). Further information has been derived from inspection of the collapsed and surviving fabric since 1983. The building was rectangular, and should have been supported by a series of major posts sunk into the ground. The wall cladding was of massive split totara slabs 100 to 300 mm wide and 2.0 to 2.2 m long, which were nailed to a top plate. There were doorways in the north and west sides. A bench was situated beneath a window in the north wall. South

Two features outside the wall line at the western end of the building appear to remain from strainer posts of a north-south fence in line with the building's western side: first, the massive post 13 on the south side of square C, rotted off below ground level, its base inclined to the north from taking the strain of wire; and second, the margin of a hole and chocking for a large post, thought to be later than the corner post 1, encountered in the north side of square A. (The chocking was of heavy iron items and tin cans and was left in position.) This post and wire fence is apparent in the photograph of c. 1910 (Fig. 10).

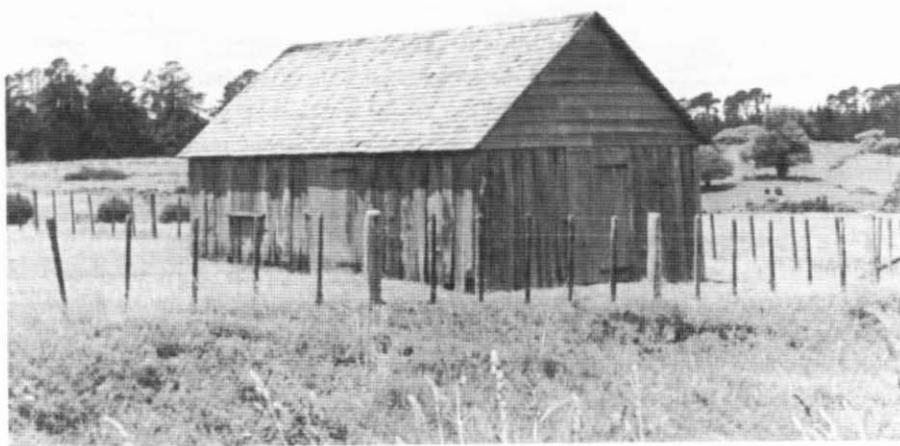
Figure 11: Photograph of the blacksmith's shop as rebuilt, 1991 (Aidan Challis).
